FAILURE ANALYSIS OF ALUMINIUM AND ZINC HEAT REFLECTOR IN TIMBER DRY KILN

Sulistioso Giat S.¹, A. Sitompul¹, M. N. Indro² and A. Rahmatika²

¹Center For Technology of Nuclear Industry Materials (PTBIN)-BATAN

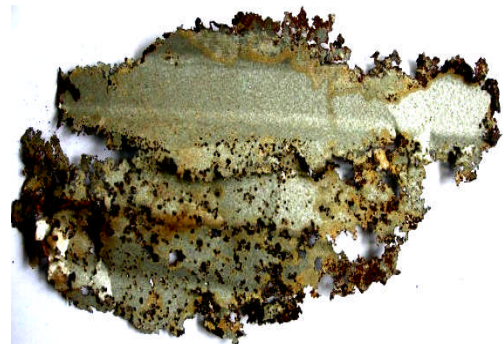
The temperature of the kiln is 110 °C and the kiln was operated in 24 hours non stop. Aluminium and Zinc (Al-Zn) alloy in this kiln to function as a sub ceiling. This ceiling was used as a heat reflector in order to isolate the heat and the heat can be reflected back to the timber. Kind of wood that was dried in timber dry kiln is Sengon wood. After six months continuous service, the Al-Zn heat reflector was corroded and rusty. Figure 1 showing the corroded and rusty Al-Zn alloy that was used as heat reflector.

Figure 1. The corroded Al-Zn heat reflector.

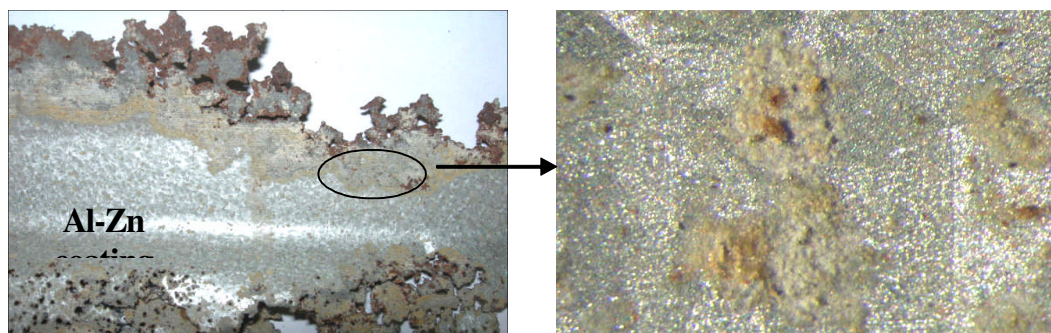
Observation by using digital camera showed that the surface texture was relatively rough and thin particularly at the edge of the sample, see Figure 2.

Figure 2. Photograph of surface exhibit the deposit around the perforated area (a) and exhibit the corrosion product seems like deposit (b).

It can be seen that the thin of the sample also followed by the existence of dark-brownish perforated area. It means the Al-Zn coating at the sample's edge has flaked off and corrosion products were observed around the perforated area on the surface. In the contrary, the visible of spangle in the middle of sample proves that Al-Zn alloy still remain. Observation of corrosion products can be clearly seen by using stereomicroscope. They adhered on the surface layer of the sample seems like deposit. [12,13].

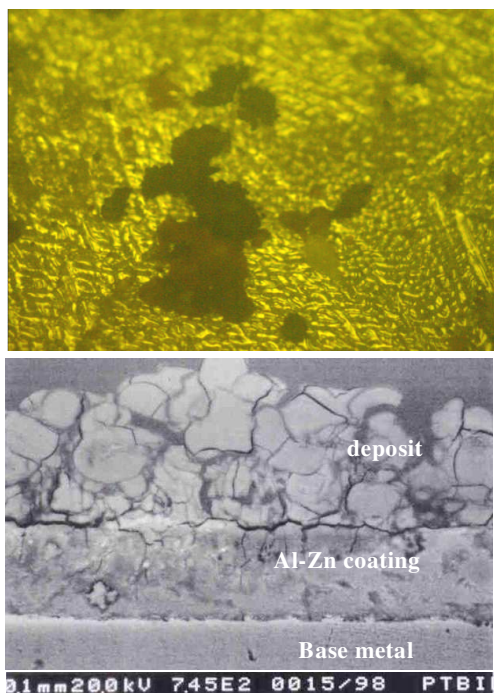
Figure 3 showing the microstructures of Al-Zn coating surface that was used as a heat reflector and corrosion deposit observed at cross section. The coating on the surface still remain intact but there is corrosion deposit adhered on the above of coating, it appear as somewhat dark reddish stain. The existence of deposit obviously detected by SEM.

Figure 3. Surface (left, 200X) and cross section microstructures of Al-Zn heat reflector.

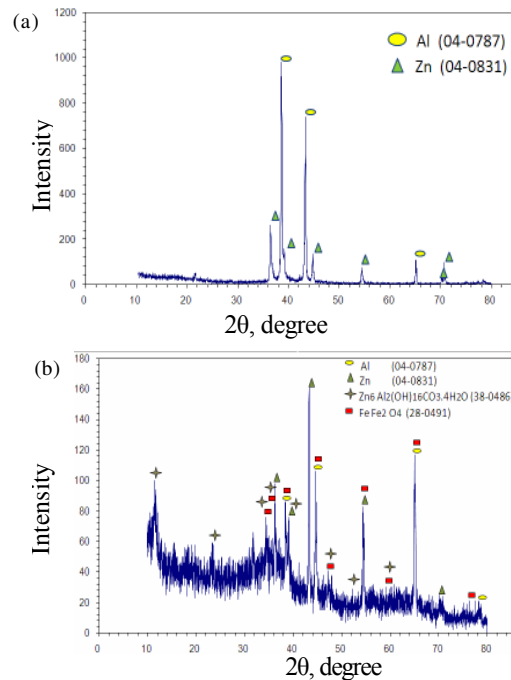
Phase analysis by using X-Ray Diffraction (XRD) in Figure 4 revealed compounds that contain in heat reflector consists of coating composition just like the fresh sample, they are Al-Zn as a strongest peak. Small amount of iron oxide (Fe_3O_4) and Zinc aluminum carbonate hydroxide hydrate ($\text{Zn}_6\text{Al}_2(\text{OH})_{16}\text{CO}_3 \cdot 4\text{H}_2\text{O}$) were also identified in the corroded heat reflector. The latter phase is predicted as dark reddish corrosion deposit that adhered on the coating.

Figure 4. XRD pattern of (a). fresh sample Al-Zn coating and (b). corroded Al-Zn heat reflector

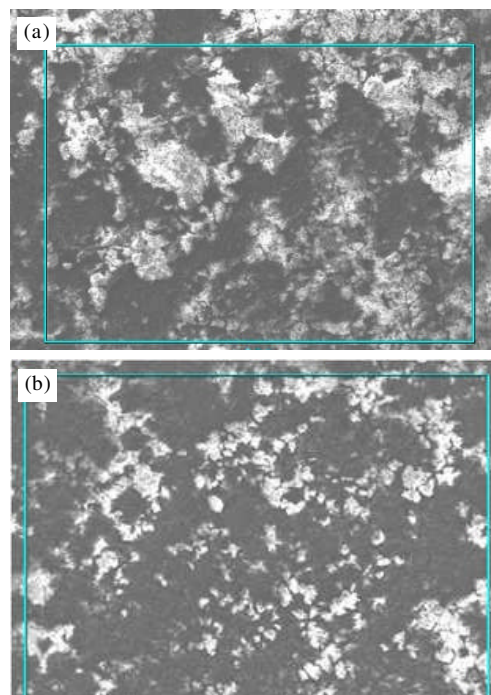
Figure 5. Square analysis of corroded Al-Zn heat reflector.

Table 1. Chemical composition of square area in Figure 5

Element (wt.%)	Square Area 1	Square Area 2
C	18.34	10.34
O	38.84	43.15
Al	10.09	17.87
S	1.82	0.73
Cl	0.62	1.70
Ca	3.91	1.44
K	--	0.09
Fe	3.82	0.91
Zn	21.17	23.62

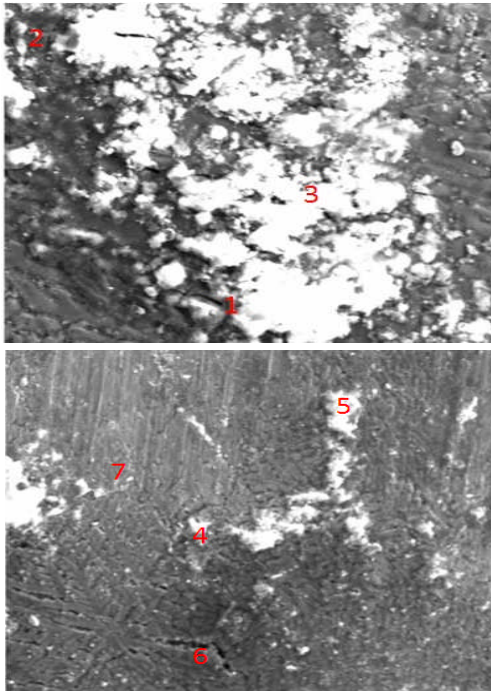
Figure 6. Point analysis on the corroded surface Al-Zn heat reflector.

Table 2. Chemical composition for every point in Figure 6

Element (wt.%)	Points						
	1	2	3	4	5	6	7
C	13.13	16.30	28.51	13.54	12.67	67.58	34.27
O	48.58	31.13	37.56	33.57	40.18	3.77	7.16
Al	15.48	2.99	5.85	14.60	12.61	9.69	21.53
Si	---	3.97	---	3.25	0.49	0.24	0.09
S	1.28	1.59	3.78	0.44	---	---	---
Cl	1.75	5.98	0.82	---	---	---	---
Ca	0.84	0.80	0.59	2.09	1.83	0.03	0.09
Fe	0.51	1.30	1.02	12.48	8.39	0.27	0.60
Zn	17.95	35.93	21.86	19.65	22.04	18.21	36.22
K	0.49	---	---	---	---	---	---

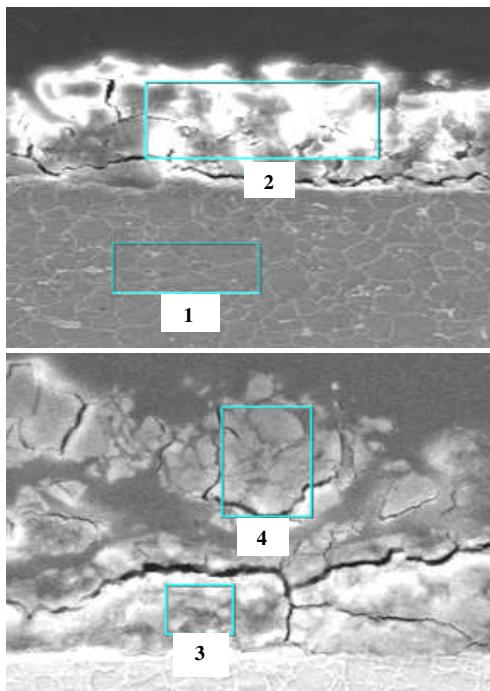
Table 3. Chemical composition of square area analysis in Figure 7

Element (wt.%)	Square Area			
	1 Base metal	2 coating	3 coating	4 deposit
C	2.27	30.47	19.34	22.46
O	0.41	35.36	34.13	43.69
Al	---	13.30	22.49	18.77
Si	0.09	1.12	2.92	0.32
S	---	0.97	1.18	1.47
Cl	---	---	0.56	0.12
Ca	---	0.55	---	1.64
Fe	97.23	0.89	1.52	0.37
Zn	---	17.25	17.86	11.16
K	---	0.09	---	---

Figure 7. Square analysis at the cross section of corroded Al-Zn heat reflector.

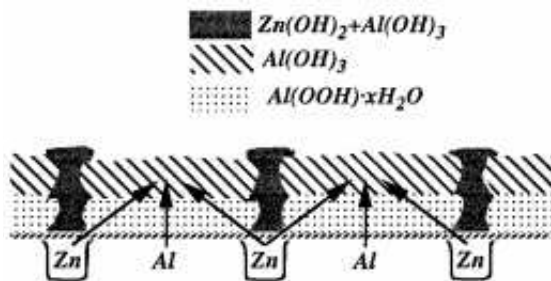
Figure 8. Formation of corrosion products in Al-Zn heat reflector.

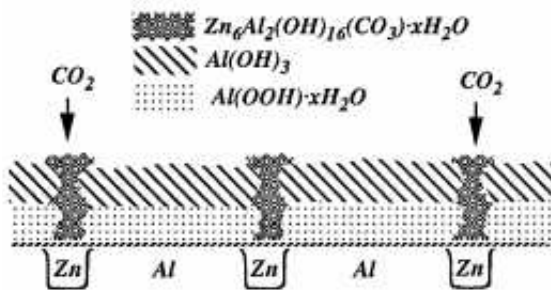
Figure 9. Formation of corrosion products of corroded Al-Zn heat reflector on the underside surface in contact with air.
