EARTHQUAKE DAMAGE INTENSITY RELATIONSHIP FOR RESIDENTIAL HOUSES IN WEST SUMATRA

Febrin Anas Ismail^{*)}, Abdul Hakam, and Fauzan

Civil Department, Engineering Faculty, Andalas University, Padang 25163, Indonesia

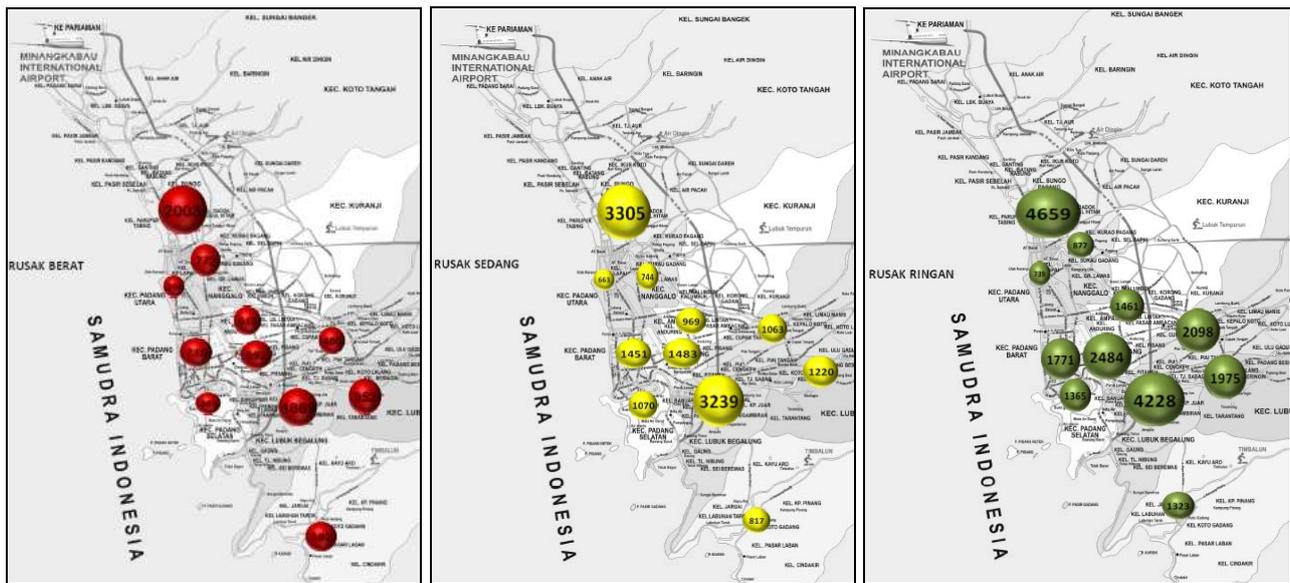
This paper shows the plot results of survey of the damage homes in Padang. The results are displayed in the term of map which is divided by districts in the city. Figure 4a, 4b, and 4c show damage to the residential

houses with the category of heavily, moderate and slightly for the city. In every figure, the number that indicated the damaged houses is displayed in. The size of the bubble also presents of the ratio damage in each district. It seems that there is quite diverse spread of damage to the house. However this spreading data may be figuring the seismic ground condition that has been reported by Sengara *et al.* in 2009 [8] (Figure 5).

Figure 4. Damage Houses in Padang
