A STUDY ON PATTERN DAMAGE OF FINGER JOINTS IN BAMBOO LAMINATED BEAMS

Agus Rivani *

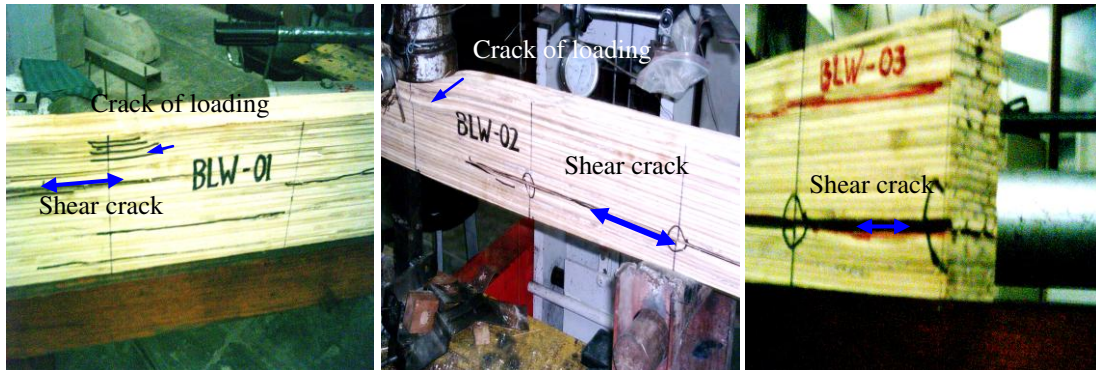
Figure 4. The pattern damage of BLW-0

The pattern damage of clear straight beams (no joint) is shear failure between laminate and glue-line. In this case, it is started with a horizontally crack (initial crack) in laminates, then it happened crack in loading point. Finally, the laminated beam was damage to the support area, which shear stress is critical. Visually, the pattern damage of beams is given in Figure 4.

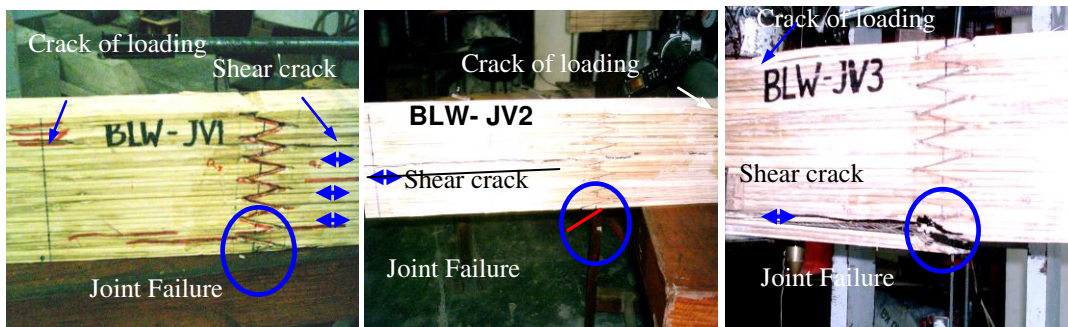
Figure 5. The pattern damage on BLW-JV

The pattern damage of vertically finger-jointed beam is shear failure in laminates before broken at joint. It is started with a horizontally crack in laminate, and then happened crack in loading point. The pattern damage of joint expands to follow line inclination of finger joint. Shear failure was dominated in the mid-span until to the support area. Finally, laminated beam suddenly broken in finger jointing. The pattern damage of

laminated beams is presented in Figure 5.

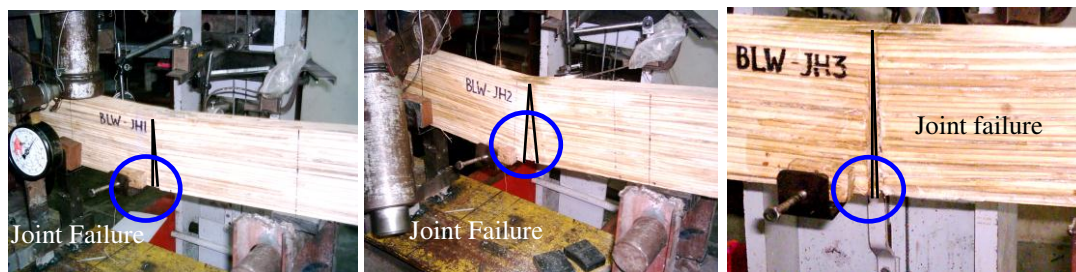
Figure 6. The pattern damage of BLW-JH

The pattern damage of beam with horizontally finger joint is bending failure at joint. It is started initial crack in horizontal direction. There is no crack in loading-point like other beam. The laminated beams are spontaneously broken at the joint. The pattern damage of laminated beams is seen in Figure 6.
