# Georadar Application for Dam Safety Study (Case Study of Selorejo Dam)

Teguh Winari<sup>1</sup>, Kamsiyah Windianita<sup>1</sup>, and Fahmi Hidayat<sup>1</sup>

**Keywords** – Dam, seepage, georadar, anomaly

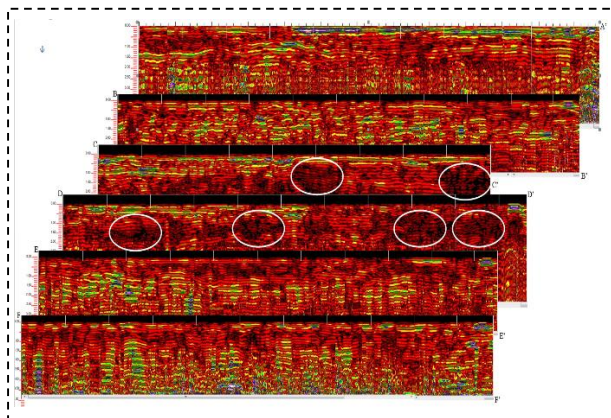
Figure 4. The georadar measurement result of longitudinal path A - A' to F - F'

The georadar measurement result of longitudinal path can be seen at Figure 4 and Figure 5. With a track measurement length of 32 m, georadar can detect until the depth of about 4 m. The radargram result on this soil stack shows a domination of layer discontinuities. This is due to material density variation that is displayed through bright colors, red and black. This bright color appears in all tracks with random spread and dominating that indicates a higher density than red and black area. The almost black and black colors show a weak zone. This weak zone is dominant on track C-C' and D-D' (white circle), and in other tracks it appears as small and local spots. The unconformity on some radargram does not indicate a structure. This thing is considering to measurement on stacks so the possibility is the discontinued layer.

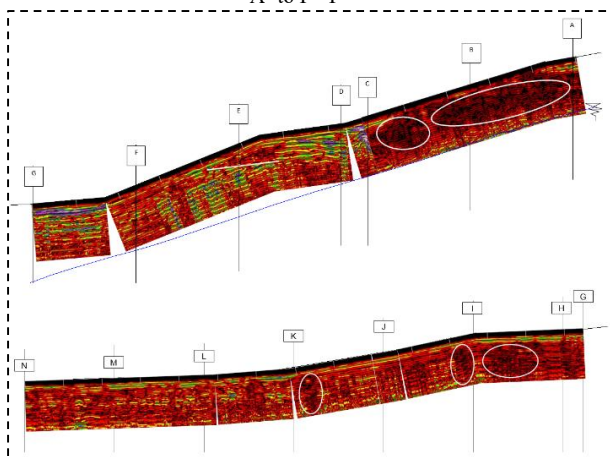
Figure 6. The measurement result of transversal path A - N

- A-N path (Figure 6), from point A to point C (about 15 m), around point I and point K
- O'-O path (Figure 7), around the point H and L - M
- P'-P path (Figure 8), random from point G2 to P
- R-R' path (Figure 10), random from G4 to R
- S'-S path (Figure 11), around point F5

There are also discontinuities (white line) on some tracks, such as track A-G, trajectory O'-G1, P'-G2 trajectory, trajectory Q'-G3, S'-G5 trajectory, and G5-S path. However, because the measurements are performed on the soil stack, discontinuities are not in the dam structure but it is less-well dense material.

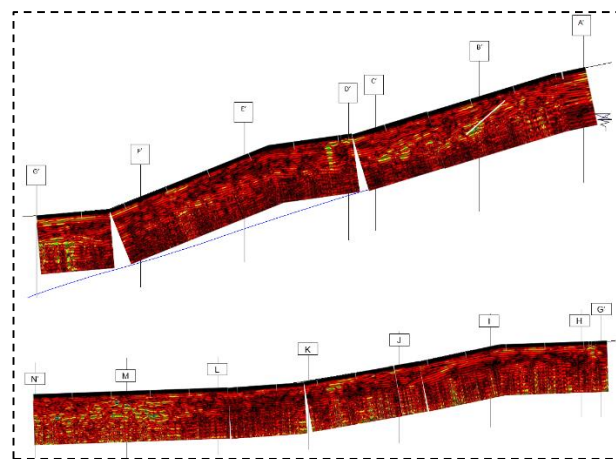
**Figure. 12.** The measurement result of transversal path A' - N'

Radargram in transversal path shows the embankment material that is divided into two layers, with the inter-layer at a depth of 1.5 m. In one track there is upper part which is denser than the bottom, and some are otherwise. The denser top is described with a lighter color (purple-blue-green-yellow) located on the upper layer of 1.5 m, while the lower part is black or dark red. There are some weak zones (white circle) that is shown by georadar measurement result in transversal path :
