Evaluation of Housing Product Quality Using Six Sigma Approach

Febtian Yusvika Wahyu¹ and Trijoko Wahyu Adi¹

TABLE 2.
 QUALITY VARIATION ILLUSTRATION

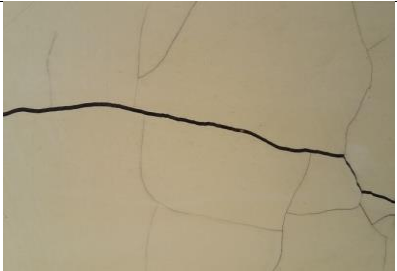
Component	Defect Group	Illustration
Wall	Crack

problem was the damages of house components like floors, walls, ceilings, doors, and windows. The component damages constituted physical damages. The physical damages could be seen by naked eyes clearly. By CONQUAS, the grouping of damage types was based on architectural viewpoint in internal finishes. The type of damages were floor damages (cracks, uneven plaster, not precise plaster, and sounds hollow), ceiling damages (rift ceiling, poor finishing), wall damages (bad finishing, cracks), door and window damages (do not work, damaged accessories, joint or gap damages). The illustration of the quality variation in the housing is attached in Table 2.
