# A Failure Analysis and Remaining Life assessment of Boiler Water Wall tube

**Abstract—** This paper presents failure investigation on the SA210GrC water wall tube by visual Site inspection, tube wall thickness measurements, chemical composition test, Hardness test and microstructure analysis with proper evidence collected to identify the exact cause of the failure. The water wall tube was failed with blister, bulging and creep cracks on outer surface located near to the Soot Blower. On-site wall thickness measurements were performed on some of the water wall tubes located at the same level of the ruptured tube. The tubes have significant wall thinning and erosion from outside. Mild corrosion deposition also seen in the inner side. Microscopic examinations on the failed rupture region and some distance away of the as-received tubes are also conducted in order to determine the failure mechanism and root cause. Failure mechanisms are also discussed and relevant data from few months back to the failure gathered to identify the failure reason. The failure mechanism is identified as a result of the combination of the significant wall thinning of water wall tube due to long term overhe

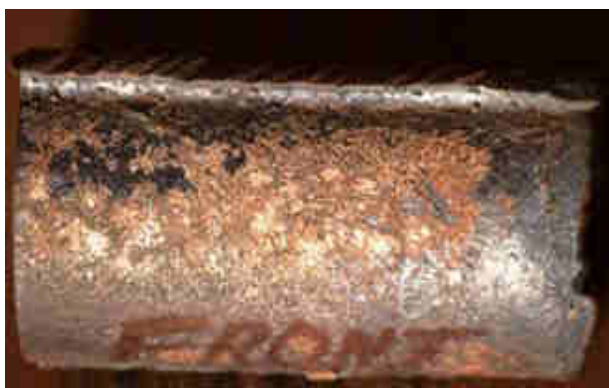
Fig.3.1: Water wall tube before failure tube

In Fig 3.1 it is seen that the tube is in working condition (not failed) and the erosion due to abrasive property of the coal is damaging the surface. In fig 3.2 Bulging of the tube produced due to long term over heating creep damage or due to increasing temperature above the prescribed limit for long time. (1) External metal Wastage is due to corrosion or erosion. In fig 3.3 the Outer surface is covered with oil ash slag which is shining with coal ash layer and wall thinning with external damage is observed. (2) In fig 3.4 Thick-lip ruptures in steam-generator tubes occurred mainly by stress rupture as a result of prolonged overheating at a temperature slightly above the maximum safe working temperature. Thick-lip rupture may or may not be accompanied by sight swelling of the tube in the region adjacent to the rupture. In Fig 3.5 Mild corrosion deposit on ID side may be due to corrosion of protective layer of ferrous oxide. Due to the increasing temperature and bad water chemistry it is happened. (3) It is seen copper segregation at some point makes caustic corrosion.

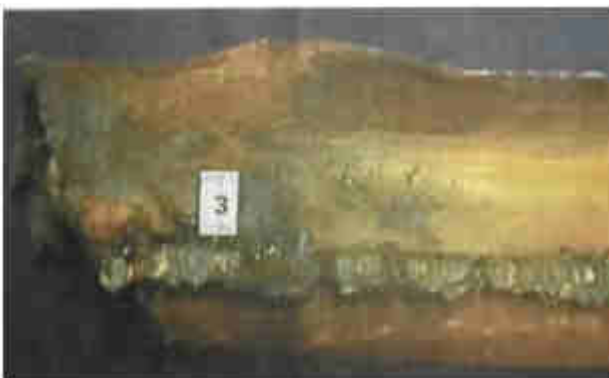
Fig.3.3: External metal wastage

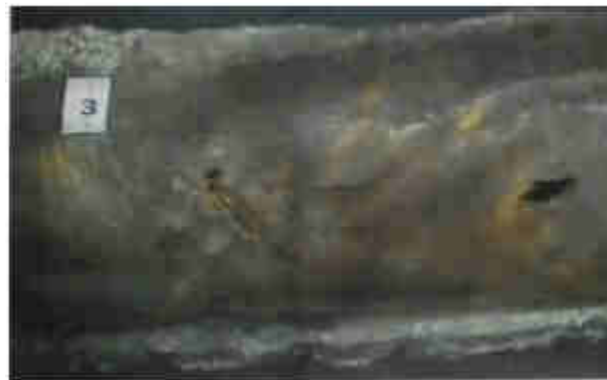
Fig.3.5: Mild corrosion deposit on ID surface in Blistered regions

So it was confirmed from that the failure was occurred after 7000h due to long term overheating and creep. The corrosion in the inner side of the tube was due to pitting/oxygen corrosion.

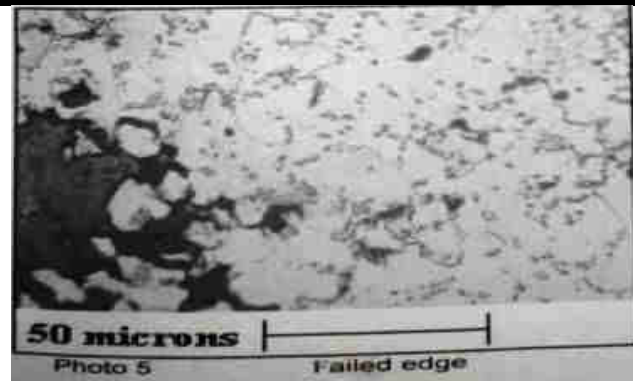
The microstructure of the failed edge shows the growth of the grain boundary. The thick black slag is oxide filled cavities. The creep cracks on surface are due to overheating for long time. The pearlite and ferrite is the main constituent in steel. It is showing the failure due to overheating. Pearlite is dispersed all over.

Fig.3.6: Oxide filled cavities and creep cracks on failed edge

From both the Microstructure Fig 3.6 and Fig 3.7 it is seen that the failure cracks are filled with oxide and blister region with growth of grain boundary. Pearlite becoming decreased and dispersed in some point. Carbon from it goes to grain boundary. So that the boundary becoming hard and brittle which is prone to failure. At some point black dots can be seen are cavities filled by oxide. (5)

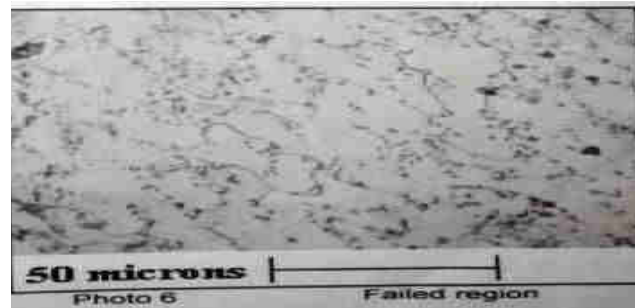
The blistered and failed region shows a microstructure of ferrite and dispersed pearlite with grain boundary carbides. The region opposite to the failed region shows a structure of ferrite and in situ spheroidised pearlite. (4)

Fig.3.7 Fail region of blister

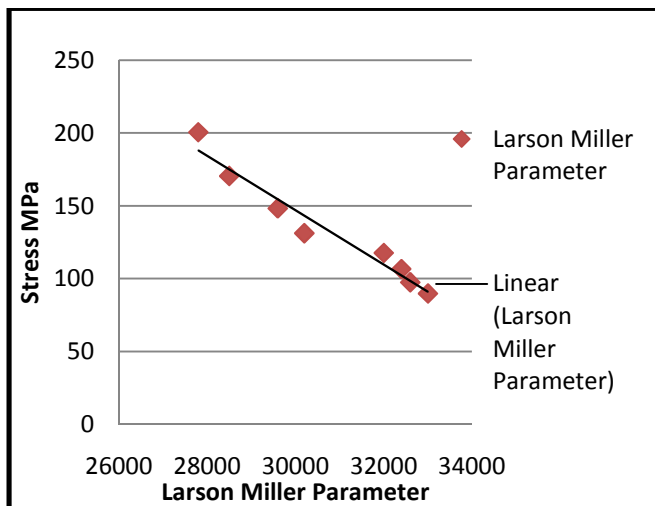
When the creep test for specific SA210 was carried out by many scientists the relation between stress and Larson Miller Parameter found that as the stress increases LMP is decreasing logarithmically. From LMP the remaining life and the cumulative creep damage is found. When the cumulative creep damage crosses the value 1.0 it is failed. In Fig 3.8 Stress vs.LMP for SA210 steel is drawn to obtain the LMP from the given stress and it is useful to find out the cumulative creep damage.

Fig.3.8: Stress vs. Larson Miller Parameter

From the graph stress vs. LMP the cumulative creep damage obtained for three different conditions. The first

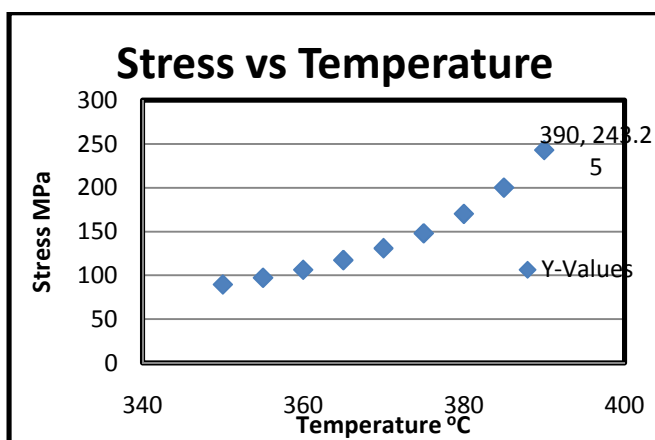
In Fig 3.9 Stress vs. Temperature for SA210 steel is drawn to show that the stress is badly affecting the remaining life with increase in temperature.

Fig.3.9: Stress vs. temperature
