Geotechnical Investigation of Fracture Patterns in a Rock Mass during Excavation by Blasting

Abstract— Overcharging in rocks (wall faces) during blasting and excavation usually causes damage to rock mass in most mining and quarry industries. This creates blast-induced fractures which can relate with pre-existing fracture pattern thereby increasing sliding and rockfall from the crest and body of an excavated wall. The spacing and orientation of pre-existing fractures are predominant at a small-scale mining (galamsey) site at 'Atta ne Atta', a town near Beposo, in the Western Region of Ghana. Geotechnical field studies were carried out to investigate the possibility of any instability within the area to eradicate the occurrence of an unexpected future wall failure (rockfall). The geotechnical mapping conducted was focused on fracture distribution and spacing. Mean spacing (S_m) of existing fractures was calculated and corrections were made to obtain calculated spacing (S_c). The scanlines of wall face 001 and wall face 002 intersect with their corresponding strike and dip at 78° and 80° respectively creating a slightly favourable fracture pattern and rock wall stability. The fractur

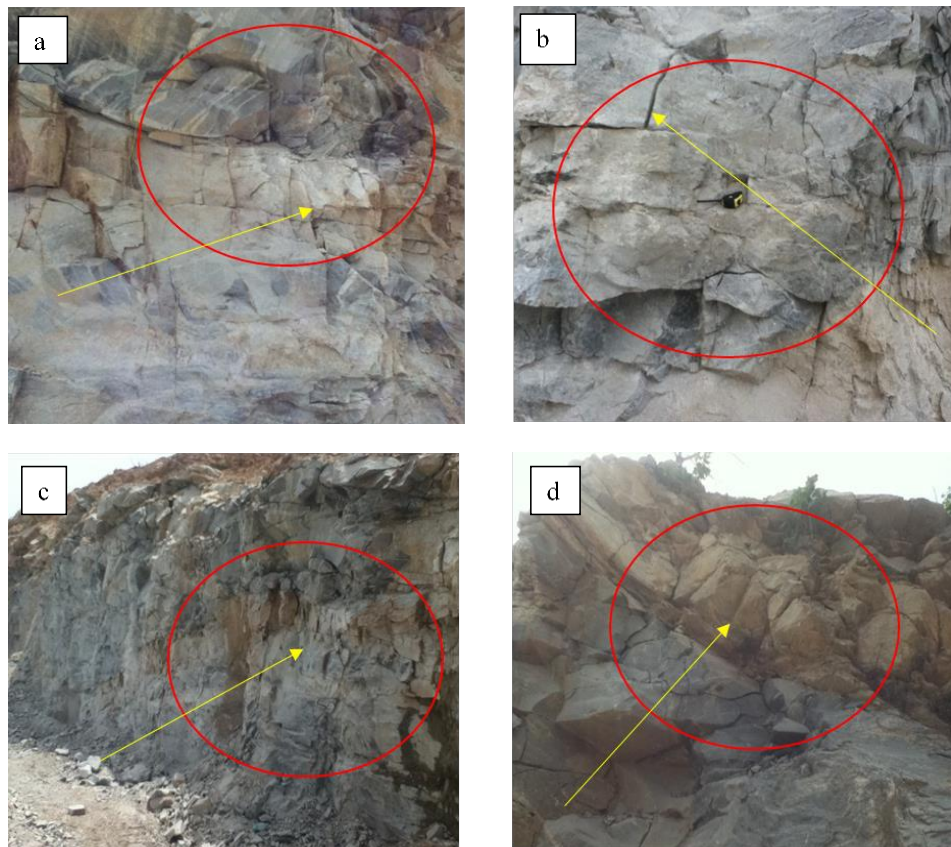
Fig. 2: (a) Fracture pattern at Wall Face 001 (b) Fracture pattern at Wall Face 002 (c) Fracture pattern at Wall Face 003 (d) Fracture pattern at Wall Face 004

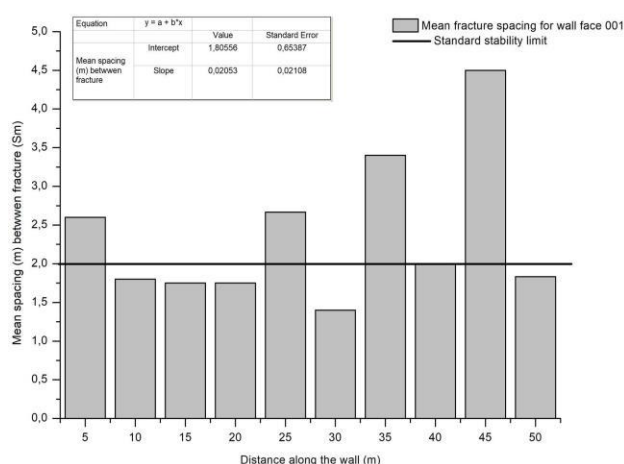
Fig. 4: A Graph of Mean spacing of Fracture at Wall Face 001

From Fig. 4 the scanlines strike 75° with their corresponding strike and dip creating a favourable fracture pattern. The fracture set at a distance of 5 m, 25 m, 35 m, 40 m and 45 m along the wall are above the 2 m spacing of fracture which represents the stability of the wall around these places. The fracture set at a distance of 10 m, 15 m, 20 m 30 m are all below 2 m spacing of fracture were observed to be unstable (below 2 m).

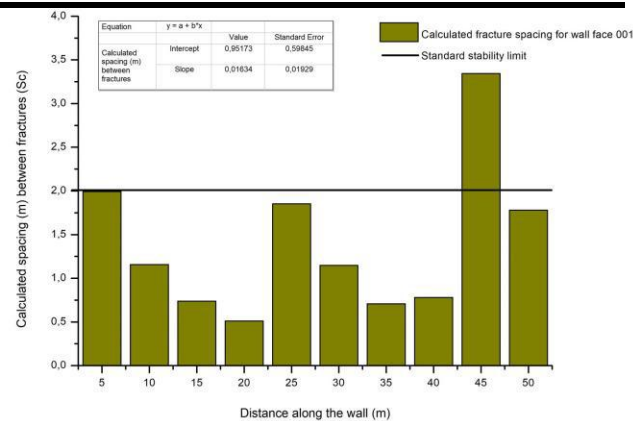
Fig. 5: A Graph of Calculated Spacing of Fracture at Wall Face 001

Considering the calculated spacing of the fracture sets, corrections were made for clear estimation of wall stability. The calculated spacing S_c was used in concluding the results because errors were corrected. As illustrated in Fig. 5, about 90 % of the fracture sets were below 2 m of mean spacing between fractures indicating marginal instability within the Wall face 001. Though only one i.e. the fracture pattern at the distance of 45 m as shown in Fig. 5 exceeded the 2 m spacing of fracture, other sets of fractures were closely below the standard stability limit making it marginally stable. The reason for the marginal stability of these walls by observation is as a result of mineral infillings (quartz veins) in the fractures and which prevents water encroachment between fractures. In addition, by physical observation on the walls, the blast holes were charged with small number of explosives hence small fracture zones were created.

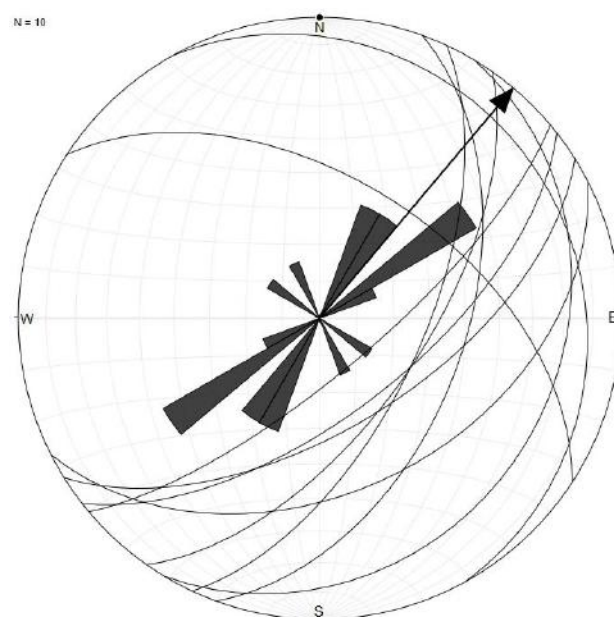
Fig. 6: Stereographic projection and Rose plot for Fracture Spacing at Wall Face 001

The stereographic projection of the dip and strike of fracture spacing within Wall Face 001 shows a general strike of NNE-SSW (Fig. 6). Observations made from the Rose plot also shows a maximum of 30 % strike between 051° and 060° .

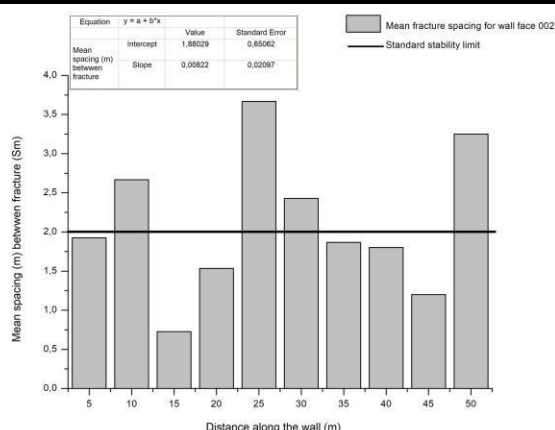
Fig. 7: A Graph of Mean Spacing of Fracture at Wall Face 002

From Fig. 7 the scanlines strike 80° with their corresponding strike and dip creating a favourable fracture pattern. The fracture set at a distance of 10 m, 25 m, 30 m and 50 m along the wall are above the 2 m spacing of fracture which represents the stability of the wall around these places, however, other fracture sets were below the 2 m spacing of fracture which indicate unstable condition.

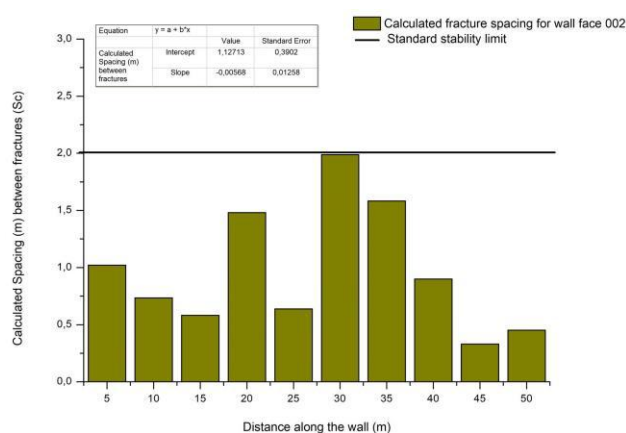
Fig. 8: A Graph of Calculated Spacing of Fracture at Wall Face 002

Again, the calculated spacing S_c was used in concluding the results because errors were corrected. As illustrated in Fig. 8, all the fracture sets were below 2 m of mean spacing between fractures indicating high instability condition within the Wall face 002. Stereographic projection of the dip and strike of fracture spacing within Wall Face 002 also shows a general strike of ENE-WSW. Observations made from the Rose plot also shows a maximum of 20 % strike between 061° and 070° (Fig. 9).

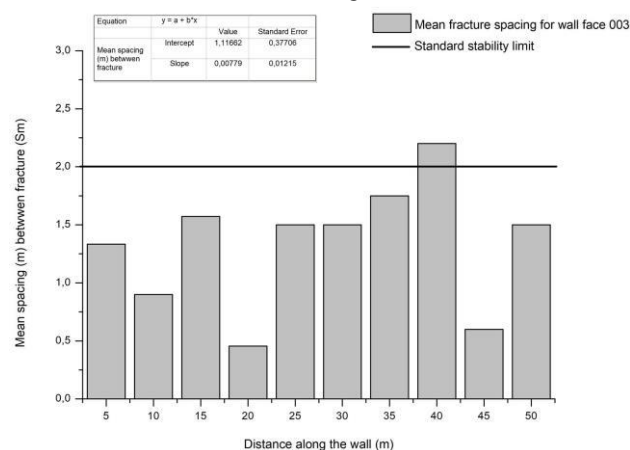
Fig. 10: A Graph of Mean Spacing of Fracture at Wall Face 003

As illustrated in Fig. 10 the fracture set along the walls Face (003) at 40 m is above 2 m spacing of fracture whereas the remaining 9 fracture sets were below the standard stability limit making them walls unstable and vulnerable to failure.

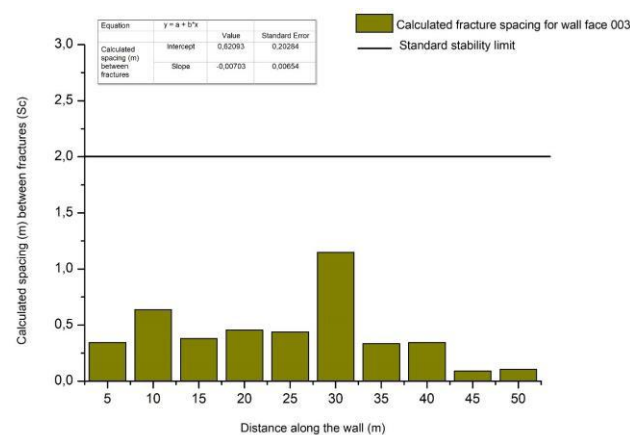
Fig. 11: A Graph of Calculated Spacing of Fracture at Wall Face 003

Wall Face 003 recorded the most harmful zones of fracture after estimation using the calculated spacing of fracture sets. Consequently, from Fig 11 all the fractures with their spacing of 0.00-1.24 m and their corresponding strikes created differential unstable parts of the walls which is very unfavourable in response to rock fall and rock slide. Blast induced fractures were observed to be widen as a result of weathering.

- Overcharging of blast holes should be avoided.
- The spacing of drill holes at regions of low stability should be wider.
- Drilling at regions of low stability should be done with extreme care.
- Investigation on the walls should be repeated after every episode of blasting.

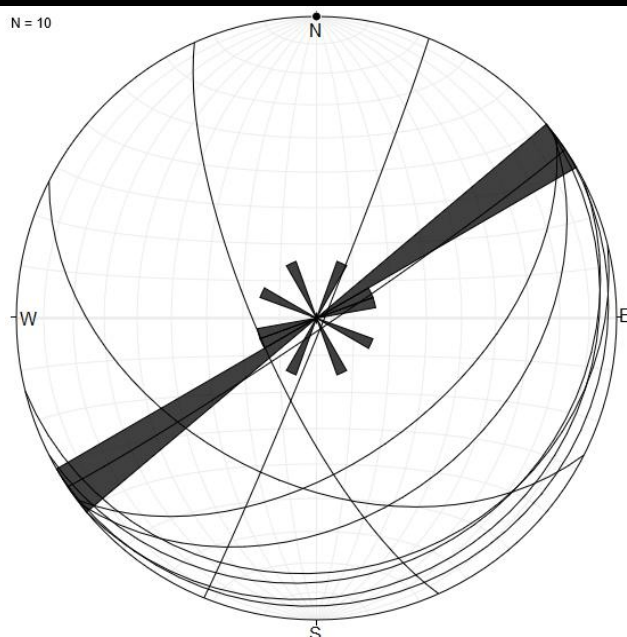
Fig. 12: Stereographic projection and Rose plot for Fracture Spacing at Wall Face 003

Results obtained from the Stereographic projection of the dip and strike of fracture spacing within Wall Face 002 also shows a general strike of NE-SW. Observations made from the Rose plot also shows a maximum of 50 % strike between 051° and 060° (Fig. 12).

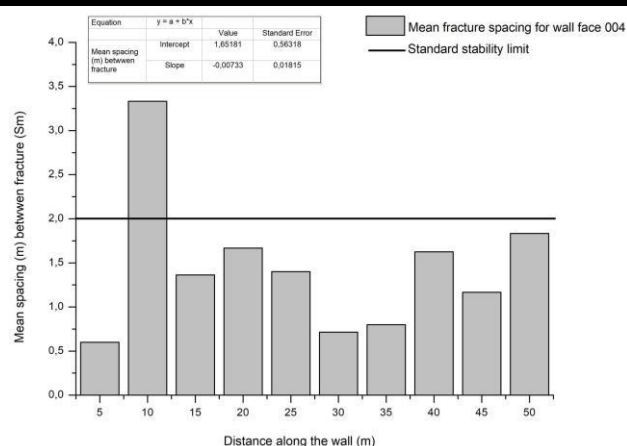
Fig. 13: A Graph of Mean Spacing of Fracture at Wall Face 004

Observations made from Fig. 13 show the scanlines strike 73° with their corresponding strike and dip creating an unfavourable fracture pattern. The fracture set at a distance of 10 m along the wall is above the 2 m spacing of fracture which represents the stability of the wall around these places. However, the remaining fracture set were all below 2 m spacing of fracture which indicates high instability within this Wall Face (004).

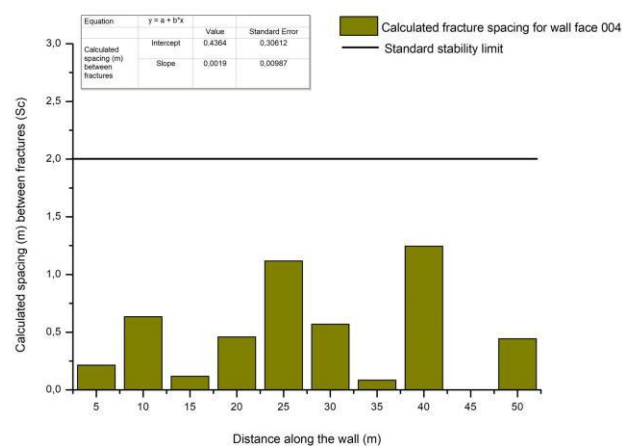
Fig. 14 A Graph of Calculated Spacing of Fracture at Wall Face 004

Again, considering the calculated spacing of the fracture sets, corrections were made for clear estimation of wall stability. The calculated spacing S_c was used in concluding the results because errors were corrected. As illustrated in Fig. 14, all the fracture sets were below 2 m of mean spacing between fractures indicating high instability within the Wall face 004. The reason for the high stability of these walls by observation is as a result of absence of mineral infillings (quartz veins) in the fractures thereby enhancing weathering of the rock surfaces due to water encroachment between fractures. In addition, by physical observation on the walls, the blast holes were charged with high number of explosives due to the presence of mineralized zones within these areas resulting in the creation of high fracture zones.

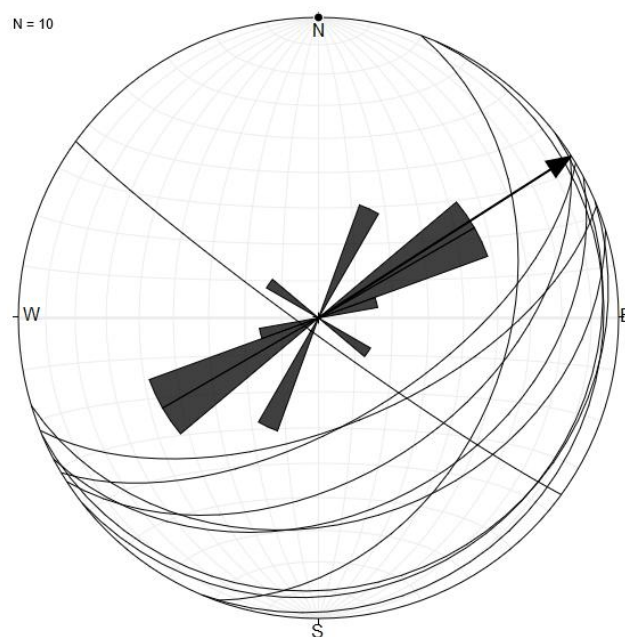
Fig. 15: Stereographic projection and Rose plot for Fracture Spacing at Wall Face 004

The stereographic projection of the dip and strike of fracture spacing within Wall Face 004 shows a general strike of NE-SW (Fig. 15). Observations made from the Rose plot also shows a maximum of 30 % strike between 051° and 060° similar to the strike recorded in Wall Face 001.
