# Hydrogen Attack of U-Bend Pipe Joint Connecting Heat Exchangers at a Methanol Plant

Abdel-Monem El-Batahgy, Sayed Hussein

**Abstract**— After 13 years of operation, U-bend pipe joint connecting heat exchangers at a methanol plant was failed in a catastrophic manner. Hydrogen attack associated with decarburization was identified as the failure mechanism. Damage or structure degradation was started at the inner surface of a circumferential weld connecting the U-bend pipe joint to the heat exchanger shell' nozzle then, propagated toward outer surface where a catastrophic brittle fracture was occurred. The cause of this failure is related to an improper selection of the material for the subject working conditions. In order to minimize the possibility of such failure in the future and then, increase the lifetime of the concerned equipment, the used ASTM A105 steel was replaced with a higher grade type; ASTM A335 P11 (1Cr-0.5Mo) steel. Periodic inspection was scheduled for the concerned equipment to evaluate its condition in order to be able to make the right decision for its replacement to avoid emergency shutdown. This includes mainly magnetic particle test, ultrasonic test, micros

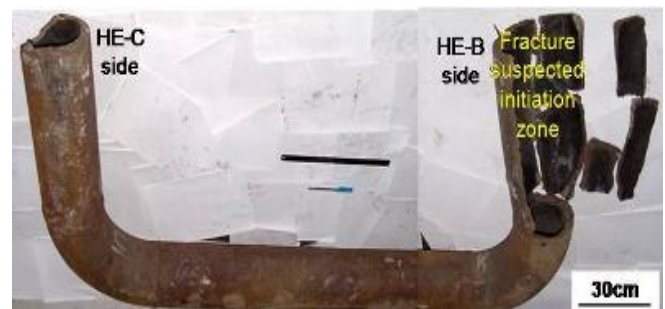
On site investigation showed that the U-bend pipe joint was fractured and separated from the shell nozzles of both heat exchangers B and C. General view of the fractured U-bend pipe joint after reassembling its segments is shown in Fig. 1. Visual inspection showed that the fracture was occurred at the two ends of the U-bend pipe joint connected to the heat exchangers B and C. However, existence of several segments of the fractured pipe joint on the heat exchanger B side increases the possibility of starting the fracture on this side. Another important point is the absence of bulging of the failed pipe joint.

Fig. 1. General view of the fractured U-bend pipe joint connecting the heat exchanger B (HE-B) to the heat exchanger C (HE-C).

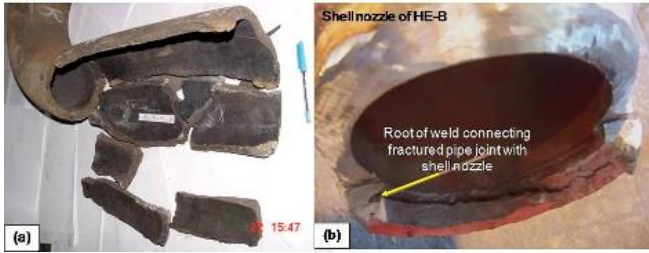
Enlarged view of the fracture zone on the heat exchanger B side showed thick wall rupture where no indications for corrosion damage or other excessive wastage were observed (Fig. 2-a). Results of wall thickness measurements showed no remarkable reduction in wall thickness of both fractured and non-fractured zones of the failed U-bend pipe joint where wall thickness of 18.7–19.1 mm was obtained compared with 19 mm nominal wall thickness, that in turn indicates brittle fracture. Close up view of the fracture surface of the shell nozzle of the heat exchanger B showed crack propagated from the circumferential weld root toward the outer surface (Fig. 2-b). In other words, beveling the fracture surface increases the possibility that the fracture was initiated at the inner surface of the circumferential weld connecting the U-bend pipe joint to the shell nozzle. Dye penetrant test results showed no indications for surface cracks either around or away from the fracture zones

Fig. 2-(a). Enlarged view of the fracture zone on the heat exchanger B side showing thick wall rupture and (b) close up view of the fracture surface of the shell nozzle of the heat exchanger B showing crack propagated from the circumferential weld root toward the outer surface.

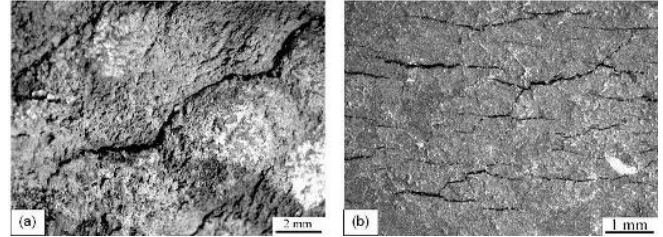
Low magnification stereoscopic photograph of the fracture surface on the side of the U-bend pipe joint is shown in Fig. 3-a. It can be seen that the fracture surface showed a brittle appearance with cracks propagated through grain boundaries. Low magnification stereoscopic photograph of the inner surface of the U-bend pipe joint is shown in Fig. 3-b. The important notice is the existence of large amount of surface cracks at the inner surface of the fractured pipe joint. On the other hand, no surface cracks were observed on the outer surface of the failed pipe joint. Scanning electron microscopic examinations of the fracture surface confirmed the brittle fracture mode and disclosed complete decomposition of pearlite into ferrite and spheroidal carbides. Another important finding is the existence of voids in pearlite colonies where fissures and cracks were propagated through such voids (Fig. 4).

Fig. 3. Low magnification stereoscopic photographs of the fracture surface (a) and the inner surface (b) of the failed U-bend pipe joint.

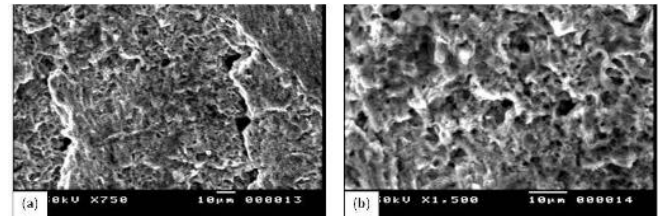
Fig. 4. Scanning electron microscopic photographs of the fracture surface showing brittle fracture mode where fissures were propagated through voids formed in pearlite colonies.

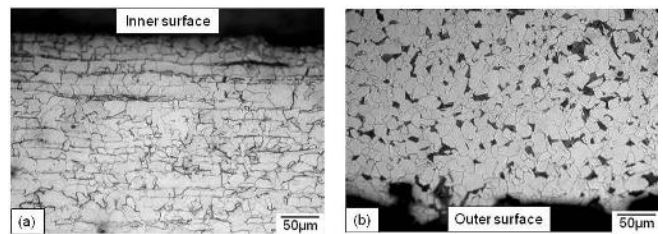
Optical microscopic photographs of a cross section taken from fracture suspected initiation zone are shown in Fig. 5. The most important notice is the occurrence of decarburization and the existence of voids and fissures at the pipe' inner surface (Fig. 5-a) while normal ferrite-pearlite structure is still existed at the pipe' outer surface (Fig. 5-b). Optical microscopic photographs of a cross section taken from a non-fractured zone, i.e. straight portion of tube, are shown in Fig. 6. It is clear that a microstructure degradation similar to that of the fractured zone (Fig. 5) was observed. In other words, decarburization was occurred and voids as well as fissures were formed at the pipe' inner surface (Fig. 6-a) while normal ferrite-pearlite structure was observed on the outer surface (Fig. 6-b). The microstructure degradation has been confirmed using scanning electron microscopy where decarburization, voids and fissures were clearly observed on the pipe' inner surface (Fig. 7-a, b) while pearlite still has its lamellar morphology on the outer surface (Fig. 7-c, d). The linear fissures observed on the inner surface are along the pipe axis.

Fig. 5. Optical microscopic photographs of a cross section taken from fracture suspected initiation zone showing decarburization and fissures on the inner surface (a) and normal ferrite-pearlite structure on the outer surface (b).

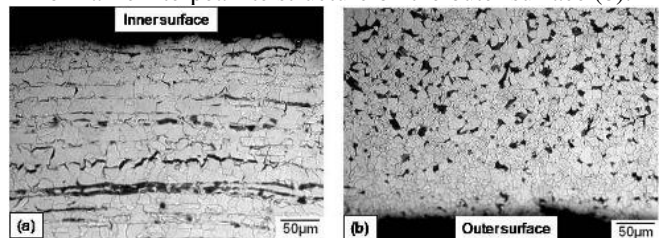
Fig. 6. Optical microscopic photographs of a cross section taken from non-fractured zone showing decarburization and fissures on the inner surface (a) and normal ferrite-pearlite structure on the outer surface (b).

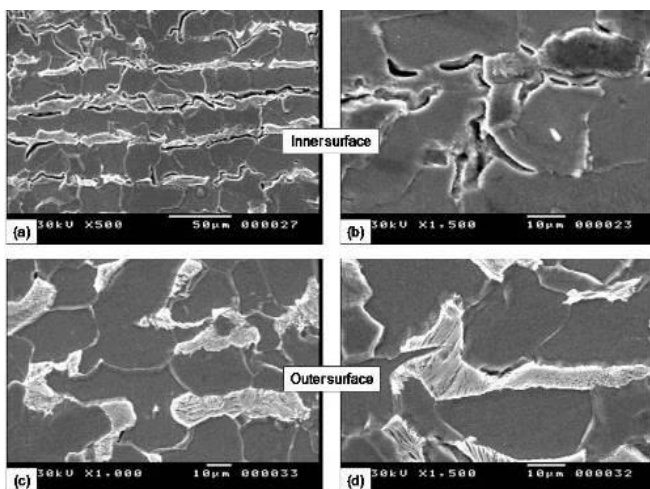
Fig. 7. Scanning electron microscopic photographs of a cross section taken from fracture suspected initiation zone. Note decarburization, voids and fissures on the pipe inner surface (a, b) while pearlite lamellar morphology still existed on the outer surface (c, d).
