METHOD OF STRENGTHENING STRUCTURE OF BUILDING

ABSTRACT

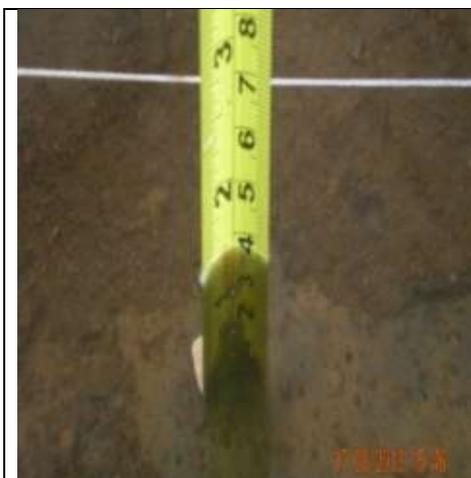
Plate Structure: broken and deflated 7cm. The reason is that the foundation is fragile, and the results of soil tests show that the carrying capacity is weak. So it is necessary to add a foundation because the building is ready so that the space for movement is limited, especially the area above. It is a 30cm diameter bore pile with a modified tool made loose, so the device enters the building, and installed in the room. The decrease in almost every basement column, even reaching 189mm (based on surveyor measurements). Because the foundation of differential settlement occurs, making the column tilted, (Triastuti, 2017) this adds a secondary moment,

Figure 1. Basement / Plate Structure: broken and deflated 7cm

All of the damage in the upper structure, the cause is a fragile foundation with little bearing capacity due to the shallow foundation of the concrete block. So it is necessary to add a 25 cm mini bore pile foundation with depth is 13m (NSPT 32).

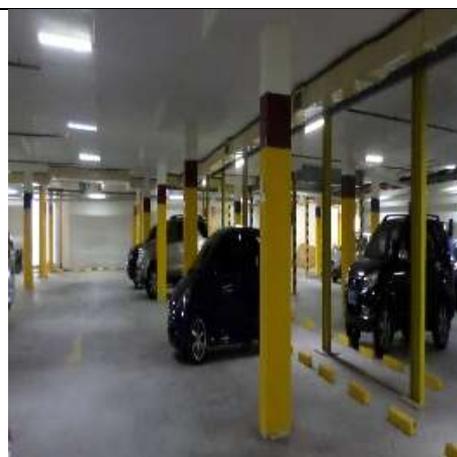
Figure 2. The decrease in almost every basement column, even reaching 189 mm (based on surveyor measurements)

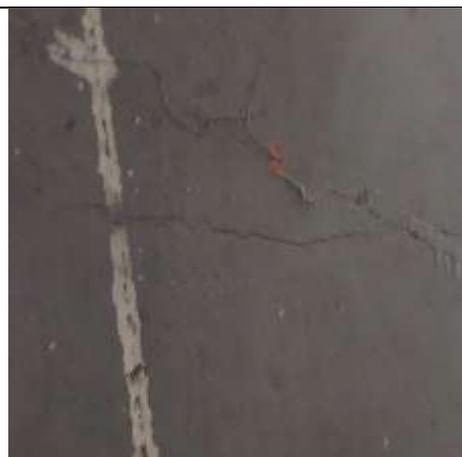
The occurrence of cracks in the span of the walls of shophouses (mostly due to tie beam structure). A foundation settlement causes the Crack. Schmertmann's Method (Hassan, 2017) differential settlement is

Figure 3. The occurrence of cracks in the span of the walls of shop houses (mostly due to tie beam structure)

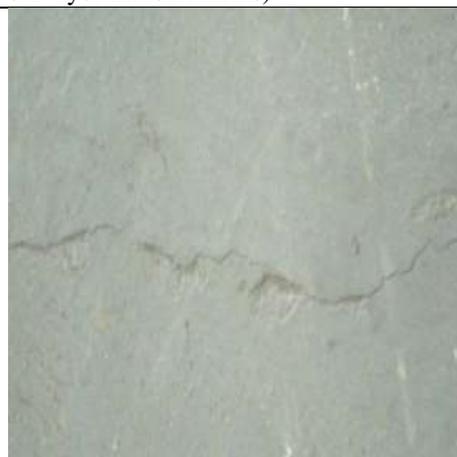
The floor has decreased (new cracks have returned to old cracks). The crack is caused by the difference in foundation settlement.

Figure 4. The floor has decreased (new cracks have returned to old cracks)

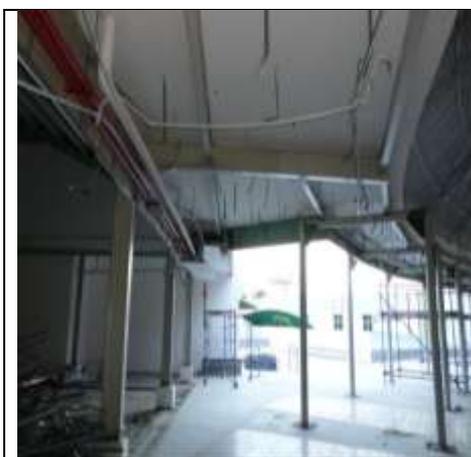
The beam is tilted and bent due to casting and settlement differences occur. The steel portal beams are bent and dented. Due to the lack of precision construction. The baseplate has no stiffener. Angkor is only at the front. The pedestal is not with stiffener. Dome always tends to expand and slide. Due to the centrifugal force of the dome with a diameter of 50 m, there is no stiffener base plate. It is not meeting the structural requirements. It can result in long-term fatigue.

Figure 5. The beam is tilted and bent

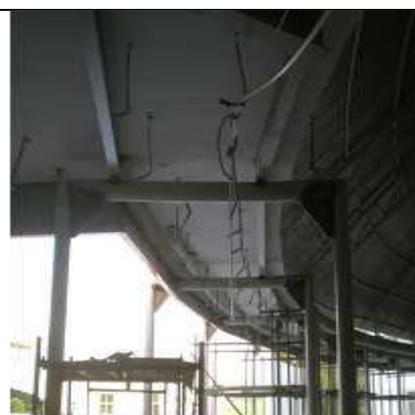
Figure 6. The steel portal beams are bent and dented

- Stiffener and 12mm round bar bracing and 25mm sling on the portal and re-welding on all connections.
- The round bar 16mm bracing on the weakest span of the dome structure.
- Steel WF 250,250.11.13.66.5 kg/m.
- Upper structure is as a pedestal dome structure.
- INP steel 400.200.9.11.56.1 kg / m, WF 100,100.9.11.17.2 kg / m, and plate 4'.8'.12mm.280 kg/sheet.

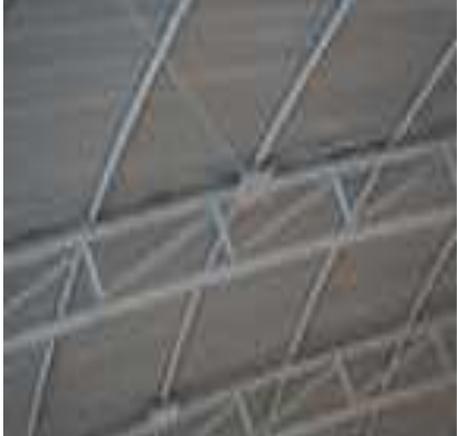
Dome with diameter 50 m is no tensile cable will result in a shift. Especially when working horizontal force, long-term collapse can occur, so it needs given a pull rod.

<p>Figure 9. Dome dia 50 m is no tensile cable</p>	<p>Figure 10. Beams supporting the roof column broken</p>

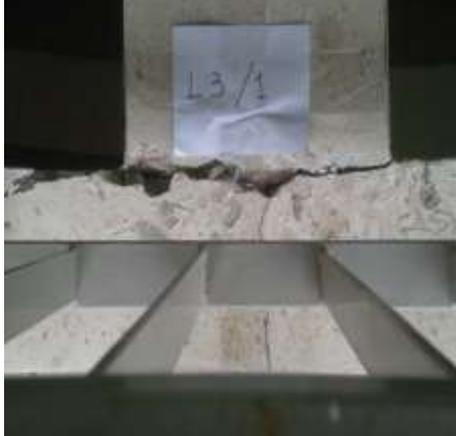
The broken of beams support the roof column. The principal bearer structure of the roof load and horizontal force must meet the requirements of strong, stable, rigid structures. If not fatal, it will take a victim.

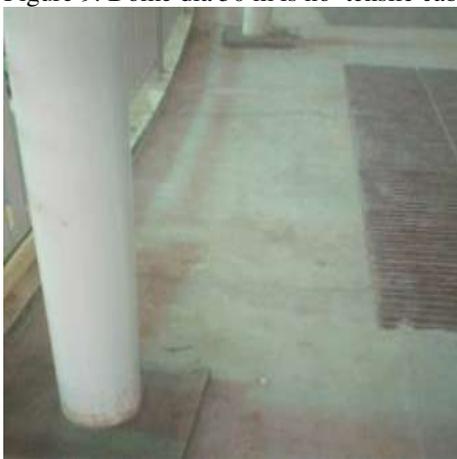
This Floor and corridors are cracked so the upper floor corridor. The structural movements were needed to be strengthened basement roofs with steel profile beams. Unto the steel profile column rests on the pile cape with the added bore pile.

<p>Figure 11. This Floor and corridors are cracked</p>
