TECHNIUM
SOCIAL SCIENCES JOURNAL

Vol. 25, 2021

Analysis of the structural framework for schools affected by the Sunda Strait Tsunami in Pandeglang Regency

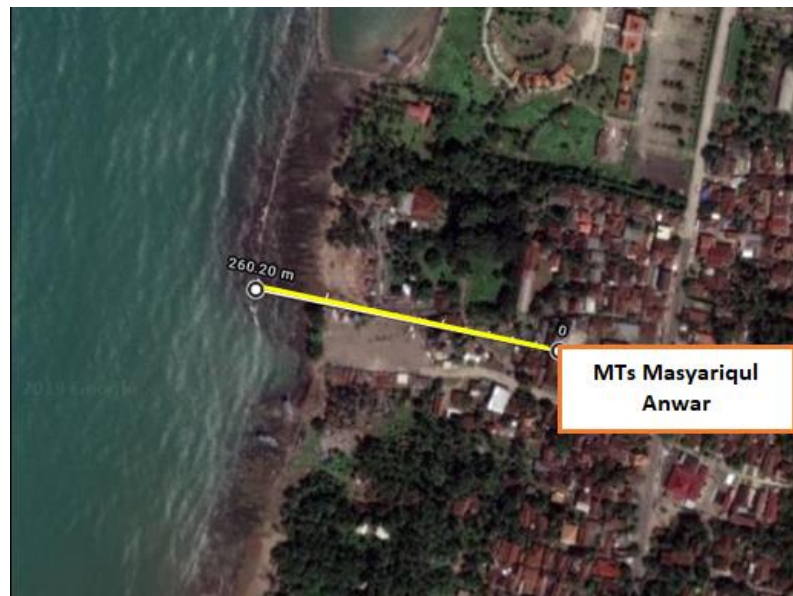
Figure 3. Location Distance of MTs Masyariqul Anwar from the Coastline
Source: Google Maps, 2019

The location of the MTs Masyariqul Anwar land is back to the beach with a distance of about 260 meters from the coastline. Based on the Pandeglang Regency Tsunami Risk Map (2014), the location where MTs Masyariqul Anwar is located is in the red zone with a high level of tsunami risk.

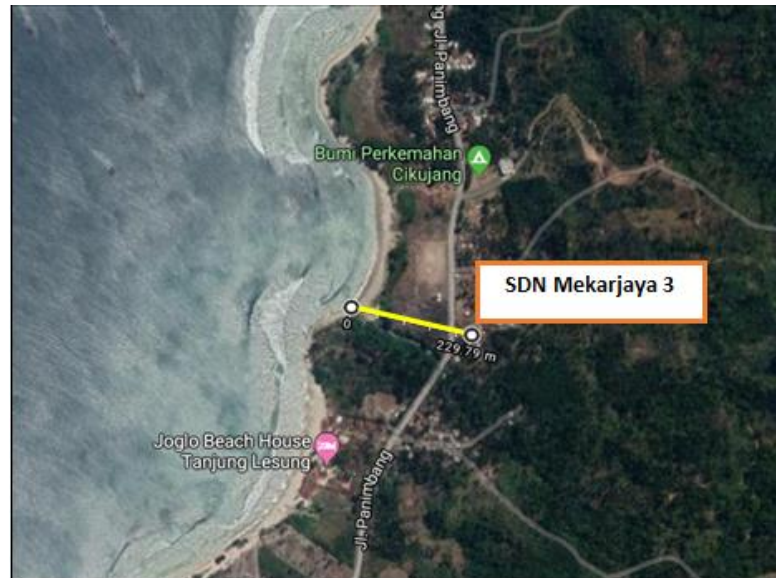
Figure 4. Location Distance of SDN Mekarjaya 3 from the Coastline
Source: Google Maps, 2019

The location of SDN Mekarjaya faces the beach and is separated by Jalan Panimbang. The distance of the school from the shoreline is 229 meters. According to the Pandeglang Regency Disaster Risk Map, SDN Mekarjaya 3 is in the red zone with a high level of tsunami disaster risk.

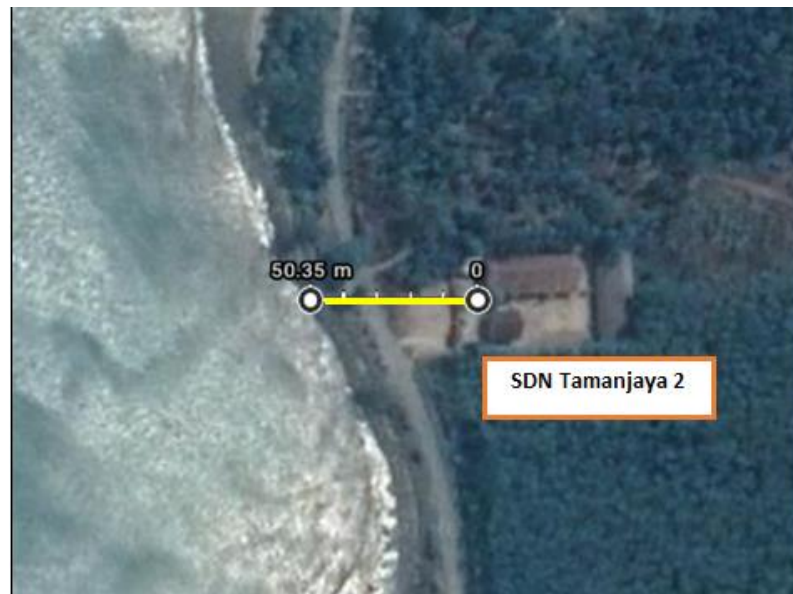
Figure 5. Location Distance of SDN Tamanjaya 2 from Garis the Coastline
Source: Google Maps, 2019

Of all the schools in Pandeglang, SDN Tamanjaya 2 is the school with the closest distance from the coastline, which is only 50 meters away. The location of SDN Tamanjaya 2 is indeed in the red zone with a high level of tsunami disaster risk. This resulted in SDN Tamanjaya 2 being affected by the Sunda Strait tsunami which was severe enough to destroy one library building and damage other classrooms.

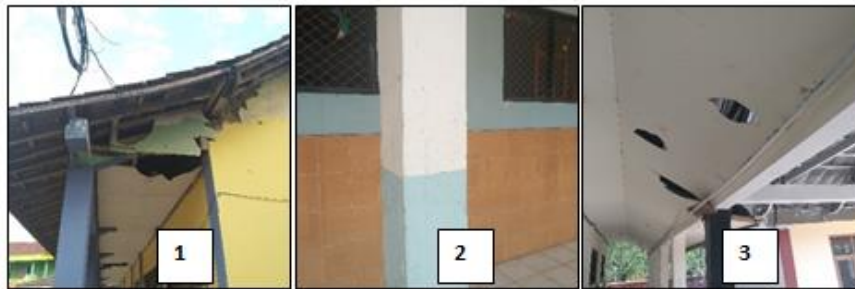
From the results of the research review at the research site, it was seen that the buildings have not undergone restoration for at least 10 years, except SDN Tamanjaya 2 which received renovation assistance from private and humanitarian organizations due to its school building being heavily damaged by tsunami waves in early 2019. What is striking in the three schools is the damage to the ceiling and roof and small cracks in the walls and columns whose material still uses heavy bricks. It can generally be seen in the following figure:

Figure 6. Condition of School Structure (1) Damaged Roof and Ceiling at MTs Masyariqul Anwar; (2) Cracked Column at SDN Mekarjaya 3; (3) Perforated ceiling at SDN Tamanjaya 2

Damaged and fractured conditions were found at several points in each school. So this will certainly be very dangerous for students and teachers who move in it. The basic materials of the walls and roof still use heavy materials (concrete and clay). But on the beams in each school building is still fairly safe and strong standing on the foundation.

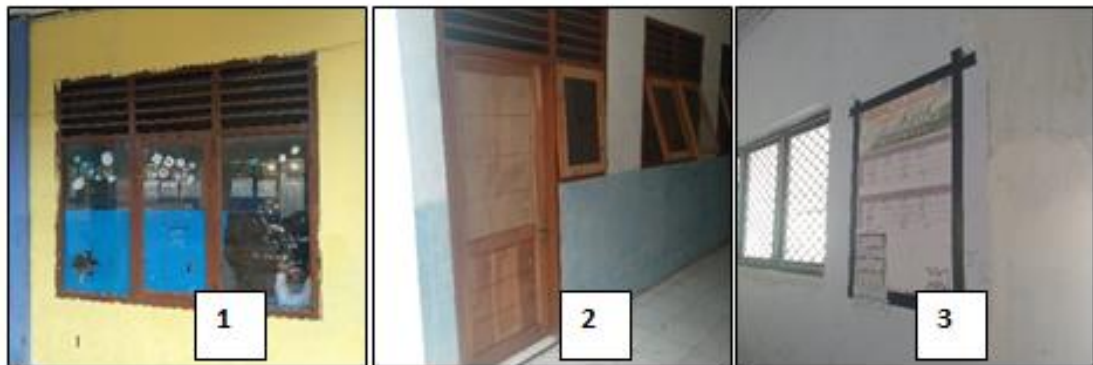
From the observations at the research site, the three schools do not yet have first aid kits in each classroom. First aid kits are only placed in the teacher's room. While the three schools also have not tied / nailed furniture that easily falls and breaks and bookshelves to the wall to strengthen the position of shelves when there is an earthquake. The three schools have also not implemented a door design that opens out. This needs to be done to facilitate the evacuation process in the event of a disaster. Figure 7 shows documentation of the results of the research site review:

Figure 7. Condition of School Architecture and Furniture (1) Classroom windows of MTs Masyariqul Anwar which have not used trellises; (2) The design of the door of SDN Mekarjaya 3 which still opens inward; (3) Wall decorations that are pasted using masking tape instead of frames at SDN Tamanjaya 2.
