On-line Diagnosing on Trayed Column of Ethylene Plant Using Gamma Ray Scanning

demonstrated to figure out the source of the problem in trayed column of quench tower DA 202. The diameter of the column is 4.2 m and the height is 40 m. The gamma emitter, ^{60}Co with activity 70 mCi, and scintillation detector were used to scan the column from the elevation of 26250 mm to the elevation of 35950 mm above ground level which cover tray # 13 to tray # 4. Selected data of measurement are presented come with the conclusion. The problem is identified based on measured data. To my understanding, publications related to this matter are rare, event in handbooks, therefore it is hope that this paper may contribute for dissemination of gamma scanning technology as promising tool for industrial application, especially in developing countries.

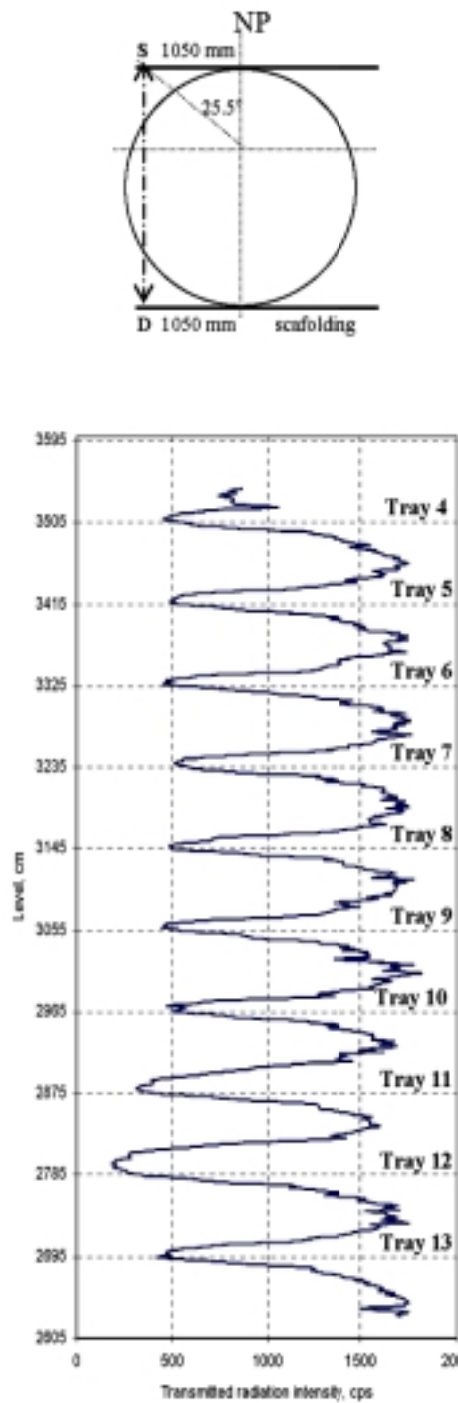
Fig. 3. Profile of tower DA-202 obtained from scan orientation 1. The source and the detector were positioned at 1050 mm (25.5°) and 1050 mm (154.5°) respectively. Trays # 4 to # 10 and tray # 13 were in position and carried approximately the same amount of liquid. Flooding on tray # 11 and tray # 12 were observed as indicated by their lower and wider scan curve.

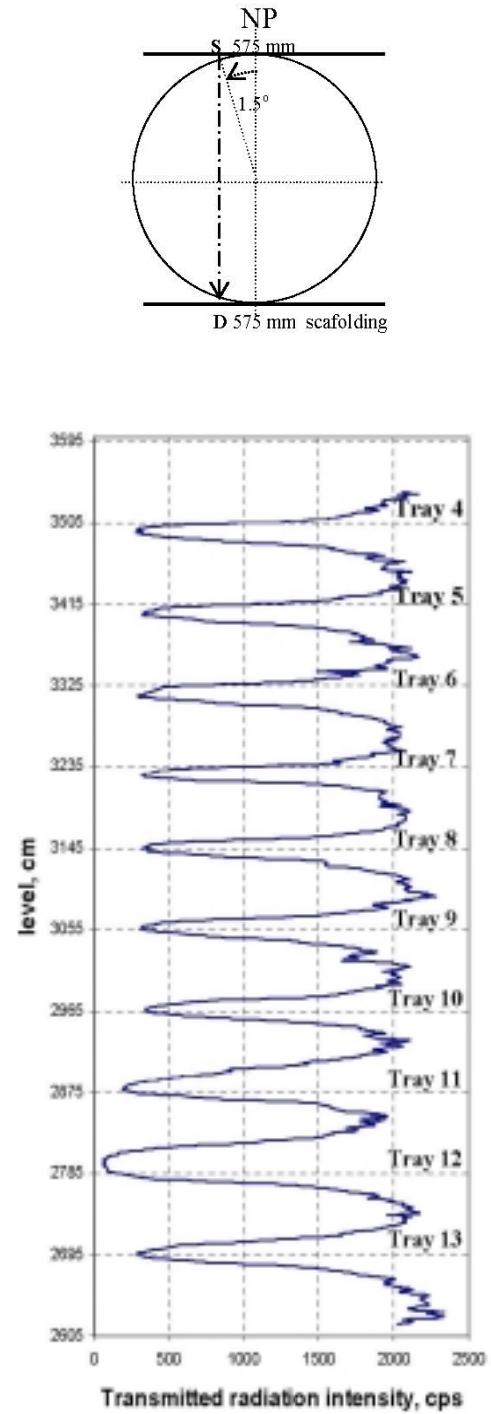
Fig. 4. Profile of Tower DA-202 obtained from scan orientation 2. The source and the detector were positioned 575 mm (1.5°) and 575 mm (178.5°) respectively. Trays # 4 to # 10 and tray # 13 were in position and carried approximately the same amount of liquid. Flooding on tray # 11 and tray # 12 were observed as indicated by their lower and wider scan curve.

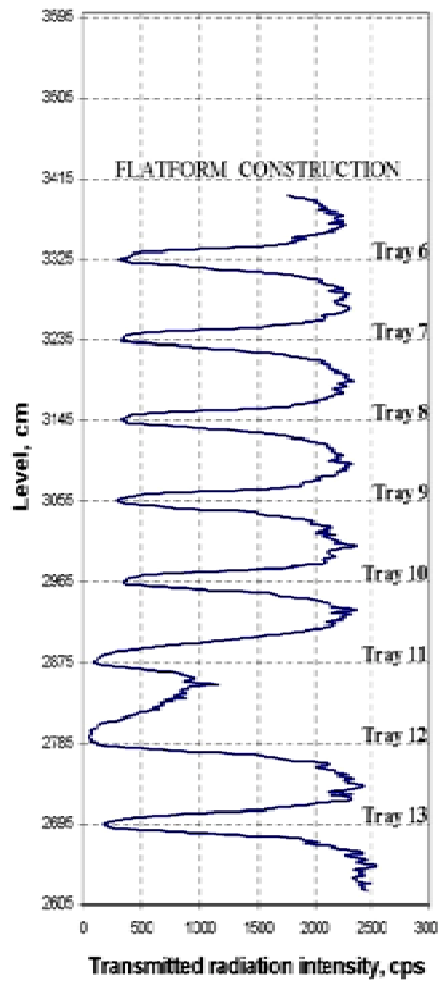
Fig. 5. Profile of Tower DA-202 obtained from scan orientation 3. The source and the detector were positioned 575 mm (358.5°) and 575 mm (181.5°) respectively. Trays # 6 to # 10 was carried approximately the same amount of liquid. Light flooding on trays # 11 and # 13 were observed. Flooding and solidified materials on tray # 12 was observed.

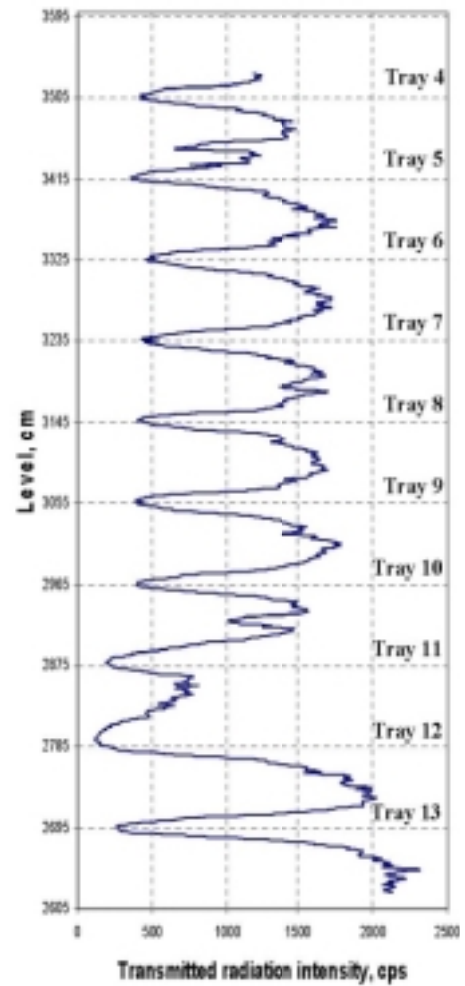
Fig. 6. Profile of Tower DA-202 obtained from scan orientation 4. The source and the detector were positioned 1220 mm (356.8°) and 1050 mm (182.7°) respectively. Trays # 4 to # 10 was carried approximately the same amount of liquid. Light flooding on trays # 11 and # 13 were observed. Flooding and solidified materials on tray # 12 were observed.

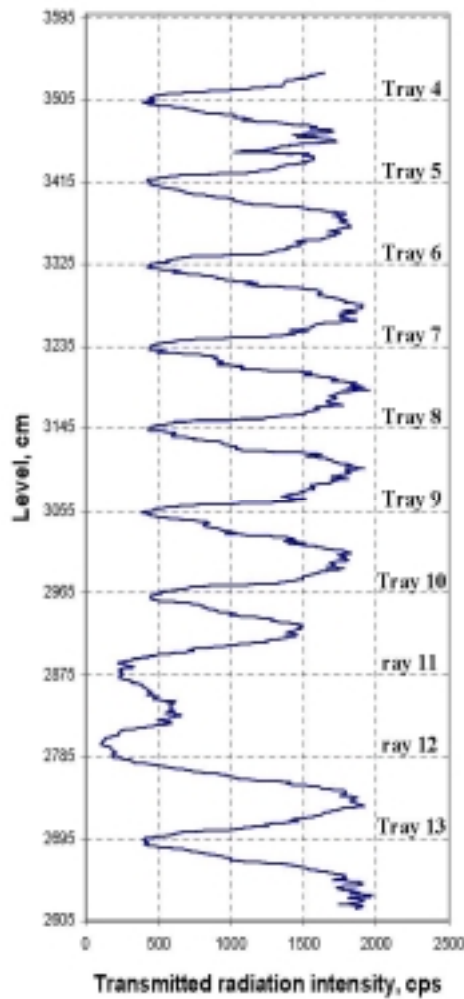
Fig.7. Profile of DA-202 tower obtained from scan orientation 5. The source and the detector were positioned at 700 mm (287.5°) and 700 mm (72.5°) respectively. Trays # 4 to # 10 was carried approximately the same amount of liquid. Light flooding on trays # 11 and # 13 were observed. Heavy flooding and solid material on tray # 12 was observed.

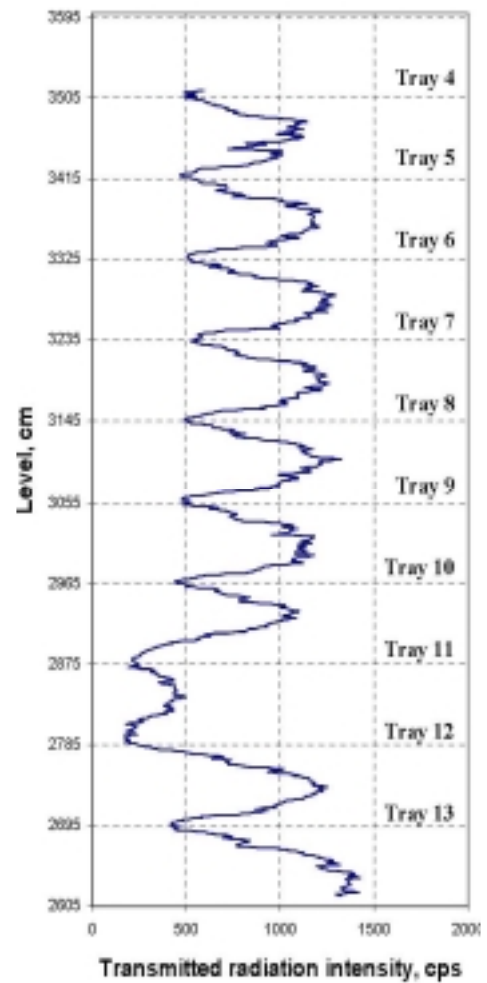
Fig. 8. Profile of DA-202 tower obtained from scan orientation 6. The source and the detector were positioned 700 mm (252.4°) and 700 mm (107.6°) respectively. Trays # 4 to # 10 was carried approximately the same amount of liquid. Light flooding on trays # 11 and # 13 were observed. Heavy flooding and solid material on tray # 12 was observed

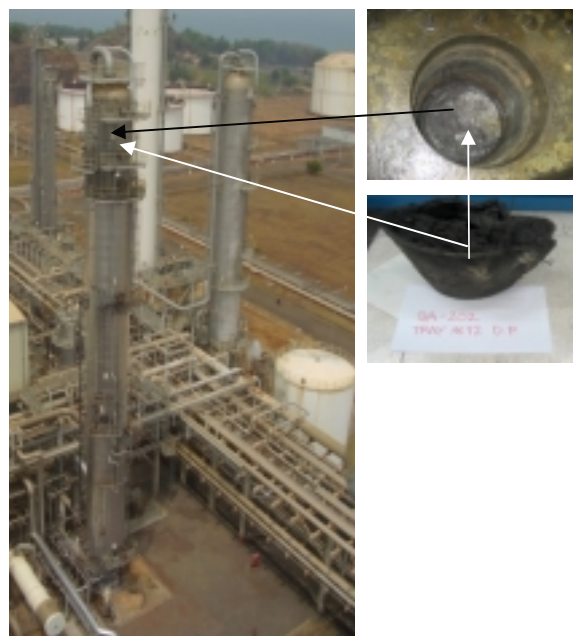
Presence of metallic bucket in down pipe of the tray # 12 is not expected to exist and it origin can be traced back to the time of last shutdown period when plant maintenance was carried out. Somebody put the bucket in the down pipe beyond the surveillance of project supervisor or plant engineers. This fact shows a carelessness of

Fig. 9. Suspicious solidified material observed by gamma scanning was verified at the time of shutdown. A bucket buried in solidified mud was found on tray # 12 of DA-202 tower.

As can be seen from Fig. 9 (top-right), the deposit was dominated by particulate matter. Deposit material due to chemical reaction including corrosion is also observed as indicated by visibly metallic freck on top surface of the tray. Particulate deposit as mud may originate from feedwater containing mud particles. Metallic deposit on the other hand surely caused by plant operating conditions which including high pressure, high temperature and processing materials. Presence of such deposit including bucket on tray # 12 leading to reduce its efficiency.
