INDONESIAN JOURNAL ON GEOSCIENCE

**Surface Rupture and Geotechnical Features
of The July 2, 2013 Tanah Gayo Earthquake**

MUDRIK R. DARYONO^{1,2} and ADRIN TOHARI¹

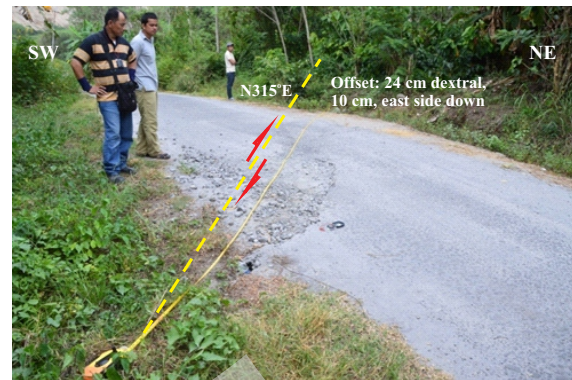
Site 1 - Kute Geulimai Surface Rupture

This surface rupture site is located on a steep hillslope, along the road between Kute Geulimai and Seurempah Villages. The surface rupture crosses the road with an orientation of 315°E exhibiting 24 cm of dextral offset and 20 cm of vertical offset with the eastern side moving down (Figure 4).

Figure 4. A photograph showing the surface rupture crossing the road between Kute Geulimai and Seurempah Villages. The rupture right-laterally displaced the road about 24 cm with a vertical displacement of about 20 cm, east side down.

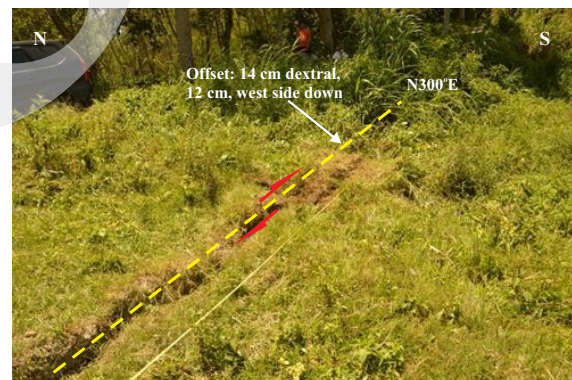
Site 2 - Kuta Malaka Surface Rupture

The surface rupture crosses a flat area at an elevation of about 940 m in Kuta Malaka Village. The group rupture is about 11 m long with an azimuthal trend of 300° , exhibiting a 14 cm-dextral offset and a significant component of vertical displacement of 12 cm with the western side moving down (Figure 5).

Figure 5. A photograph showing the surface rupture at Kuta Malaka Village with a 14 cm dextral displacement and vertical displacement of 12 cm, west side down.

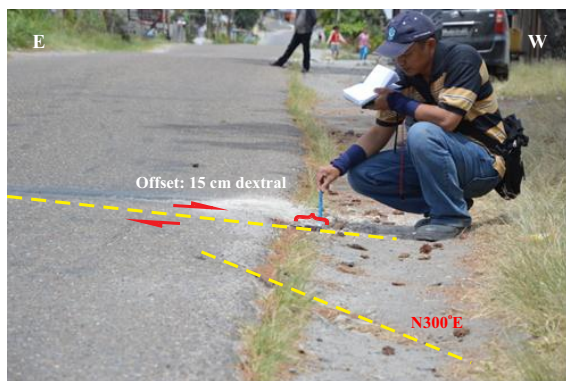
The ground surface rupture is located at Jamur Ujung Village. The rupture begins with an azimuth of 300°E , exhibiting 15 cm-dextral offset (Figure 6), then crosses the road with an azimuth of 85° , and cuts a brick fence (Figure 7). The rupture continues with the orientation of 320° , exhibiting 30 cm-dextral offset and 54 cm-normal displacement with the western side

Figure 6. A photograph showing the ground surface rupture at Site 3, Jamur Ujung Village. There are two ruptures with azimuthal trends of 85° and 300°. The inferred dextral offset is 15 cm.

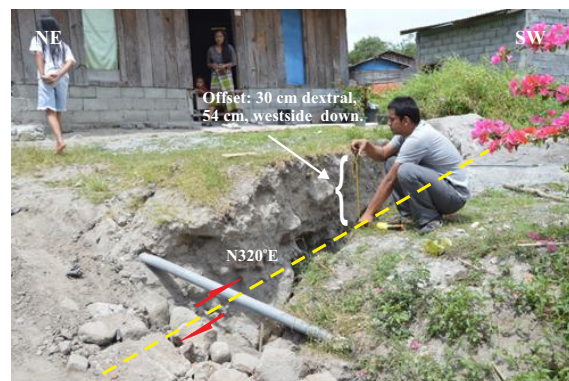
Figure 8. A photograph showing the change of Site 3 surface rupture orientation to 320°, exhibiting 30 cm dextral offset and 54 cm normal offset with west side moving down.

moving down of 54 cm (Figure 8). The surface rupture also caused the water in small pond to drain out shortly after the earthquake (Figure 9).

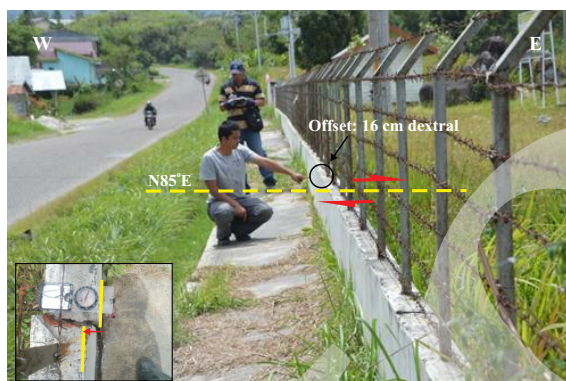
Figure 7. A photograph showing the Site 3 surface rupture continues through a bent brick fence with 16 cm dextral offset. The black circle indicates the centre of deflection of the brick fence. The inset photo shows the lateral offset of the brick fence wall, indicated by a red arrow.

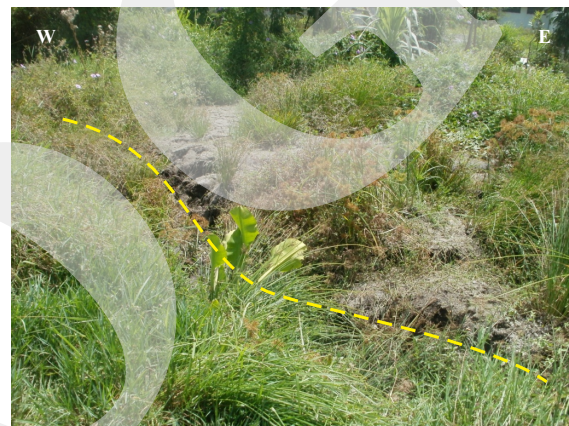
Figure 9. A photograph showing the small pond dried out due to the ground surface rupture at Jamur Ujung Village. The surface rupture track is indicated by a yellow dashed line.

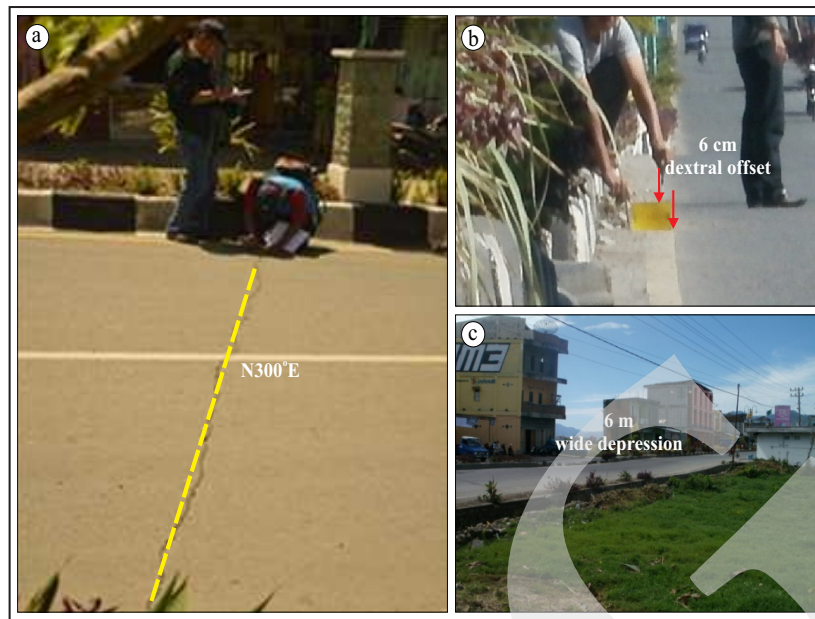
Site 4 - Mongal Surface Rupture

This surface rupture site is located in a flat area within Mongal Village, north of Takengon Town. A ground rupture crosses an asphalt road with an azimuthal trend of 300° (Figure 10a) and caused the road to right-laterally displaced about 6 cm without vertical displacement (Figure 10b). This rupture is associated with a 6 m-wide depression as observed on the road surface (Figure 10c).

Figure 10. Photographs showing the geometry and kinematics of the surface rupture in Mongal Village. (a) A rupture cut through the road with an azimuthal orientation 300°; (b) A 6 cm- dextral offset measured from the deformed roadside marker; (c) A 6 m-wide depression observed on the road surface.

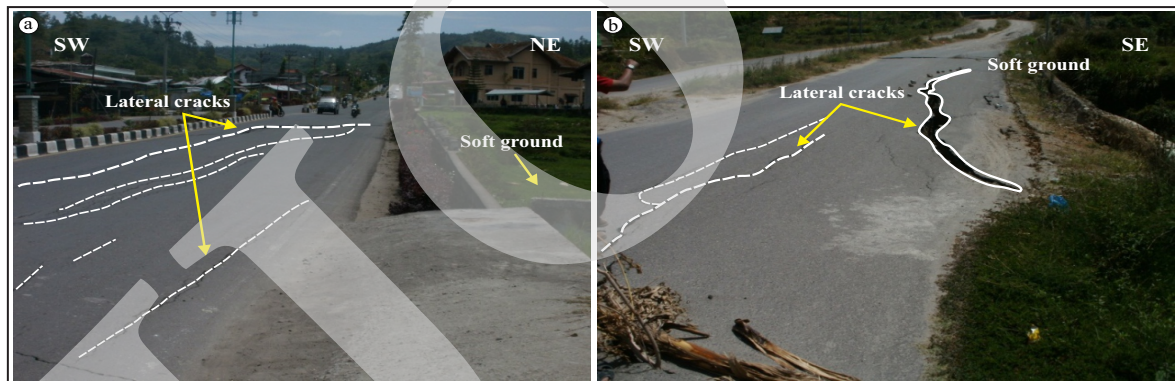
also triggered ground failures associated with liquefaction and landslide. Liquefactions, such as lateral spreading and sand boiling, were mainly found in flat areas within Central Aceh Regency. The lateral spreadings were commonly observed to occur in many road embankments constructed in soft soil ground. Some good examples of lateral spreading were evident in the road embankments in the vicinity of Takengon Town (Figure 11). This type of ground failures is influenced by the geological condition of Takengon flat area / lowland. According to the geological map of Cameron *et al.* (1983), the lowland is underlain by Quaternary lake deposits, especially in the areas around the Lut Tawar Lake. These young soil deposits have obviously low strength to withstand the ground shaking.

Figure 11. Photographs showing ground failures associated with lateral spreadings of road embankment around Takengon Town. (a) On the main road connecting Takengon Town and Bireun, (b) A lateral spreading on a new road connecting Takengon Town and Kute Panang.

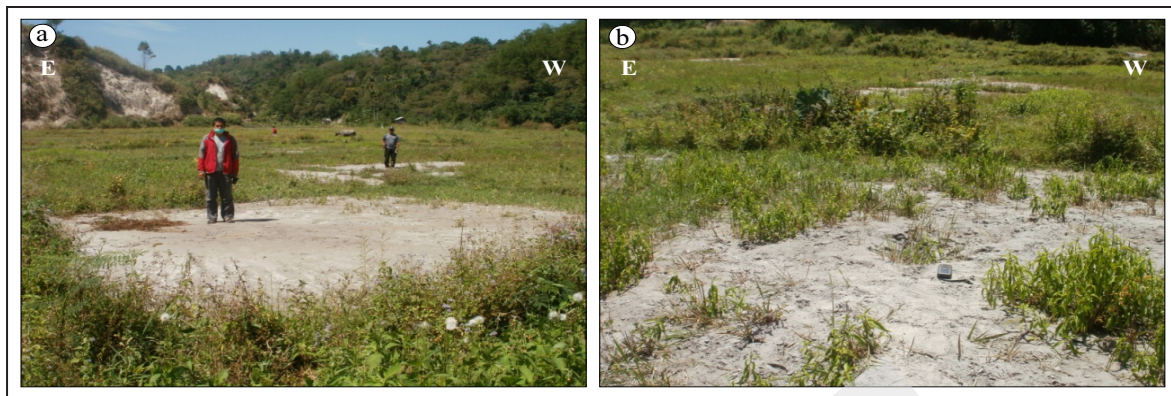
Another type of ground failure was associated with liquefaction as observed in Kuta Malaka Village at an elevation of 950 m above sea level (Figure 12). Numerous sand boilings were found in a flat area where the Kuta Malaka surface rupture is located. The local groundwater level is about 5 m below the ground surface. According to an eyewitness, the occurrences of sand boiling was seen to commence from the first earthquake event (Mw6.1) for two days. As seen in Figure 12, greyish white fine-grained sands spouted of the ground cracks in several locations in a flat

area surrounded by hills, probably associated with Quaternary tuffaceous sand-filled lake. The occurrences of liquefaction indicate the intensity of earthquake event of at least MMI 6 in this area. According to the Shake Map produced by USGS soon after the event, the earthquake intensity in the Central Aceh area ranged between MMI 6 and 7 (Anonymous, 2013).

Figure 12. Photographs showing the liquefaction induced sand boilings due to the July 2, 2013 earthquake (Mw 6.1) in Kuta Malaka Village. The white fine-grained sands were spouted out the ground cracks.

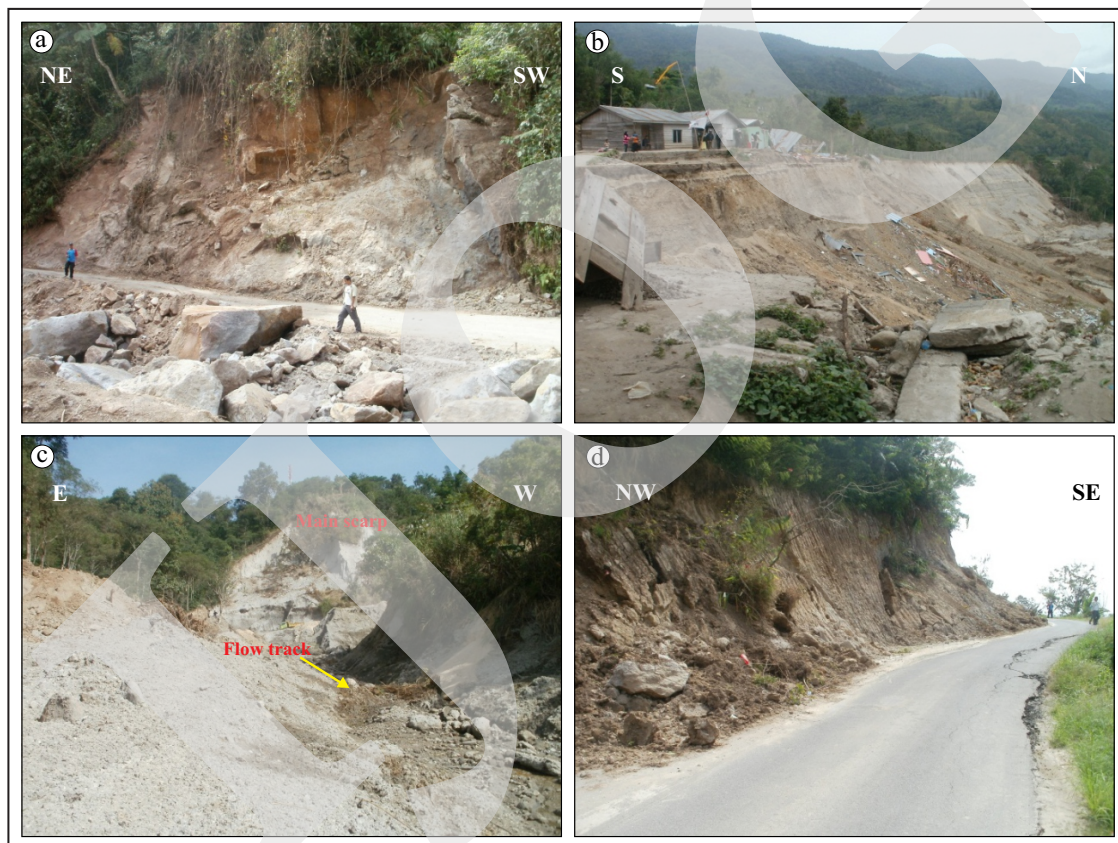
Figure 13. Photographs showing types of landslide triggered by the July 2, 2013 earthquake in a Gayo Highland area. (a) Rock fall of intrusive outcrop along the road to Kuta Panang, (b) A larger-scale landslide in Seurempah Village, (c) A dry earth flow triggered in the tuffaceous sand slope, (d) A surficial cut-slope failure along the roadside from Takengon to Blang Mancung.

Based on field observations, earthquake-induced landslides in this area can be categorized into four basic types. The first type is rock falls of igneous rock. This type of landslides occurred within a narrow area, controlled by the main rock fractures. Figure 13a shows the example of rock

fall of igneous outcrop with strike orientation of N60°E and dip direction of 48°.

The second one is large-scale slope failures that commonly occur in steep slopes (>45°) of loose tuffaceous sands. This type of landslides involves a large volume of soil masses. One of which occurred in Seurempah Village in Ketol Subregency, claiming eleven lives and destroying a twelve houses (Figure 13b). The landslide materials temporarily blocked and changed the flow of Air Pesangan River. As seen in Figure 13b, the tuffaceous sand deposits are horizontally layered; thus, the occurrences of the large scale landslide are mainly controlled by the slope morphologic factor. Other large-scale slope failure can also be seen in steep slopes along the Air Pesangan River such as in Bah Village located in the south of Seurempah Village. It is interesting to note that this type of landslides forms steep slopes.

Earth flows are also common throughout the surveyed area and are very well observed on the hillslope of tuffaceous sands. The occurrence of the earth flow is controlled not only by the slope geomorphologic condition but also by the looseness of the earth materials. The tuffaceous sands are evident to travel to a distance of tens to hundreds meters from the landslide sources in a dry state condition (Figure 13c). The fourth type of landslides is surficial slope failures, involving a thin surface soil material (Figure 13d). This type of landslide commonly occurs in unprotected steep cut-slopes along a road side. The mode of failure is a nonrotational slide and the soil materials are not travelled far from the failed slope. This type is capable of blocking the road, and triggering a hazard to down-slope areas.
