Multi-geohazards of Ende city area

IGAN SUPRIATMAN SUTAWIDJAJA¹ and SUGALANG²

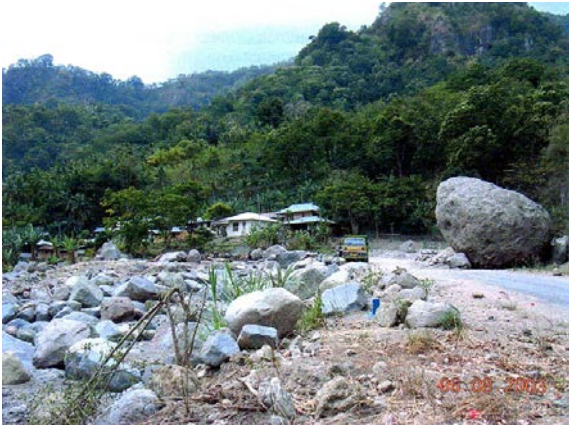
debris, and 27 people were killed in this event (Figure 2). A big portion of the Ende airport was flooded up to 1 m deep and covered by debris. The airport could not be used for several days. The city of Ende was isolated from the outer world for about one week, since the roads to Bajawa and Maumere cities were blocked and the airport inundated.

Figure 2. The debris flow deposits in the village of Ndungga/Detumbawa. The picture shows the formerly populated area, 27 people lost their lives in this event. The big block to the right was also carried by this debris flow and was estimated to weight more than 100 tons on April 2nd, 2003.

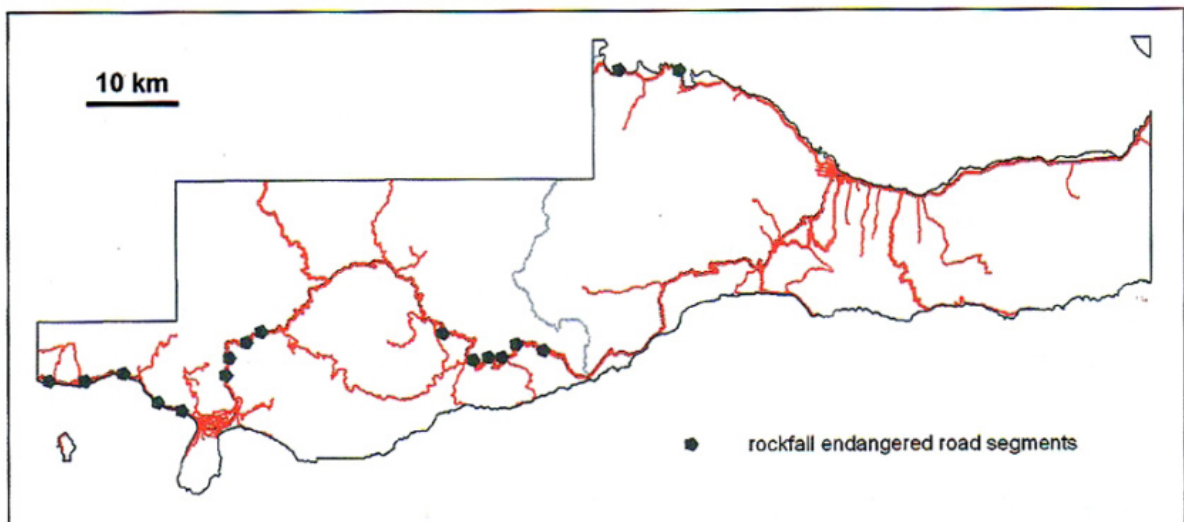
Falling rocks are hazards for areas located below very steep slopes and rock faces. In the project area a problem arose in many parts of the road between Ende city and Detusoko and the road between Ende city and Wolowaru (Figure 3). In those places the road was cut into the natural relief, producing steep and unstable slopes. Although rock falls are not a direct threat to settlements, boulders and gravels frequently block the roads, hampering transportation and economy. Additionally, passing vehicle and people can be subject to falling. Rock falls cannot be precisely predicted, but in the mapped road segments they occurred frequently, so people using the road should be aware of this danger to react accordingly. Therefore, road signs indicating the risk and warning the people should be installed before and at the

Figure 3. The rock-fall endangered segments of major road.

affected road segments. Because rock falls may also block the road, sufficient equipments to clear and repair the road should be available and functional in major settlements.

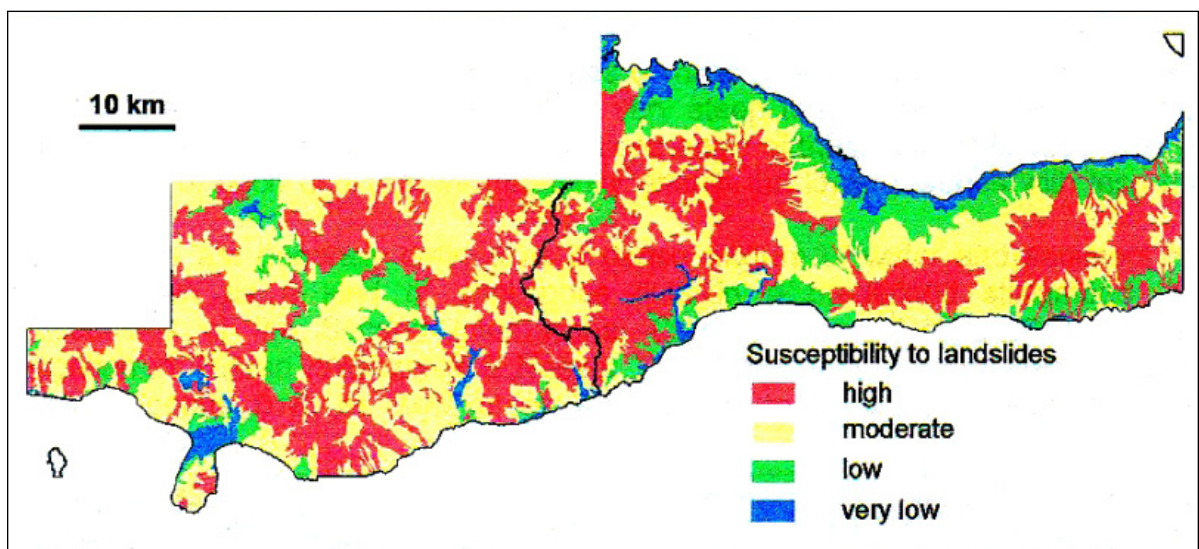
Figure 4. Landslide susceptibility map of the project region, which should be used as a bases for planning and emergency activities.

Generally, there should be no further development within the red zone. In the yellow zone, development should be carried out only after con-

sultation with landslide experts. Settlements, which are located within the red and yellow zones should be protected or replanted by natural vegetation (forest) mainly on the slopes nearby the settlements and vital infrastructure, especially crucial infrastructure for possible cracking. Furthermore, the local people should frequently observe the slopes. In the case cracks occur, the people should plug them with clay to prevent water infiltration and evacuate the possible affected houses.

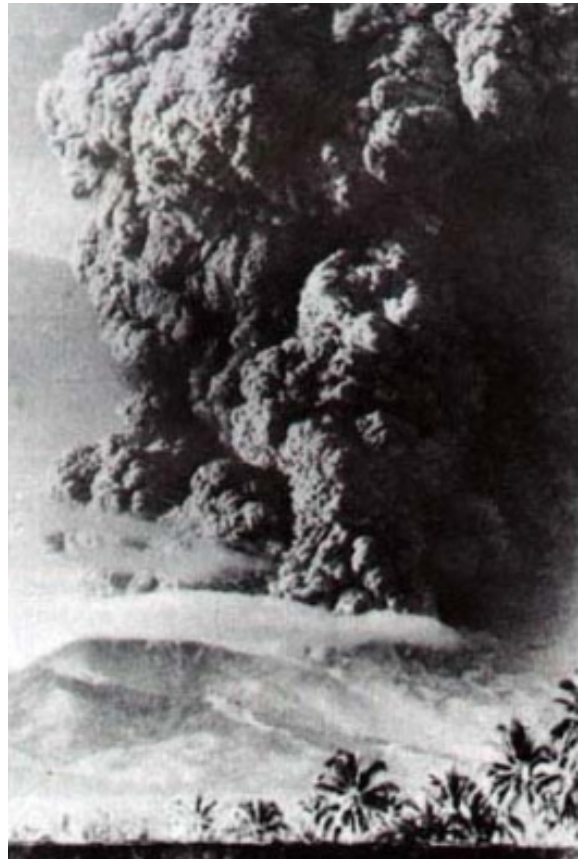
Figure 8. The eruption of Mount Iya in 1969. (Photo Doc. VSI).

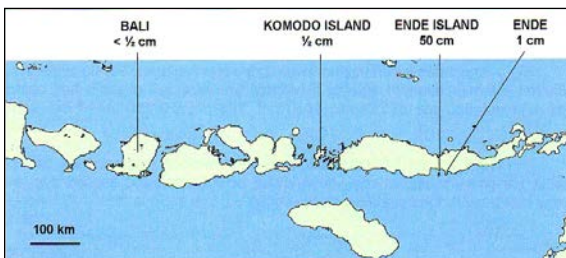
was only covered by 1cm thick of ash fall during the 1969 eruption. This case was due to favourable wind-direction from east, which caused the ash to drift to the sea (Figure 9). In case of heavy ash-fall in and around the city, it has to be worried since it can cause disruption of all infrastructure facilities (air-, land-, and sea-transport, telephone communication, water supply, *etc.*) (Reksowirogo, 1969). Moreover, the people will strongly suffer from respiratory problems. Additionally, the heavy upload to buildings could easily result in its collapse as happened in Ende Island in 1969. Thick ash-fall in the mountainous surrounding the Ende city can generate lahar flows, that can endanger most villages located on mountain flanks. When a volcanic eruption takes place during a rainy season, all evacuation measures have to consider this aspect, if a village is used as evacuation barracks, otherwise it will endanger refugees.

Figure 9. Distribution of ash-fall during the Iya eruption in 1969.

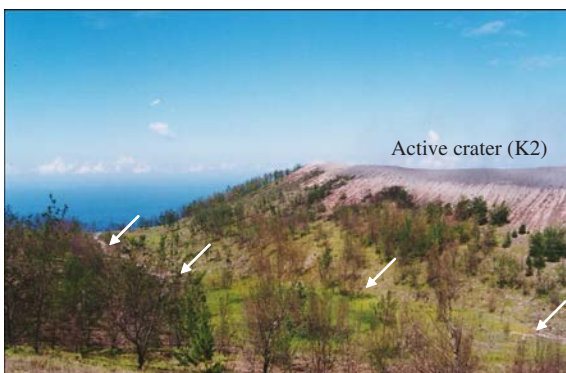
Another major threat from the Iya Volcano which was evaluated during the fieldwork in 2003 and 2006 was a well developed crack that runs across the active crater (K2) of Iya Volcano (Figure 10). Fumaroles appear along the crack where the temperatures ranged between 60° to 80° C. Thermal infrared photograph shows very active fumaroles along the crack (Figure 11). It is thought, that the crack indicates a major weakness within the volcano, which could resulted in the occurrence of a giant landslide surging into the sea during future eruption of Iya. A computer simulation of this possible landslide is shown in Figure 12, where about 70 million m³ of rock lies on the unstable area and prone to slide. Although this material will not directly threat the settlements (since the sliding direction will be south to southwest), the kinetic energy transmitted to the water column may result in the occurrence of tsunami. The amplitude of this tsunami depends very much on the speed and form of the fearfull sliding process. It is expected that the whole rock portion surges into the sea at once within minutes (worst case scenario), but it is also possible that the unstable volume would gradually slide down into the sea

Figure 10. A well-developed crack (white arrow) runs all around the active lower crater (K2) of Iya volcano.

within weeks, months, or years. Although no further modelling was carried out to map the tsunami hazard along the coasts in Ende Regency, most of the coasts especially Ende Island should be informed about the alert level of Mount Iya and in case an eruption (before the eruption) occurs. Evacuation of people to higher places should be carried out.

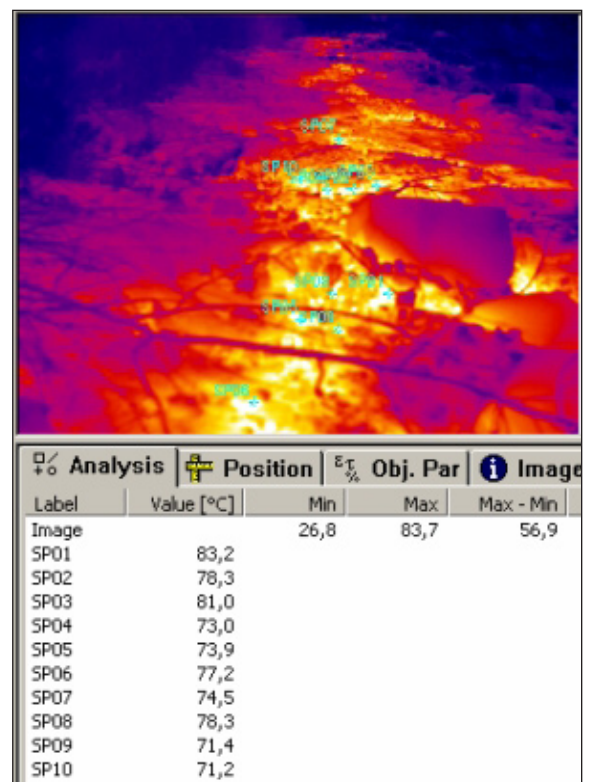
Figure 11. Thermal infrared photograph of the crack showing the temperature of fumaroles along the crack range between 70 to 85 degrees C.

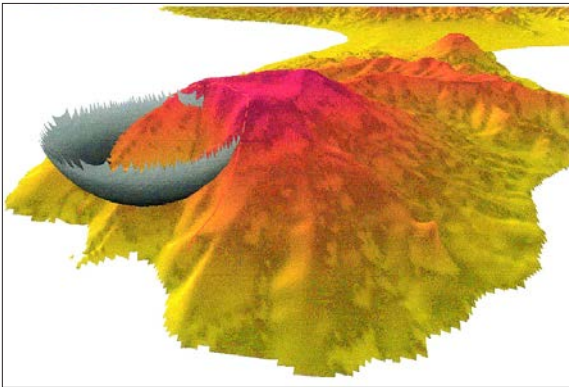
Figure 12. The computer model of Mount Iya simulating a landslide triggered by an eruption. The dash-red line indicating the crack.

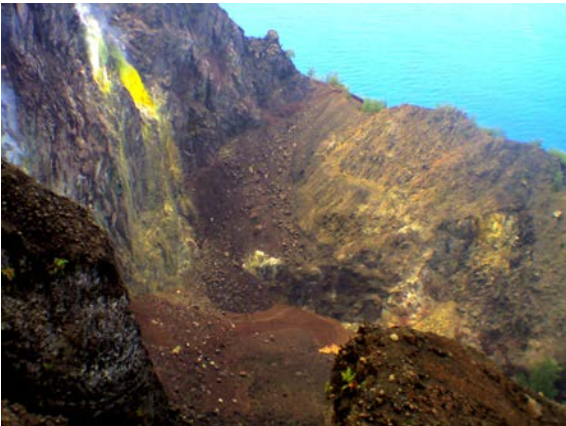
port the activity to the CVGHM and Bupati (Head of SATLAK-PB). A cooperation programme between BGR and CVGHM has produced Volcanic Hazard Zone Maps of Iya (Figure 13), Kelimutu and Egon Volcanoes. The present activity of Mount Iya is shown by the existence of solfatar emission on the north wall of the crater (Figures 14 and 15).

Figure 14. Digital photograph of Mount Iya crater.

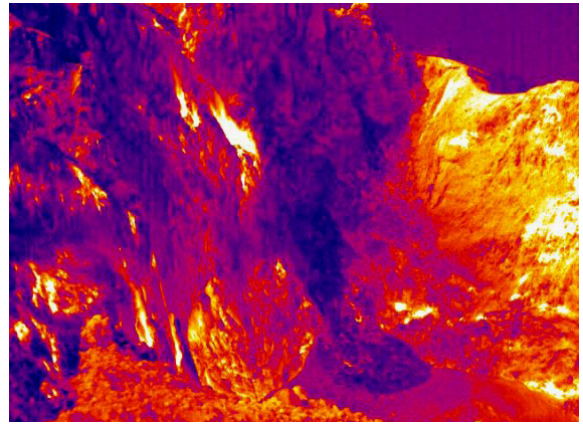
Figure 15. Thermal infrared photograph of Mount Iya crater.

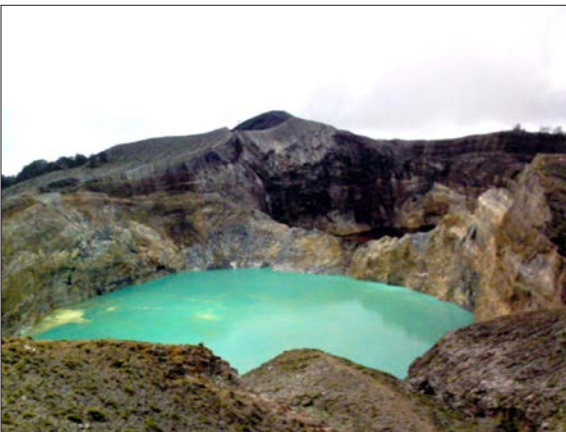
The volcano is one of Indonesia's top tourist attractions and is the main reason why tourists are interested in visiting Flores. The tourists can drive up to a car park, and take a short walk, so the most popular viewpoints are found. These beautiful crater lakes give advantages to the local people who live in the surrounding villages. At present, the Tiwu Ato Polo crater (the red one) is located very close to Tiwu Nua Muri Kooih Fai crater (Figure 16). It is separated only by some meters of a thin wall, which

is quite different from the condition in 1990, when the wall was still thicker, between 15 – 20 m. In case an eruption occurs in one of these two craters, the wall is likely to be damaged and the two lakes would merge to become a big crater. It seems that currently the three craters are very quiet, and even the oldest craters (Tiwu Ato Mbupu) and Tiwu Ato Polo nearby, have almost no activity at all.

Figure 16. Tiwu Nua Muri Kooh Fai crater is one of three different colors of Mount Kelimutu's crater lakes. In the background is Tiwu Ato Polo crater which has a brownish black color.
