INDONESIAN JOURNAL ON GEOSCIENCE

The Stability of Metasedimentary Rock in Ranau, Sabah, Malaysia

Abstract - The aim of this paper is to determine the stability of slopes and to propose preliminary rock cut slope protection and stabilization measures for Paleocene to Middle Eocene Trusmadi Formation along Marakau-Kigiok in Ranau, Sabah, Malaysia. The rock of Trusmadi Formation is slightly metamorphosed and dominated by interbeds of sandstone with quartz vein (metagreywacke), metamudstone, shale, slate, sheared sandstone, and mudstone. The rock unit can be divided into four geotechnical units namely arenaceous unit, argillaceous unit, interbedded unit, and sheared unit. Twelve slopes were selected for this study. Geological mapping, discontinuity survey, kinematic analysis, and prescriptive measure were used in this study. Results of this study conclude that the potential modes of failures are planar and wedge. Terrace, surface drainage, weep holes, horizontal drain, vegetation cover, wire mesh, slope reprofiling, and retaining structure were proposed protection and stabilization measures for the slopes in the studied area.

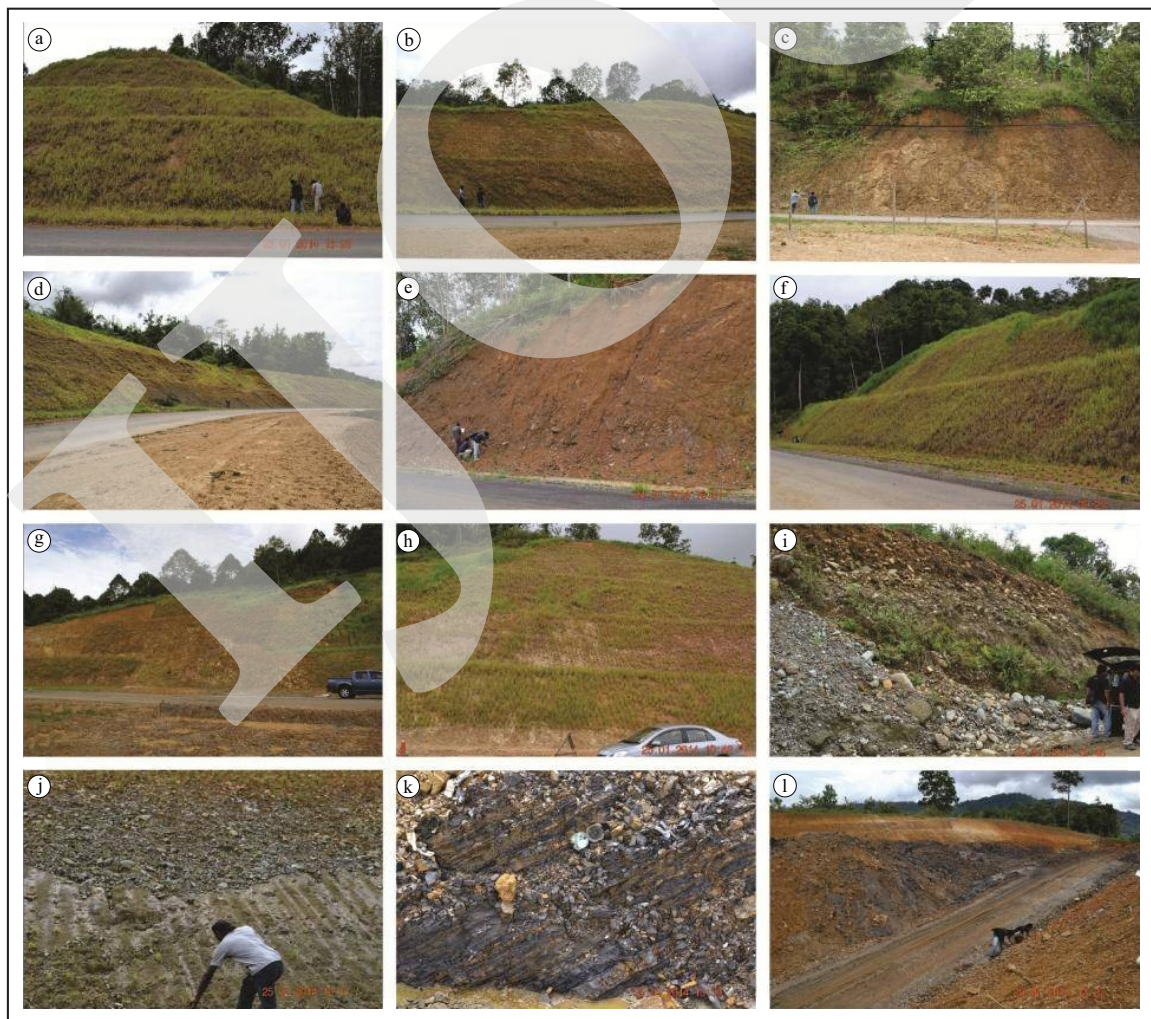
Figure 2. Slope sections. (a) slope 1; (b) slope 2; (c) slope 3; (d) slope 4; (e) slope 5; (f) slope 6; (g) slope 7; (h) slope 8; (i) slope 9; (j) slope 10; (k) slope 11 left; (l) slope 11 right.

The slope stability assessment was conducted on twelve slopes along the road (Figure 2). In this

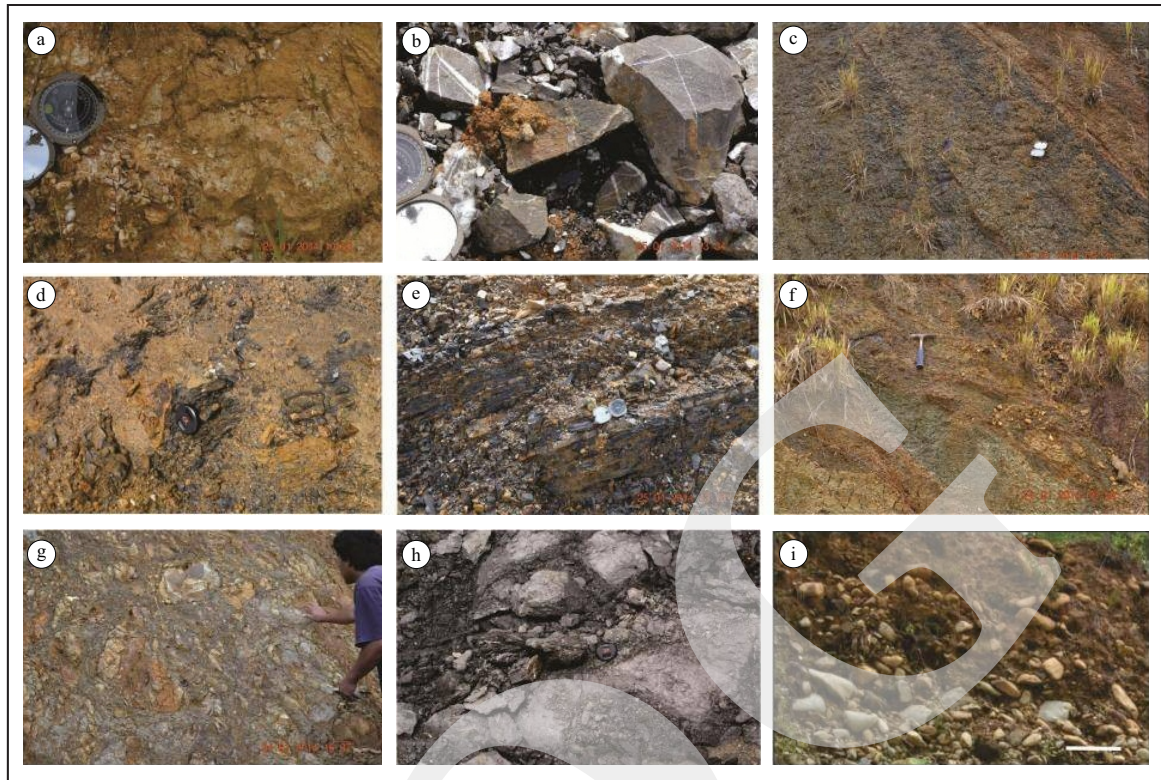
Figure 4. Geotechnical units. (a and b) arenaceous unit; (c and d) argillaceous unit; (e) interbedded unit; (f, g, and h) sheared unit; (i) alluvial unit.
