# Stability Analysis of Brahmaputra Riverbank at Neulgaon

**Abstract**— River bank erosion is a recurrent problem in Jorhat district of Assam. Most of the rivers in Jorhat are shifting in nature and thus river bank erosion is common. Erosion has lead to the general widening of the river and instability of the river banks. River migration and land degradation displaces large number of people annually. This study intends to investigate the nature of river erosion and provision of adequate structural measures. Hydrological data and topographical sheet gathered from government departments have been used as a basis for this project. Software analysis and chronological survey techniques are used for the measurement of channel migration and thus eroded distances. Based on software viz. ARCGIS, channel migration of the river Brahmaputra in Neulgaon, Jorhat is found out. Secondary data were also collected from the local residents to explain the erosion status. The geotechnical properties of the eroded site are important parameters for construction of anti-erosion structures. The design of a structure mainly depends on the topography, hydrological data, and the materials of construction, th

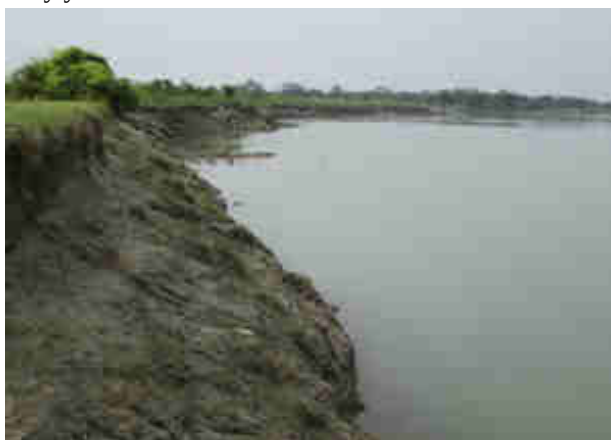
Fig.2: View of riverbank erosion at Neulgaon

Jorhat by-pass 37# highway. In this area villagers suffer extensive damages to agricultural fields and properties every year due to erosion. Villagers reported that the Brahmaputra River wash away 40-50 meters of the bank every year in the area.

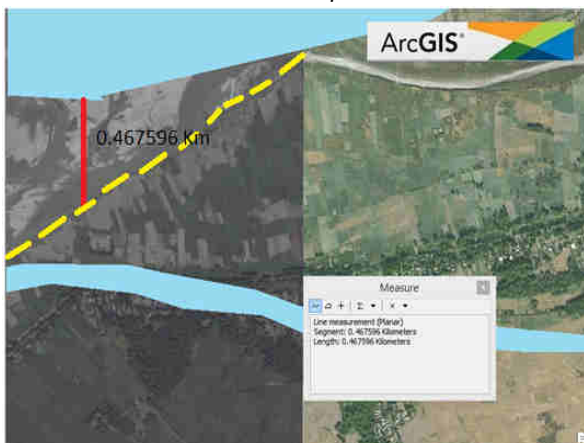
Fig.5: Superimposed braided channel layer at the site showing an eroded distance of 0.467596 km
