Cement Mortar Restorations and Disorders in the Archaeological Site of Chellah

Meriem Benharbit

Institut National des Sciences de l'Archéologie et du Patrimoine

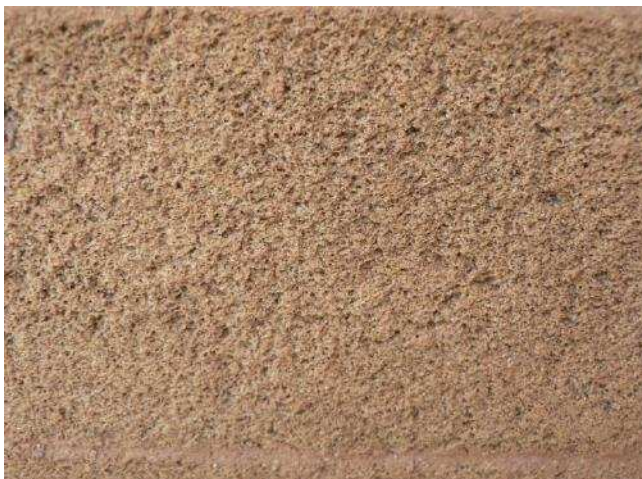
The cut stone used in the construction of the Roman structures, of plio-quaternary age, is outlined in the form of a system of elongated dune cords juxtaposed parallel to the line of the Atlantic coast from El Jadida to Larache. It corresponds to the local appellation of calcarenite of Salé. The rock, of beige color, shows stratification levels (So). The grain is predominantly millimetric. The petrographic study of the calcarenite shows a detrital fraction composed of rock debris and quartz grains and a bioclastic fraction (Lamellibranchiata, brachiopods and echinoderms shell fragments). These elements, which may present specific variations in terms of content and particle size, are linked by a mainly calcareous phase.

The rock has an important porosity ranging from 25 to 35% (Rahmouni A., et al., 2013) releasing cavities of varying shape and size. This porosity conditions the sustainability of the rock in the long term: it regulates fluid transfers, gives the material a surface roughness for fixing pollutants, and also opens the way to biological colonization.

Fig. 3: Macroscopic aspect of the calcarenite of Salé

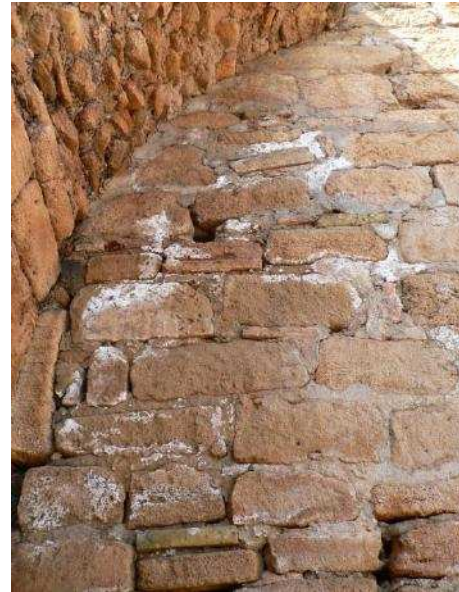
illustrated in glossary ICOMOS (2008) going, from the least harmful, of simple efflorescences saltworks to more or less dense saline encrustings “fig. 4 and 5”. However, other figures witnessing of more advanced disorders are also present: sandy disintegration “Fig.6”, alveolation “Fig.7” and gulying “Fig.8”.

Fig. 4: Damage Salt develops as encrustation covering the stone in interface with cement mortar

In Chellah, masonries are not isolated at their base. The capillary increase of water since the ground convey these salts which forward owing to the porosity of the rock. The cement mortar used to joint the blocks of calcarenite constitutes an obstacle for the mobility of the fluids which concentrate and deposit, during evaporation, the elements dissolved in the porosity of the rock. These salts generate disorders which are studied since the 19th century (Turner, 1833). The constraints exerted by salts in the course of growth on the walls of the porous network of the rocks (Scherer 2004, Putnis and Mauthe, 2001) can in the long term create and/or to widen cracks in the rocks.

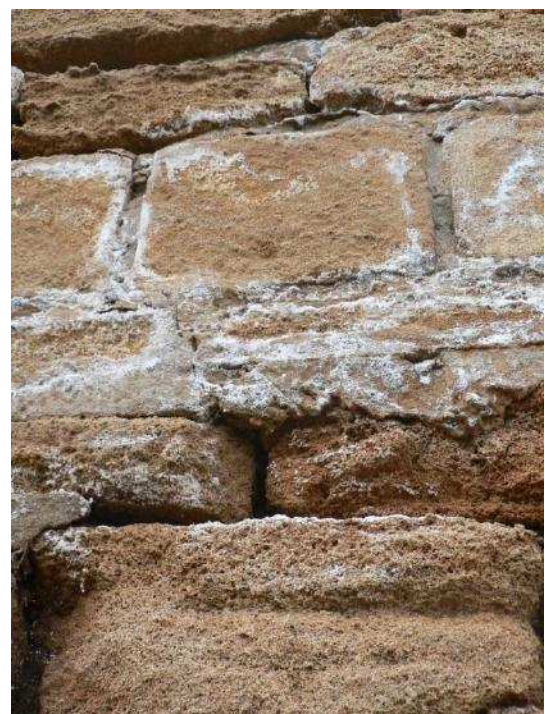
Fig. 5: Details of the saline efflorescences and encrusting on the calcarenite of Salé, at the interface stone-mortar

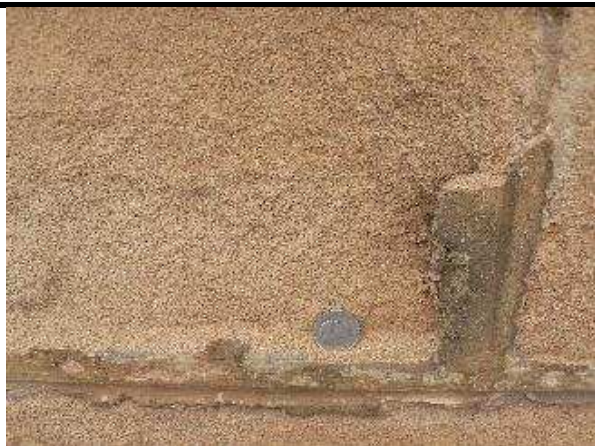
Fig. 6: Granular decomposition of a block of calcarenite, consequence of the use of a hard cement mortar. The rock has grown into a single alveolus.

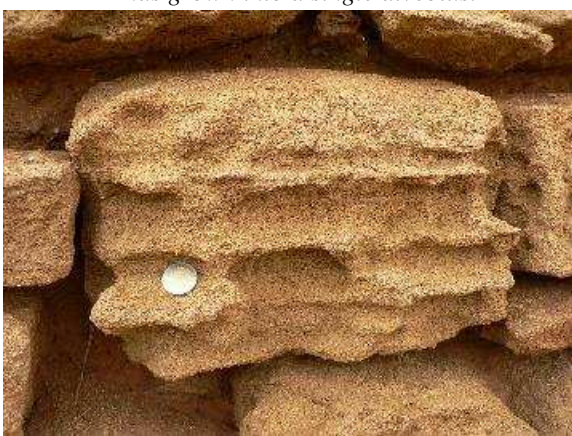
Fig. 7: formation, on the stone surface, of deep interconnected cavities

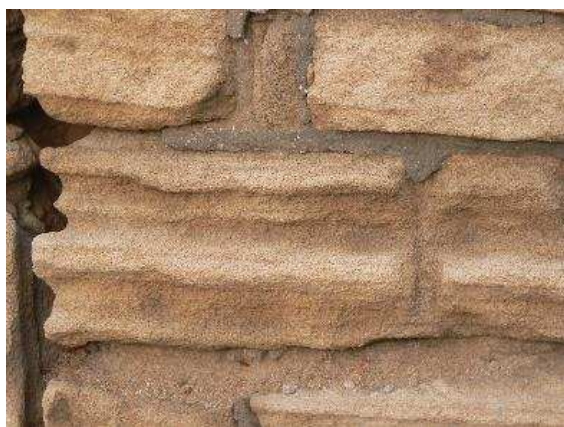
Fig.8: In contact with cement mortar, the rock has deep grooves that hollow out the material highlighting the hardest levels

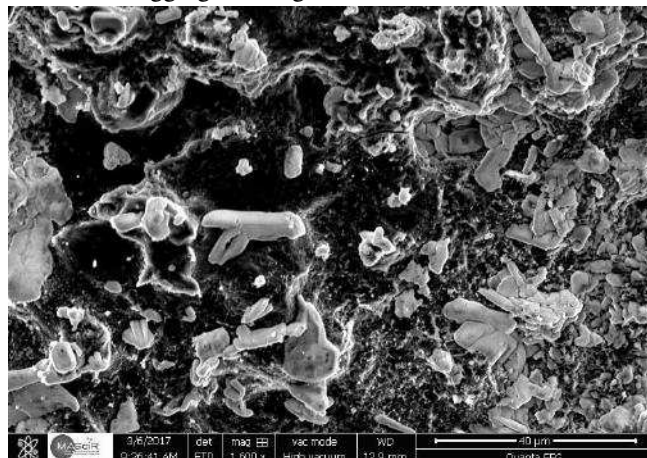
Sampling was carried out on the saline coverings developed at the stone-mortar interface and observed using the Moroccan Foundation for Advanced Science, Innovation and Research (MAScIR) environmental field emission electron microscope (FEG). Observations show

that the surface of the rock is lined with deposits of potassium sulphate. "Fig. 9" and cracks propagating between the aggregates" Fig. 10 "

Fig.9: observation with the MEB (X 1600) of potassium sulphate deposits recovering the surface of the calcareous rock

Analysis of the salt deposits formed shows the presence of potassium sulphate K_2SO_4 . This salt is commonly used as a fertilizer, potassium being an element that promotes the accumulation of reserves in both raciness and fruit.

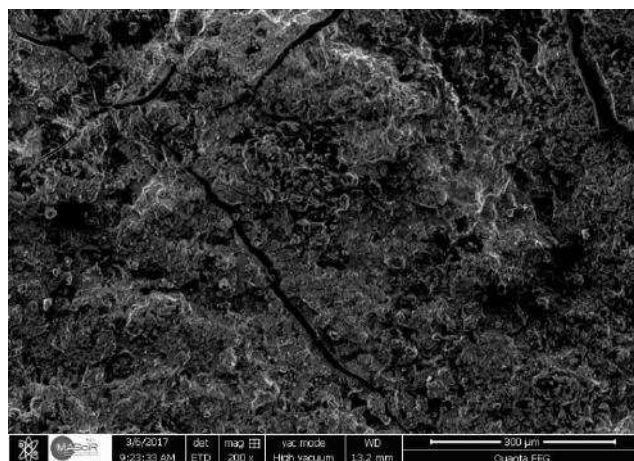
Fig.10: development of microcracks propagating on the surface of the rock

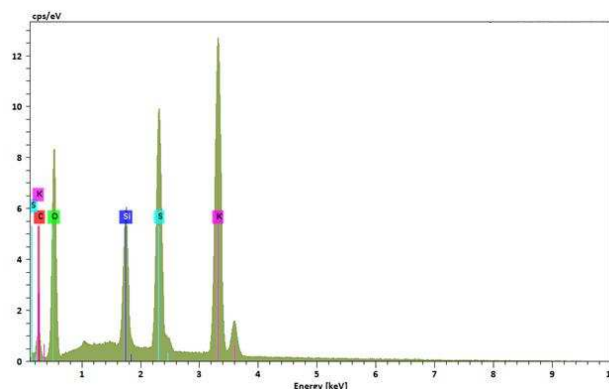
Fig.11: elementary spectrum of analysis obtained with the MEB of crystallizations saltworks showing of the potassium and sulphur peaks
