# Structural Retrofitting of a Reinforced Concrete Chimney

**Abstract**— In this study, structural strengthening on Turkey's oldest iron and steel factory, Iskenderun Iron and Steel Co. Ltd. (ISDEMİR)'s No:1 Blast Furnace Aspiration Concrete Chimneys were examined. These reinforced concrete chimneys were built according to the Russian standard in 1975. For reinforced concrete chimney concrete and reinforcing rebar, Russian Norm standards have been translated into norms that used in Turkey. For years, industrial dynamic effects, occurring in the region through strong winds and heavy industrial dust circulation in the chimney consisted of visible damage to the chimney. For the determination of the current status of the chimney infrared detection devices were used for the location, identification of reinforcement steel bars. Tensile tests were used on reinforcing bars to determine the material properties of steel rebar. Compressive tests were performed on concrete core samples. After a detailed investigation a concrete jacketing method is utilized to strengthened the 59.2 m long chimney. This study will summarize details of the strengthening on the chimney.

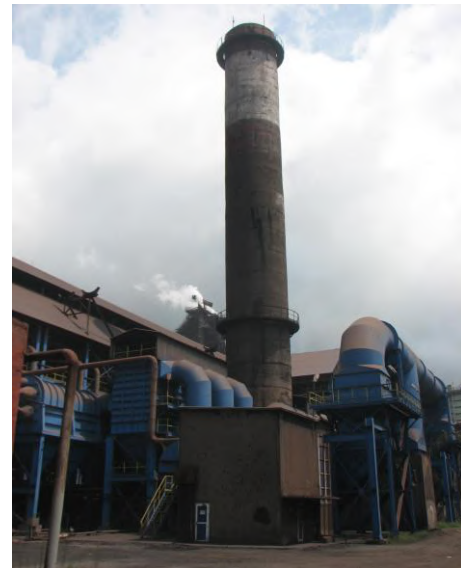
Fig. 1: General view of the chimney

In this study, ISDEMİR (Iskenderun Iron and Steel) Factory, No:1 Blast Furnace Aspiration reinforced concrete chimneys will be evaluated according to the ACI 307-98 and the 2007 Earthquake Standard (Figure 1).

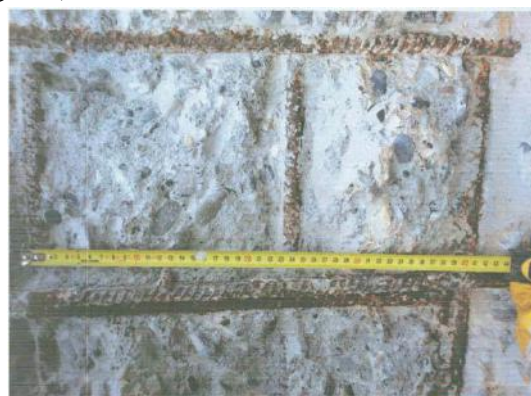
Fig. 3: Reinforced Steel Bar Pull Detection Activities

After the evaluation of the material properties of the existing structure, following processes are determined; The average strength of the concrete shows unexpected quality. A large difference between the experimental results are observed. The quality of the concrete was determined according to the results of the core samples: No. 1 characteristic compressive strength is (YF1) 142 kg/cm<sup>2</sup>. The quality of the concrete is lower than expected, also received the aggregate gradation of cores was found poor. The rebar class determine close to the St-I class by the reinforced steel bar pull detection and tests (Figure 3).

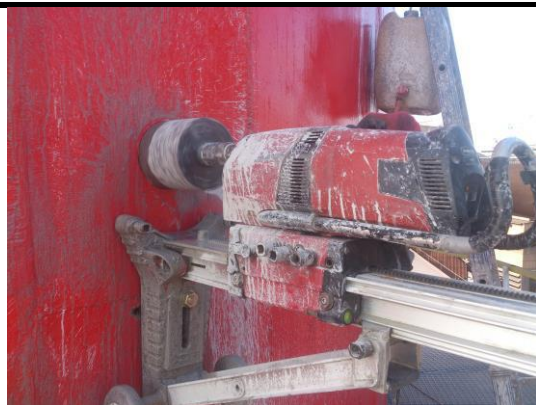
The concrete samples were taken from chimney and tested (Figure 4). The average of carotene concrete samples is 23.13 Mpa. Standard deviation is calculated for this samples as 6.55.  $F_{ck}$  value to be used in the model are calculated as follows  $f_{ck} = 0.85 \times (23.13 - 6.55) = 14.195$ .

Fig. 4: Taken concrete samples from chimney

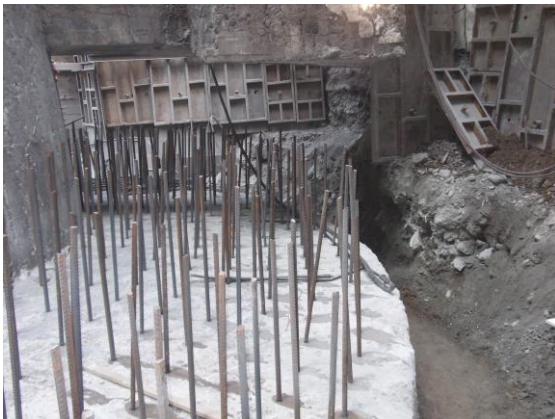
Fig. 6: Anchor works in chimney foundation

Anchor foundations made available to the chimney mantle has been initiated. Excavation width, taking into consideration the depth of the excavation is set. All necessary precautions to avoid contamination of the environment has been taken by the contractor. The rebars put the holes which was prepared before and filled by the chemical grout.

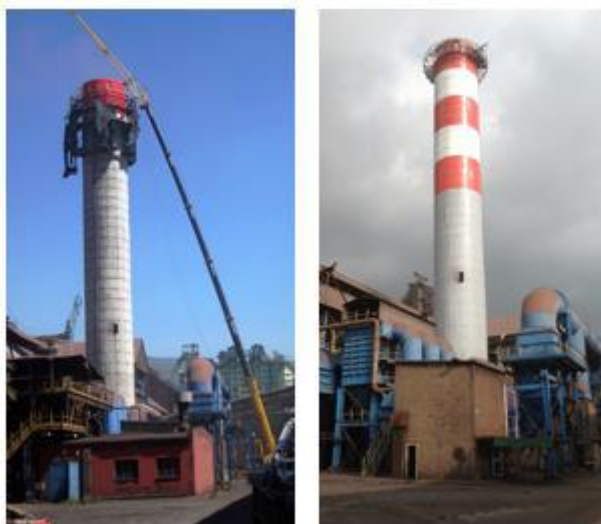
Fig. 9: View of chimney after jacketing and after painting

Detected holes in the concrete before painting has been repaired with structural repair mortar. After jacketing application on the concrete surface 50  $\mu$  thick epoxy concrete primer was applied by roller with a roll of 200  $\mu$  thick surface tolerant epoxy intermediate coat paint, as top coat 50  $\mu$  thick polyurethane paint one coat is applied by a roller. Concrete primer and epoxy paint colours were chosen can be distinguished. Thus, the application could be controlled.

Starting from the top of the chimney last coat of paint to the red (RAL 3020) and white (RAL 9003) was to be painted as shown in figure 11. 25 m from the top portion

red and white was chosen for the warning. The rest was painted gray (RAL 7040). (Figure 9.)
