Evaluation of Flexible Pavement Failures-A Case Study on Izki Road

Reem Salim Nasser Alaamri¹, Rafeeq Ameen Kattiparuthi², Alaa Moosa Koya³

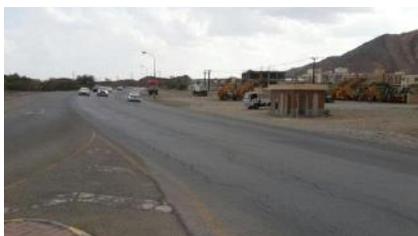
Fig 3: Izki road

Izki Road is located in the province of the Ad-Dakhiliyah, Izki, which is about 123.5 km from the capital Muscat. It is estimated that the length of the road is about 35 km and its two way road. The width of the road without shoulders is 618 cm. Izki Road is a service road, serving industrial and commercial areas, educational institutions and large residential communities. The road has been constructed more than 10 years ago. The road has not received any major repairs or modifications except for "Patching" to some of the affected areas.

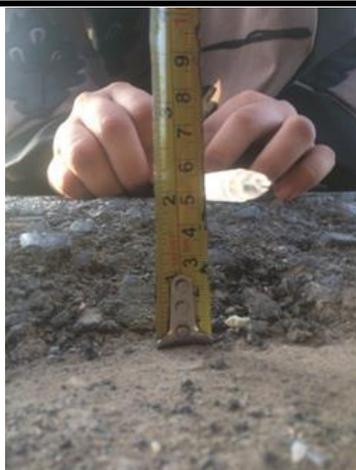
Fig.4: Road thickness

Izki Road is located in Ad-Dakhiliyah, starts from Izki and ends at Nizwa. It is estimated that the length of the road is about 35 km and its two way road. The width of the road without shoulders is 618 cm. the thickness of asphalt is 55 mm. Izki Road is a service road, serving industrial and commercial areas, educational institutions and large residential communities. The road has been constructed since more than 10 years ago.

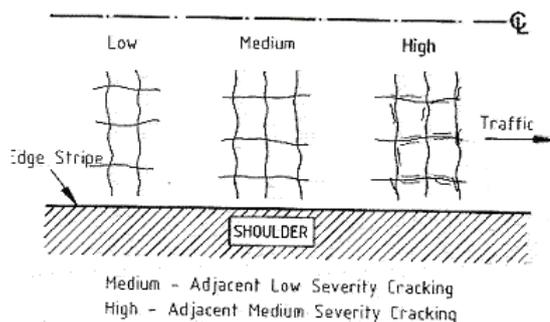
Fig.5: Severity Levels [Paul, T., 2003]

Block cracking is overlapping cracks that divide the pavement into rectangular or square pieces. The area of the block range from about 0.1 m² to 9 m². Large blocks are classified as transverse or longitudinal cracking. The difference between the Block cracking and Alligator/Fatigue Cracking is that the Alligator Cracking is small pieces and located in the wheel path but the Block cracking is located everywhere on the pavement. The figure below shows the block cracks and levels of intensity:

- ❖ Low: Cracks with a mean width ≤ 6 millimeters (mm).
- ❖ Moderate: Cracks with a mean width > 6 mm and ≤ 19 mm.
- ❖ High: Cracks with a mean width > 19 mm.

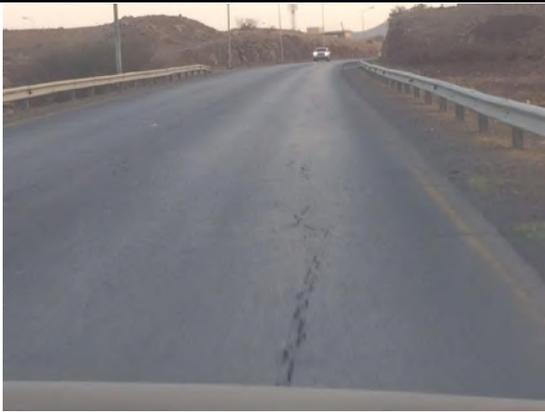
Fig.6: Longitudinal Cracks

The longitudinal cracks are parallel slits to the pavement's centerline; these cracks are structural defects (weakness of paving layer) and Functional defects (roughness of the paving surface). The loads and moisture accelerate the deterioration of these cracks.

Section	Type of distress	Length (mm)	Width (mm)	Severity Levels
Section A	Longitudinal cracking	1958	5.7	Low
Section B		2065	13.1	Moderate
Section C		1460	2.6	Low
Section D		1657	5	Low

Weak joint construction or location: The joints are usually the least dense areas in the pavement. Therefore, the joint should be constructed outside of wheel path so that it is loaded only irregularly.

Shrinkage of the asphalt layer due to temperature change or hardening of asphalt: During casting asphalt (the temperature must be more than 140 °C).also the possible Causes is the thickness of the asphalt layer is Insufficient (found that the road thickness is 55 mm).

The longitudinal cracking in section A, B, C and D are low severity levels. So, the suggested maintenance is Crack seal (fill the crack) to prevent moisture entering into subgrade through the cracks. Provide side drainage ditches to reduce cracking.

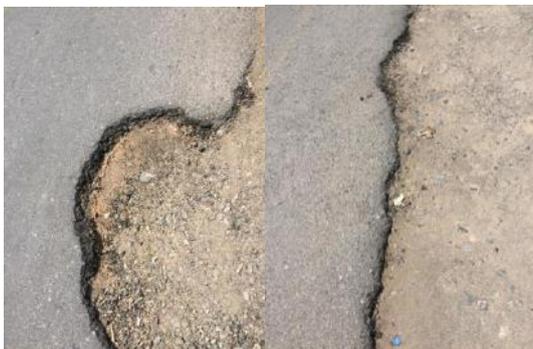
Fig.7: Edge Cracking

Edges cracking generally are parallel to the edge of the pavement. The shape of cracks is crescent or fairly continuous cracks. Edge cracks are increased due to excess traffic loads.

Section	Type of distress	Length (mm)	Severity Levels
Section A	Edge Cracking	2570	Moderate
		1258	Low
Section B		1641	High
Section C		610	High
Section D	1315	Moderate

Edge cracks appear due to the weakness of the base or subgrade layer near the edge of the pavement, lack of lateral support, heavy traffic and Poor drainage.

Improve drainage. Remove vegetation close to edge. Reconstruct of the edge and support the edge with paving stones.

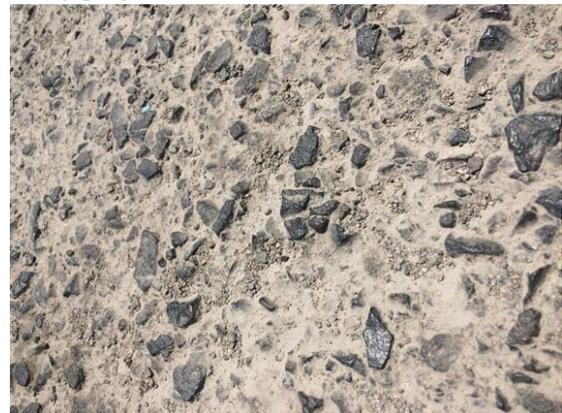
Fig.8: Raveling

Raveling is loss of material that covered asphalt surface or is the progressive disintegration of HMA layer as a result of the dislodgement of aggregate particles. These defects indicate that asphalt materials may be hardness or the asphalt mixture that was used is poor.

Section	Type of distress	Length (mm)	Width (mm)	Severity Levels
Section A	Raveling	1748	618	Not applicable
Section B		885	309	
Section D		2540	618

The possible Causes of raveling are Heavy traffic volume (in Izki road they are many types of vehicles), the emission of hydrocarbons from vehicles engines (hydrocarbons act as solvents for asphalt), water (Lack of drainage Causes water pooling; Water permeates the layers through the blanks) and Inadequate compaction during construction (High density is required to develop sufficient cohesion within the HMA).

For small raveled areas which centered areas of raveling (section B), Remove the raveled pavement and patch. For large raveled areas (section A and D) indicative of general HMA failure, Remove the damaged pavement and overlay*.

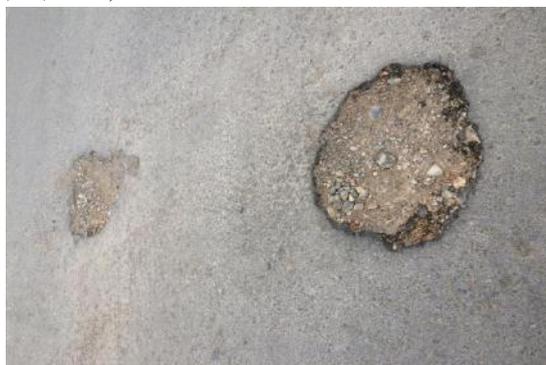
Fig.9: Pothole

Pothole is a hole in a road surfaces that penetrate the road through the HMA layer down to the base course. Potholes generally have sharp edges and vertical sides near the top of the hole. Normally the potholes occur on road that has the thickness less than 70mm (thickness of Izki road is 55mm).

Section	Type of distress	Length (mm)	Depth (mm)	Severity Levels
Section A	Pothole	456	11.2	Low
Section B		810	60	High
Section C		295	45	Moderate
		150	23.25	Low
Section D		470	40.5	Moderate

Generally, potholes are the end result of cracking. As alligator cracking becomes severe, the interconnected cracks create small chunks of pavement, which can be dislodged as vehicles drive over them. Also the possible causes of pothole are Weak spots in the base or subgrade, Poor surface mixtures, pavement surface have been dislodged and heavy traffic volume (traffic action accelerate potholes).

The suitable maintenance for pothole in section A and C is fill-depth but for section B and D is patching.

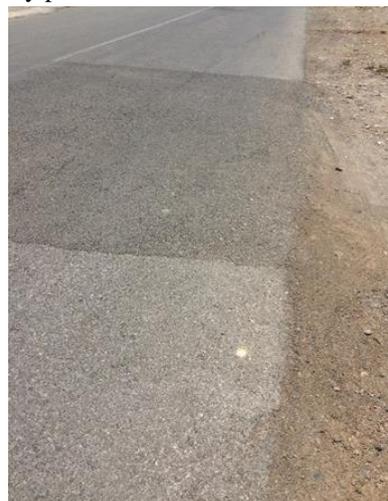
Fig.10: Patching

Patching is a part of the pavement surface that have been removed and replaced with additional materials applied to the pavement after the original construction. Some of defects that can treat by patching are longitudinal cracks, pothole, edge cracking and others of defects. If the patching is inappropriate it will affect into vehicle wheels. In fact, patching is a defect in itself, even if it is performed well.

Section	Type of distress	Length (mm)	Width (mm)	Severity Levels
Section A	Patching	452	618	High
Section C		570	150	Low
		963	618	Moderate

Possible causes of faulty patching are excessive traffic loads (Izki road is not ready to cross heavy vehicles such as trucks and accommodate a large number of vehicles), poor quality of materials that are used to construction and poor implementation of asphalt.

Cut and reconstruct especially in section A; Care must be taken in dealing with the maintenance procedures used in the treatment of any previous defects.
