Seismic Behavior of Tunnel Form Building under Lateral Cyclic Loading

Abstract. A three-story single-unit tunnel form building (TFB) was designed using a non-seismic code of practice (BS 8110). Two one-third scale test models were constructed and tested under in-plane lateral cyclic loading and out-of-plane lateral cyclic loading, respectively. The specimens were tested at $\pm 0.01\%$, $\pm 0.1\%$, $\pm 0.25\%$, $\pm 0.5\%$, $\pm 0.75\%$, $\pm 1.0\%$, $\pm 1.25\%$, $\pm 1.5\%$, $\pm 1.75\%$, $\pm 1.8\%$, $\pm 1.9\%$ and $\pm 2\%$ drifts, after which severe cracks were observed on the wall-slab joints and wall panels. Subsequently, the damaged specimens were repaired and retrofitted by wrapping carbon fiber reinforced polymer (CFRP) around the damaged walls and affixing steel plates and steel angles at the wall-slab joints using several different repair and retrofitting schemes. The repaired specimens were retested using the same drifts. The comparison of the seismic behavior between unrepaired and repaired specimens was made based on visual observation of damage, hysteresis loops, lateral strength capacity, stiffness, ductility, and equivalent viscous damping. The experimental re

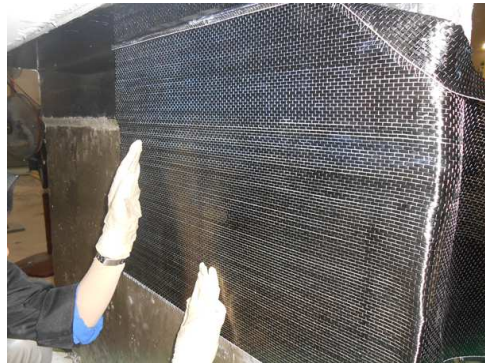
**Figure 4** Repair and retrofitting process of test model using CFRP fabric.

After the two specimens were tested under in-plane and out-of-plane lateral cyclic loading, respectively, the specimens were repaired and retrofitted using different repair and retrofitting schemes depending on the severity of the damage. The first TFB specimen, which had been tested previously under in-plane lateral cyclic loading, was repaired and retrofitted using CFRP, with a steel plate and a steel angle. Figure 4 shows the process of repairing and retrofitting the TFB specimen by affixing the steel plate and the steel angle at the wall-slab joint and then wrapping the whole shear wall with CFRP. The characteristic tensile strength of CFRP is 2800 MPa, the Young modulus $E = 165 \text{ kN/mm}^2$, and density is 1600 kg/m^3 . The second specimen, which had been tested under out-of-plane lateral cyclic loading and had suffered severe damage at the wall-slab joints, was repaired using a steel plate and a steel angle. Then, this specimen was re-tested using the same loading pattern before repairing it, until more cracks were observed at the outer and inner wall. Finally, the damaged wall panel was repaired again using CFRP fabric, and retested for a third time. A comparison was made between the unrepaired and repaired specimen based on visual observation damage, hysteresis loops, stiffness, ductility, and energy dissipation. Table 1 shows the amount of drift imposed on the unrepaired and repaired test models under in-plane and out-of-plane lateral cyclic loading.

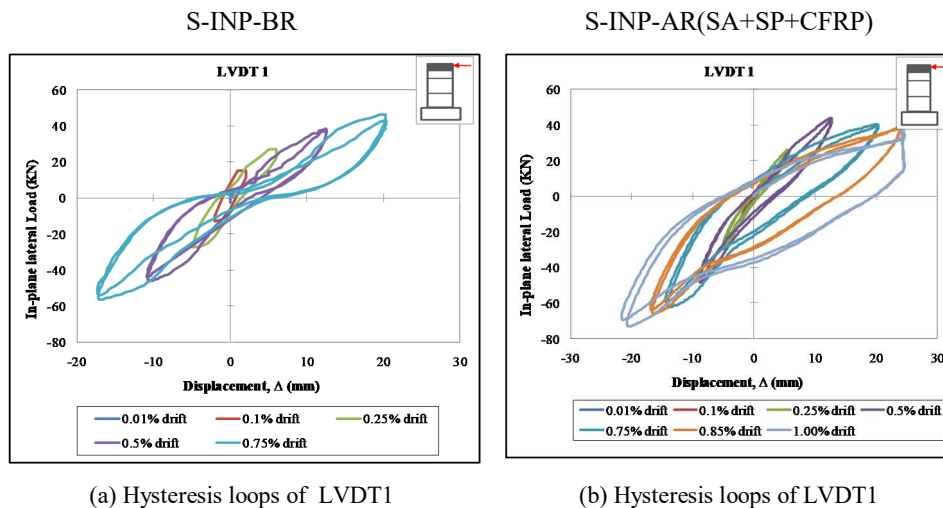
Figure 6 Comparison of hysteresis loops between unrepaired and repaired specimens.

Figure 6 shows a comparison of the hysteresis loops between the unrepaired and repaired specimens based on the measurement of load versus displacement obtained at LVDT1 at the top part of the test model. The ultimate in-plane load for the S-INP-BR specimen was 42kN and 45kN for the S-INP-AR(SA+SP+CFRP) specimen at $+0.75\%$ drift. It can also be observed that the area of the hysteresis loops was higher for the repaired specimen than for the unrepaired specimen. This means that the repaired specimen could absorb more seismic energy and better protect the wall from damage and collapse.

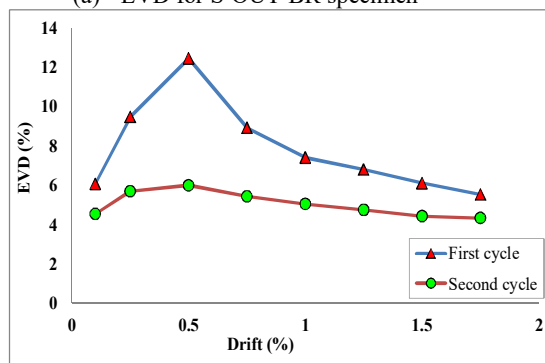
(a) EVD for S-OUT-BR specimen

(b) EVD for S-OUT-AR(SA+SP+CFRP)

Figure 10 Comparison of equivalent viscous damping (EVD) between unrepaired and repaired specimens.

Figure 10 shows a comparison of equivalent viscous damping (EVD) in terms of difference percentage between the unrepaired and repaired specimens. It shows that the EVD for the first cycle was always higher than for the second

cycle for both specimens, because the first cycle always required more energy to overcome the elastic strain energy before it reached the yield lateral load and yield strain. The second cycle indicates that the tunnel form building system exceeded the yield stress and yield strain of the reinforcement bars and required less energy to dissipate during testing or earthquake excitations.

Figure 10(a) shows that the EVD for the S-OUT-BR unrepaired specimen with a maximum value of 13% occurred at 0.5% drift in the first cycle. Meanwhile, Figure 10(b) shows the EVD of the S-OUT-AR(SA+SP+CFRP) specimen with a maximum EVD of 12% occurring at 0.01% drift in the first cycle. It can be seen that the value of EVD decreased when the area of the hysteresis loops recorded at LVDT1 was very small, or vice versa. It can be concluded that the EVD for the repaired specimen became steadier when compared to the unrepaired specimen [30].
