Vibration Analysis of Unbalance on Axial Fan Engine 5.5 KW

Abstract— The unbalance on an axial fan engine causes vibration and noises in a small open wind tunnel construction circuit. The unbalance is not only speeding up the damage to the engine but also disrupt the convenience surrounding the engine, especially for the engine users. In this research, measurement analysis is done to find the cause of the unbalance. Initial vibration measurement results show the amplitude exceed[s] the ISO 10816-3 standard limit (0.292 G-S equal to 15.45 mm/s). After going through the balancing process, the unbalance of the axial fan decreases by 84% with the amplitude of 0.047 G-S equal to 2.5 mm/s, so the engine vibration and the vibrations of its surrounding rope.

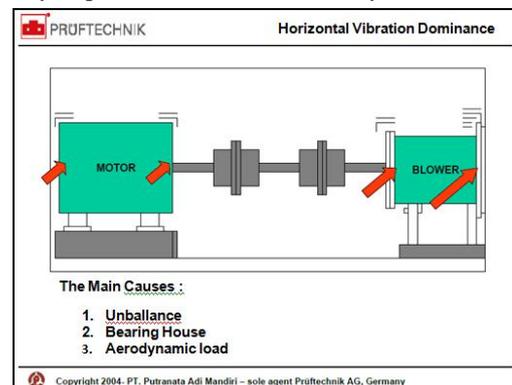
Fig.1: Dominant vibration in horizontal direction.^[2]

The axial fan engine construction that is installed in the open type wind tunnel has a direct connection between the axial fans with the engine through a coupling like a rotor connected to the stator. According to reference data the damage to direct connection machines is usually caused by an unbalance, bearing damage, and excessive aerodynamic load (see Figure 1).^[2]

Referring to the figure 1, excessive vibration on the axial fan engine 5.5 KW is estimated by the occurrences of a type of static unbalance, resulting from an engine misdeeds (such as the un-similarity in an angle between blades) or due to the imperfection in fabrications of engine components.^[2]

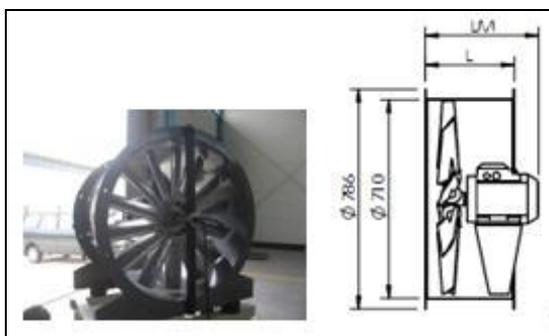
Fig.2: Construction of an axial fan engine.

Engine	: Axial fan
No. of blade	: 14 pieces
Power	: 5.5 KW
Speed motor	: 3000 RPM
Transmission system	: Direct
Speed balancing	: 1700 RPM
Diameter impeller	: 28.4"

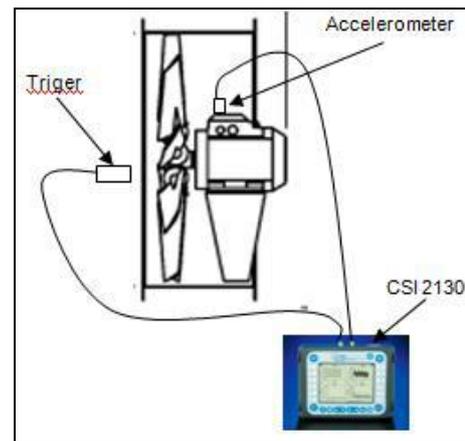
Fig.3: Setup measurement.

For this axial fan engine case, the vibration data required is in the vertical direction, so the accelerometer is placed parallel to the z axis in the engine's front bearing area. While the trigger is placed on the front of an axial fan engine hub (see figure 3). Then the device is connected to the CSI-2130 analyzer as a vibration counter.

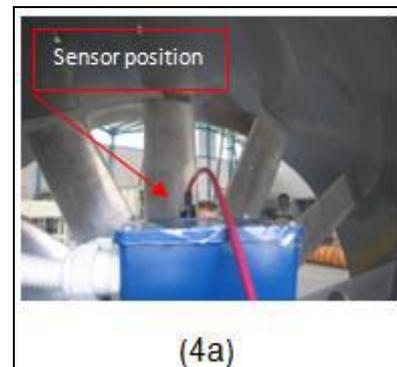
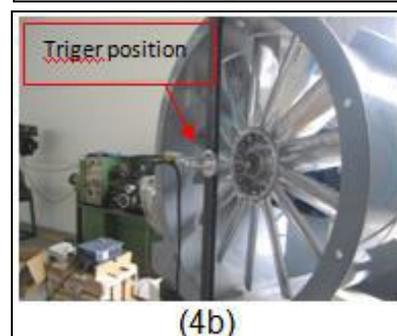
Fig.4: The locations of the vertical direction sensor on bearing no.1 of an axial fan engine (4a) and the locations of trigger (4b).

The first step, the axial fan engine is turned on, and then measures the initials unbalance to the engine by the measurement acquisition system (accelerometer, trigger, CSI 2130), the measurements were made in the front bearing positions of axial fan engine in a vertical direction only (see figures 3 and 4a).

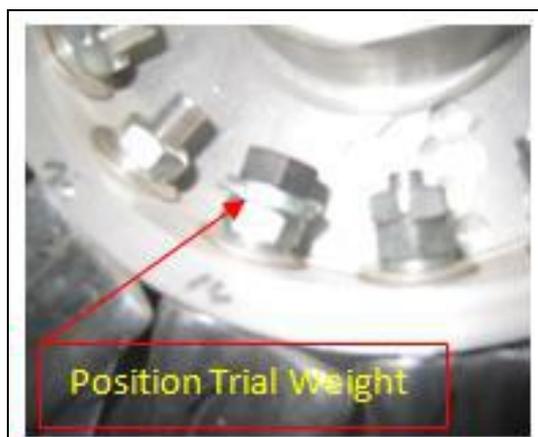
Fig.5: Location of trial weight on blade no. 14 at a hub axial fan engine.

The second step is to provides a trial weight as shown in fig. 5. This trial weight will be used to calculate the correction weight, at this moment the trial weight is used 20.1 grams at an angle of 0° on the axial fan engine hub (see first positions/ no. blade 14). Then turn on the engine again.

From the measurement, it is obtained the value of initials unbalance velocity of the axial fan engine, that is 0.479 G-S (25.34 mm/s) 326° . Besides that, it is obtained the correction load phase angle and the correction load value as explained in step three, Afterward, the engine is turned off.

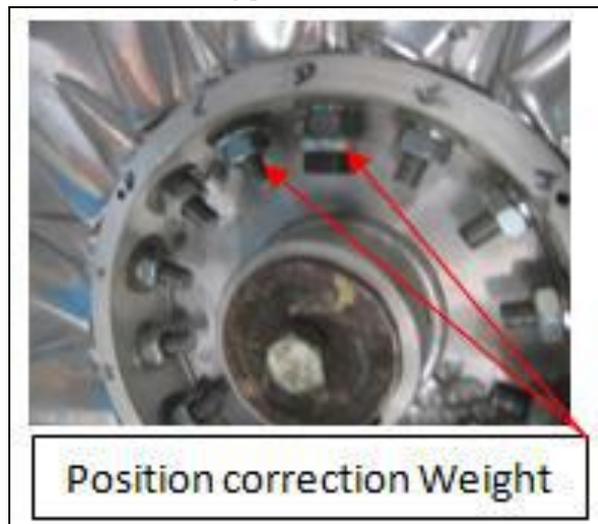
Fig.6: The locations of the correction weight in blade no. 6 and 7 at a hub of axial fan engine.

The third step is to provides the correction weight, that is 25.29 grams at 231.4° (at first positions/ blade no. 6), and 5.42 grams at 205.7° (at second positions/ blade no.7) as shown in fig. 6, then put the engine on again. Then the initials unbalance of axial fan engine is re-measured at front bearing positions on vertical direction.

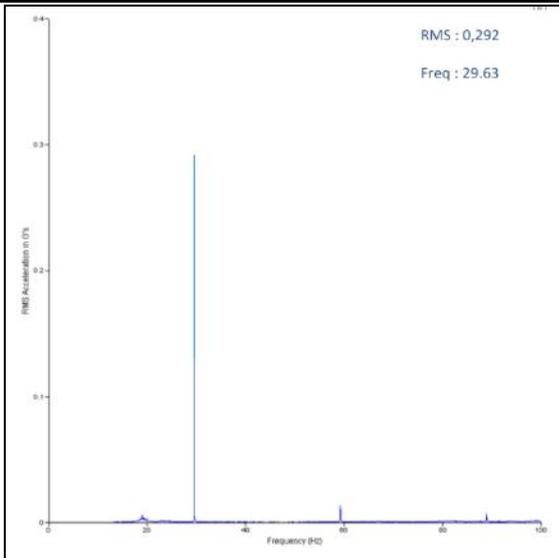
Fig.7: Axial fan engine vibration spectrum data owned by PT. Chroma before correction

From the measurement results obtained by the value of amplitude of initials unbalance 0.2924 G-S (15.45 mm / s) at 318° phase angle (see point 1at Fig. 10a and 10c), then the engine is turned off.

The value of unbalance obtained from the measurements of 15.45 mm/sec is quite large beyond the allowable vibration limit for the axial fan engine, therefore the value must be reduced to the allowable limit.

Measurement and recording with FFT spectrum data curve is very helpful in conducting vibration monitoring or analyzing a problem on the machine. Therefore FFT spectrum data curve is often used by experts as a guide to quickly and accurately indicate an abnormal problem of vibration on the engine see figure 7, 8, and 11).

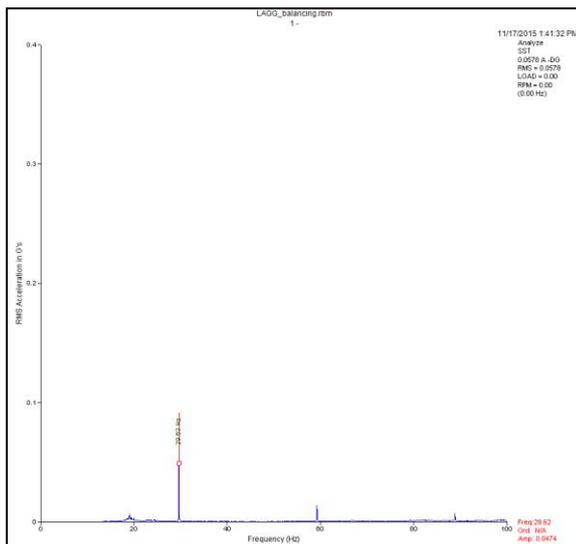
Fig.8: Axial fan engine vibration spectrum data owned by PT. Chroma after.

The result shows that the initials unbalance value decreases to 0.047 G-S (2.5 mm/s) at 31° phase angle (see point 2 - figure 10b and 10c) from the previous initials unbalance velocity value of 0.2924 G-S (15.45 mm/s). It means that the initials unbalance positions moves from the positions of point 1 to point 2. The displacements from point 1 to point 2 wants to show that visually the

change in the value of the amplitude of the unbalance vibration becomes better especially if the visual change in the value of the amplitude of the unbalance vibration approaches the point (0,0). The percentage change in the value of vibration amplitude is decreased by 84%. Judging from this, the balancing process is considered successful.

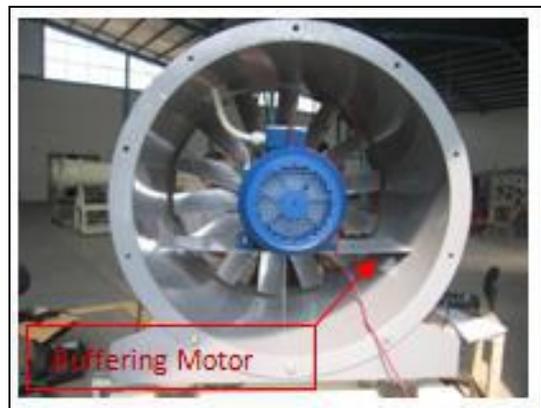
Fig.9: Buffering of axial fan engine that needs to be reinforced.

Evaluation of measurement of vibration bump test to the axial fan engine buffer, showed the increase rapidly in vibration and frequency from 7.81 Hz to 19.70 Hzwith rapid increase of the velocity from 0.0030 in/s to 0.0060 in/s. This shows the effect of natural frequencies on the less rigid axial fan engine buffer (see table 5 and figure 9).

Based on the results, it comes to consideration that the axial fan engine buffer needs to be strengthened so that the natural frequency value of the axial fan engine buffer occurs outside the engine's operation frequency (see figure 9 and 11).

1. The axial fan machine work activities must be monitored regularly (recommended every month) to find out the trend of engine vibration spectrum data. If the data shows a trend of increasing unsafe vibration operations, it is immediately possible to analyze the source of the bad vibration spectrum data so that identification of repairs to the machine can be known precisely, then the engine is protected from damage (see figure 7).^[1]
2. If there is a cause of vibration in the engine due to static unbalance, it is recommended to do onsite static balancing procedure as above, then the problem of unbalance on the machine can be overcome immediately, so that the engine can work again with good accuracy and the delay time of the engine is not lost too long.
3. Strengthen the buffering of axial fan engine to minimize static unbalance interference on the rotor.

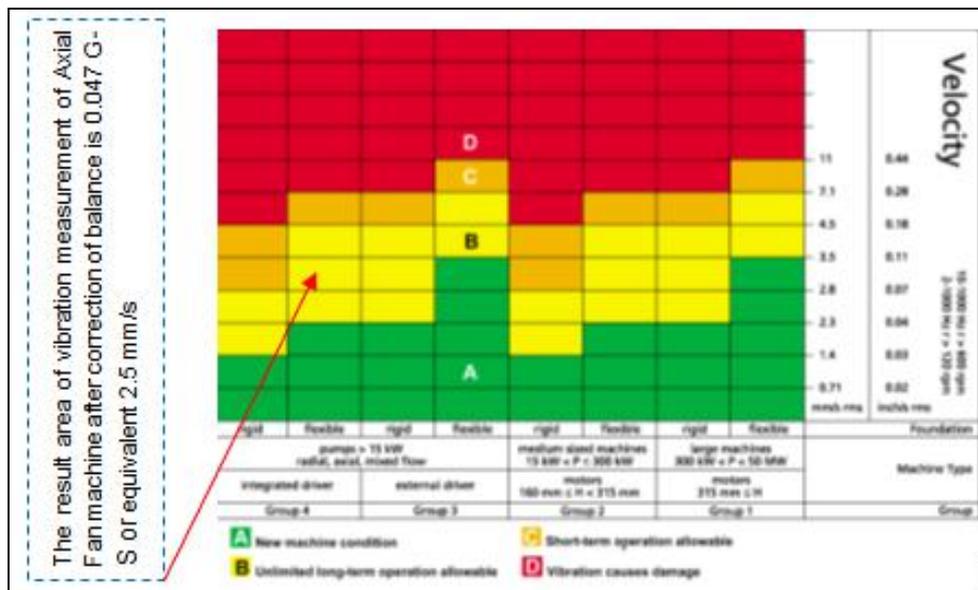
Table.7: The result of vibration data before and after the measurements of on-site balancing at bearing positions 1 of axial fan engine owned by PT. Chroma.

Sensor Location	Bearing 1		Explanation
Sensor position	Vertical		
Vibration before balancing	0.292 G-S	15.45 mm/s	Vibration causes damage
Vibration after balancing	0.047 G-S	2.5 mm/s	Operation allowable

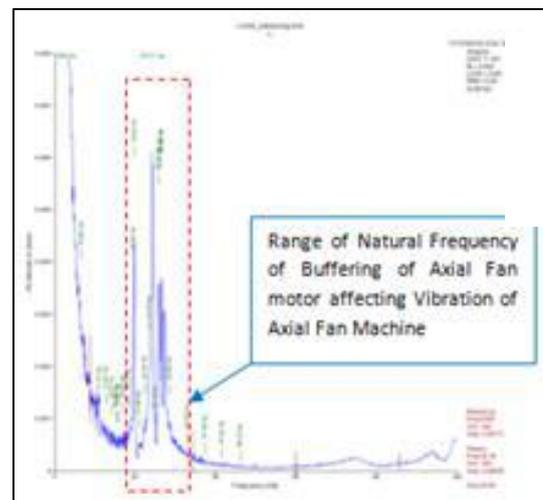
Fig.11: Resume of spectrum vibratory bump test data of buffering of axial fan engine

The fourth step is to measure the natural frequency and velocity vibration of the buffering of the axial fan engine by the bump test method. From the measurement found there are rapid increase in frequency from 7.81 Hz to 19.70 Hz, as well as a rapid increase of velocity from 0.0030 in / s to 0.0060 in / s. This shows that probably there is an effect of natural frequencies on the less rigid axial fan engine buffer (see table 5 and figure 11).
