Specific Features of Historical Structures of Buildings and Road Facilities in Bulgaria in 19th and In the Beginning of 20th Century

Abstract— The aim of the study is an analysis of some constructive systems in Bulgarian architecture in 19th century and in the beginning of 20th century. In the historical development of Bulgaria this is the time of changes in all areas of life. The period is connected with the transition from the Middle Ages to the Modern Era and the perception of the changes brought about by the industrial development in Europe. The wooden and steel constructions used in cult and public buildings and facilities have been explored. The use of different types of materials for these structures is related to the functions of the facilities, their social and industrial significance. In the course of the study, the hypothesis of the unity of the construction system and its relation to the terrain is confirmed. The unity of the construction system is considered as a significant problem, because builders during this period follow the local historical tradition and good knowledge of the craft. Following the tradition they work with historic, traditional materials such as w

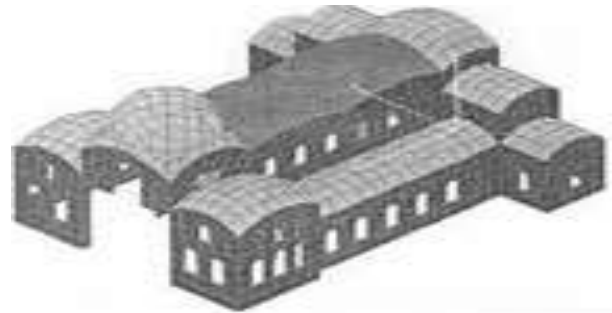
Figure 3: FE model of the St. Sofia basilica

unstrengthen structure in 1989 by the computer programs COSMOS [5] using 3D brick finite elements [6]. The second analysis is performed in 1998. In this study the spatial model is composed from existing structural elements from one side and some new strengthening elements (two reinforced concrete shells above the existing masonry domes and six tension bars of the roof arches and vaults) on the other hand [7]. The analysis is made by the finite element method (FEM) using also the COSMOS computer program [5]. The model contains 2475 finite elements and 2283 nodes with 6 DOF (3 displacements and 3 rotations) in each one (Figure 3). The total number of equation is 12666. The shell elements have bending and membrane stiffness. The shear deformations are taken into account. Elastic and isotropic material is assumed. The particular structural elements are defines as regions. The finite element mesh of each region has a maximal dimensions up to 1,5 m (Figure 4). The adjacent regions are connected each other by common nodes which guarantee displacement and rotation compatibility. Supporting nodes are entirely fixed. The geometrical characteristics of the structure are the following: the wall thickness varies from 1,10 to 2,00 m, the masonry vault thickness is 0,30 m, the new r/c shell is 0,10 m thick. The material properties of the brick masonry are: the Young's modulus is $E=1350$ MPa, the shear modulus is $G=0,4E=540$ MPa, the mass density is $\gamma=1800$ kg/m³, but for the concrete they are: $E=25000$ MPa, $G=0,425E=10625$ MPa, $\gamma=2500$ kg/m³. The basilica structure is analyzed under vertical load and seismic actions of 9th degree according to MSK-64 and Bulgarian design codes [8]. The first 3 periods of the undamped free vibration are obtained as $T_1=0,287$ sec, $T_2=0,216$ sec, $T_3=0,197$ sec. The internal forces and stresses are computed considering the first 50 natural mode shapes. The seismic analysis is accomplished by two simultaneous horizontal seismic signals given by two correlated horizontal spectra. As a result the stresses in the dangerous points of the structure are obtained for the following two combinations: 1st combination - max stress = stress caused by the vertical load + stress from the seismic action; 2nd combination - min stress = stress caused by the vertical load - stress from the seismic action. The characteristic stresses of the wall masonry are: compression stress is 0,9 MPa, tension stress is 0,03 MPa, tension stress under bending is 0,04 MPa, shear stress is 0,05 MPa but for the roof masonry they are 0,5 MPa, 0,005 MPa, 0,01 MPa, 0,01 MPa respectively. The vertical stresses σ_z and the tangential stresses in walls and columns caused by the vertical and seismic loads exceed the material strengths. As a result brick elements are in danger. The stress concentration around the tension members is observed. Full scale dynamic experiment is realized too [9]. The numerical and experimental results have good agreement.

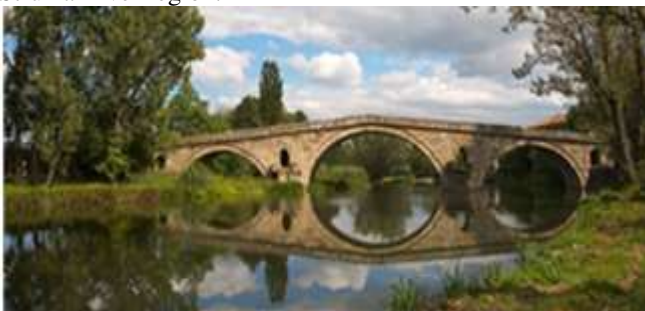
Figure 6: Kadin bridge.

Kadin Bridge is an arch bridge over the Struma River near to Nevestino, Kiustendil region. The bridge was built in 1470 on the order of Vizier Isaac Pasha during the reign of Ottoman sultan Mehmed II. Nowadays the bridge is still in use with a limited load-carrying capacity of 200 kN vehicles[10]. The bridge was proclaimed a monument of culture in 1968. The structure is a close-spandrel deck-arch stone bridge with a total length of 100.00 m and includes three main spans of 14.80 m + 20.00 m + 13.50 m. Additional two spans help to capture the capacity of the spring high level of the river water. They have spans of 4.80 m and 3.00 m. All arches are approximately semicircular shaped and have a total width of 6.00 m. The bridge deck is 5.60 m wide and has symmetrical longitudinal slopes of 10‰. The stone parapet is 0.40 m wide and the height varies from 0.40 to 1.00 m. The main piers have dimensions of 5.00x6.00 m. The material used for the bridge construction is high quality granite. The piers are supported by timber piles. The bridge structure survived one of the strongest earthquakes in Bulgaria in 1904 with a magnitude of 7.8 of the Richter scale and epicentre in the Struma River region.

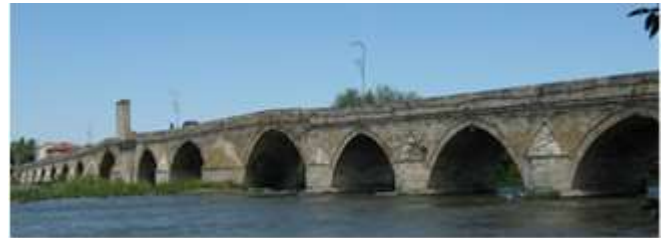
Figure 7: The Old Bridge.

The Old Bridge or Mustafa Pasha Bridge is a stone arch bridge as shown in Figure 7, over the Maritsa River near to Svilengrad (with an old name: Mustafa Pasha). The bridge was built in 1529 on the order of Vizier Mustafa Pasha. The bridge is proclaimed as a monument of culture with an owner the Road Infrastructure Agency. The structure is a close-spandrel deck-arch bridge with a total length of 286.00 m and includes 18 main spans with a widest span of 18.00 m. Additional two spans help to capture the capacity of the spring high level of the river water. The bridge arches are shaped according to the typical Arabian style with tapered crowns of arches. The total width of the bridge is 7.00 m. The deck has a stone parapet 0.33 m wide and the height varies from 0.40 m to 0.80 m. The three middle piers have dimensions of 9.50x6.80 m; the remaining piers have dimensions of 3.50x6.80 m. The piers stone footings are timber pile foundations. The bridge structure survived one of the strongest earthquakes in Bulgaria in 1928 with a magnitude of 7.0 on the Richter scale with epicentre near to Popovica.

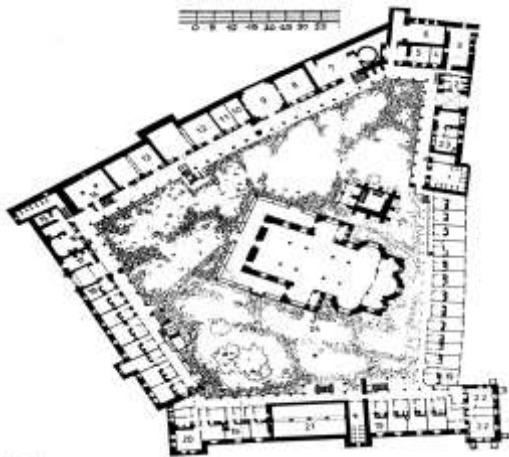
Figure 8: Plan of Rila Monastery.

The Monastery was erected as a closed complex of buildings, surrounding an inner yard in the form of an irregular quadrangle (Figure 8). The outer architecture has the characteristics of a fortress. The walls were built by using stone masonry and have window openings. The width of the walls varies in proportion to their height from 1.6 m at the foundations to 0.8m at the top. The front elevation consists of two main elements - arches and columns. The inside walls have timber structures filled with brick masonry. The floor and roof structures are made of timber. The roof was repaired in the twenties. The Central church is constructed in Byzantium Athos monastery traditions. It is domed basilica. The monastery housing wings have four storey's and contain more than 300 monastic accommodations, 4 chapels and numerous guest-rooms and storerooms. The most interesting of all premises is the large monastery kitchen, called "magernitsa"[11]. It is a massive tower in the form of a pyramid, which passes through all floors and ends up over the

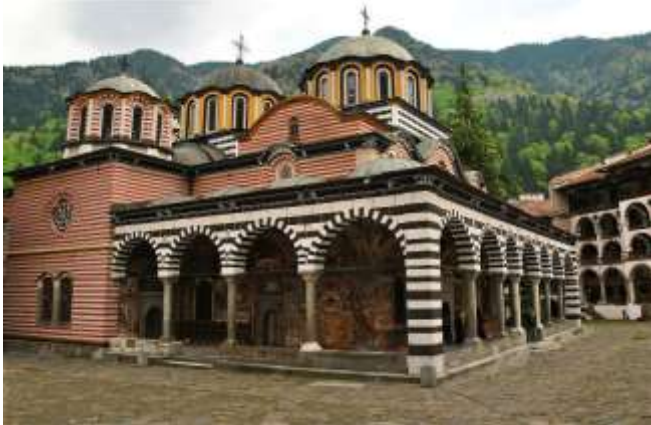
Figure 9: Church Holly Virgin.

The main Church “Holly Virgin” in the Rila Monastery was built in 1834-1838 in the middle of the monastery yard. With its layout, design and front elevation solutions, the church represents an astonishing achievement of Bulgarian architecture during the age of the Revival. It is a five-domed building with two lateral chapels and a gallery opened to the West, to the North and to the South (Figure 9). Three large domes with high drums form the axis of the main space of the church, which has the impressive dimensions of 14/31m. Wide-span arches at the transverse axes of the domes create a complex cross-like composition. The one-storeyed arched gallery is interesting with its unequal spans between the columns and blind domes at the roof. The western wall of the church bends into a triple yoke-like gable, which forms the main cornice of the building. The walls of the church were erected by using layers of stones and bricks. The complicated architectural and structural composition of the Church “Holy Virgin” represents the emphasis in the whole monastery complex. This remarkable religious monument is an integral part of the thorough harmony of the monastery complex.

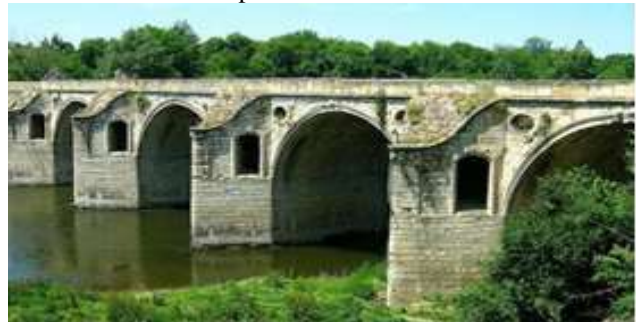
Figure 14: Belenski bridge.

Belenski bridge (Figure 14) is a stone arch bridge placed over the Yantra River near to Byala, Rousse region (Figure 14). The bridge was built in 1867 on the order of Mithad Pasha – statesman of the Danube Province in Ottoman Empire. The bridge builder was the famous local master Kolyo Ficheto. The bridge owner is the Agency “Road Infrastructure” and it was proclaimed a monument of culture in 1980. The structure is a close-spandrel deck-arch bridge with a total length of 276.00 m and includes 14 spans of 12.60 m. All arches rise 4.335 m above the ground. All arches are approximately semicircular shaped and the roadway is 9.00 m wide. The arches are built of two rows of stones with a total height of 0.8 m. The bridge deck has a stone parapet and with dimensions of 0.2x0.9 m. The material used for the bridge construction is a high quality limestone. The arch piers have dimensions of 5.40x9.00 m. Part of the piers footings have a pile foundation consisting of timber piles 6.00 m long with diameter of 0.20 m and distance between them of 0.30 m. The remaining part of the piers footings are bedded on a solid gneiss rock. The bridge structure survived one of the strongest earthquakes in Bulgaria at 1901 with a magnitude of 7.2 on the Richter scale and epicenter near Shabla.

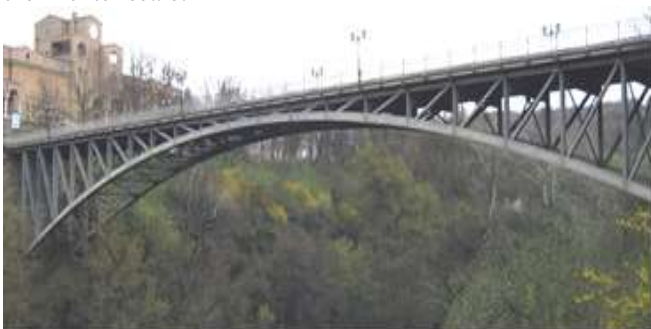
Figure 16: Stambolov bridge.

The Stambolov bridge is an example of quick penetration of steel construction in the road system in the 19th c. It is a steel deck-truss arch structure over the Yantra River at Veliko Tarnovo town (Figure 16). The bridge was designed and built by the Austrian “Waagner-Biro” company and is opened to traffic in 1892. The structure consists of two parallel Pratt-type truss arches with a distance between them of 5.60 m. The truss arches are 8.60 m high at the abutments and 1.20 m at the middle. They have 26 panels with a total length of 81.60 m. The bridge deck is 7.30 m wide. The upper horizontal chord and lower parabolic arch chord of the trusses are “U”-sections, 500 mm deep and fabricated by four angle sections with dimensions of 80x80x10 mm, back to back with a steel plate between them of 20 mm thick.

The outside flanges are additionally strengthened by steel plates with dimensions of 50x240 mm. The vertical and the diagonal members of the trusses have “I”-shaped cross-sections fabricated by four angle sections with dimensions of 120x70x7 mm, back to back with a web of 10 mm thick. The diagonal members are riveted directly to the chord members without gusset plates. The floor beams of the bridge are “I”-shaped, 600 mm high, fabricated by angle sections. The stringers also have an “I”-shaped cross-section. All fabricated cross-sections are fastened by a riveting. Lateral “X” bracings are placed at the upper and the lower chords and at the panel ends.

The bridge is supported on the abutments by steel hinged bearings. The abutment’s foundations are bedded on the solid rocks. The bridge structure survived one of strongest earthquakes in Bulgaria at 1913 with a magnitude of 7.0 on the Richter scale.

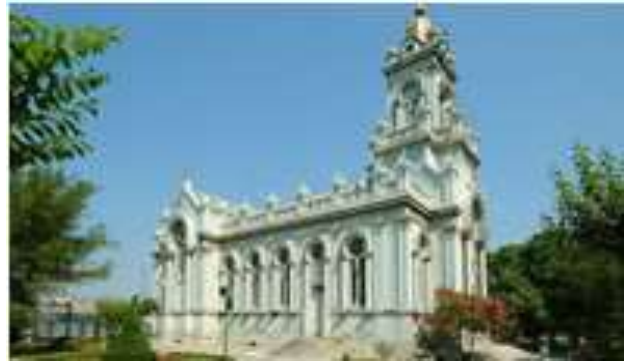
Figure 17: St. Stefan church, front of view.

The church of St. Stefan in its present form was built between December 1895 and July 1896, funded by the Bulgarian government. The designer was Hovsep Aznavur, an Istanbul architect of Armenian origin. The church itself was constructed by the Rudolf Phillip Waagner Company, and was made with a cast iron façade and steel sheets or rolled sections for the structural elements and ornaments. It was

taken to lighten the weight of the building, which is to be lifted on a landslide terrain which is pre-erected with pendulous piles [12]. According to its plan, the temple is a single-apse three-nave basilica with a short transept and empora, and with an eclectic façade decoration style. Unique roof structural system of church of St. Stefan in Istanbul, together with its architectural design will be explained through its main portal frame systems with precisely designed geometry [13], with circular columns in the mid of the space, truss beams and roof detailing with bars. The constructions are without filler and have steel finishes. [14].

The orthodox church of St. Stefan in Istanbul (Figure 17 and 18) is situated near the Golden Horn in the historical part of the peninsula between the Fener and Balat districts. This church is under the supervision of the Bulgarian Churches Foundation in Istanbul. On the Balkans, however, shared maintenance between Bulgaria and Turkey has led to problems for many architectural monuments. The temple, like many other Bulgarian religious buildings in Turkey and Turkish religious buildings in Bulgaria, has the status of an architectural monument and has been maintained by both countries according to the Bilateral Agreement on Cultural, Scientific and Educational Cooperation (1997) between the governments of the Republic of Bulgaria and the Republic of Turkey.

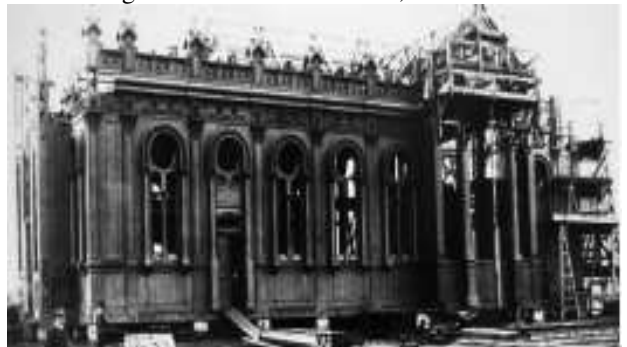
Figure 18: Construction phase of the church—iron structure

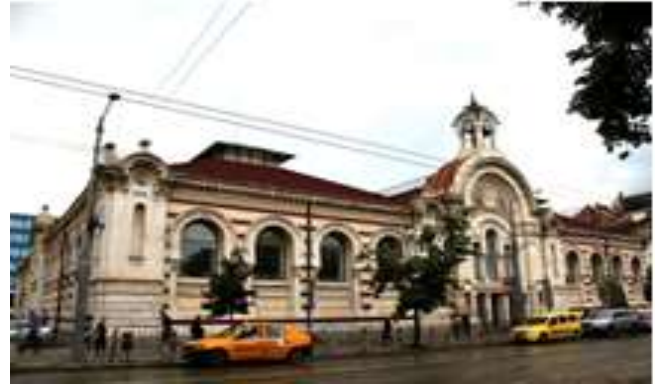
Figure 21: The front facade of the Central market hall

The modern peculiarities of 20th c. are developed in the Central Sofia Market Hall in 1909. Its architectural design as the cover of the building has three parts in architectural planning, as main entrance axis, with two side areas for stalls (Figure 21) [16]. Then it has two different portal frame solution, one for main entrance axis and other one is for two side areas of the entrance axis. Its iron-steel roof structural system has a unique solution from the point of steel architecture. Central Sofia Market Hall has three parts in floor plan. One is the entrance hall which is main axis and narrower than the other two parts which are at the both sides of the entrance hall. The entrance hall has the full height of the building, where the other two has one floor upstairs. Then the both floors are having the half height for each of them. In the mid of the plan, main exit is perpendicular with the other corridor axis for the doors at the sides. There is a perimeter

wall, surrounding whole building complex, having 4 doors and totally, 40 windows, which are designed for one storey building and now gives service for light for two storeys. The roof design is as gable roof for main entrance hall and as hipped roof for the side parts. Three of them have clerestory for daylight. There are 12 circular hollow section columns at the sides of entrance hall to get the loads coming from the roof levels (Figure 8). At the side ends of the building, the loads coming from the roof, are transferred to the perimeter wall (Figure 22).

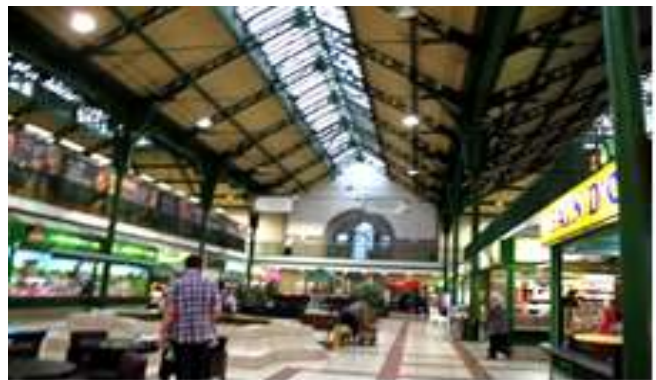
Figure 22: The main entrance door of Market hall from inside

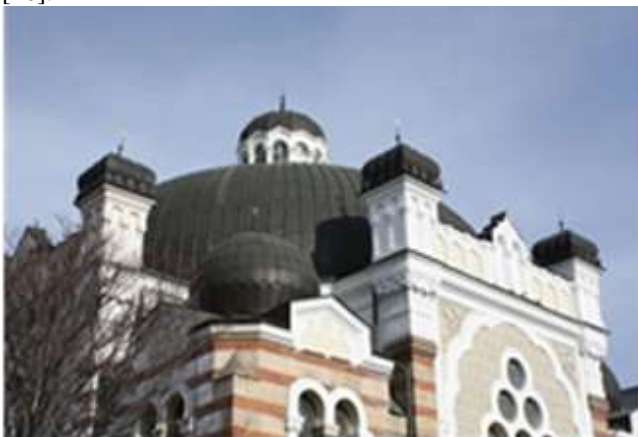
Figure 23: The front of View of Synagogue

The synagogue building in Sofia is located in the central part of the city and was built between 1905-1909. Since 1955 it has been included in the list of monuments of culture in the Republic of Bulgaria. The exterior building is planed in a rectangular shape and the interior is shaped as a symmetrical octagon with two different lengths, symmetrically aligned with the main and axes. The total built-up area is about 1000 square meters (Figures 23, 24). There is a gallery on seven sides of the octagon. The prayer hall has a square in plan shape with dimensions 27x27 m. Its cover is made of a steel dome. The dome has a 24 m aperture and is constructed as a rod construction consisting of radial and ring-shaped truss construction. It is supported by individual brick columns, which in turn step on powerful brick pilasters that form the corners of the octagon. The dome is constructed of three types of radially located truss construction and has four ring-shaped reinforcement truss construction. A small dome with a 4,40-m-wide hole is built on the top ring-shaped truss, which is made of light, radially spaced steel truss. The main dome support of the large dome is at the points of radial truss construction that pass through the corners of the octagon and is executed by trapezoidal shaped bricks columns that connect to the outer ring walls by a 30 cm thick wall. Radial truss

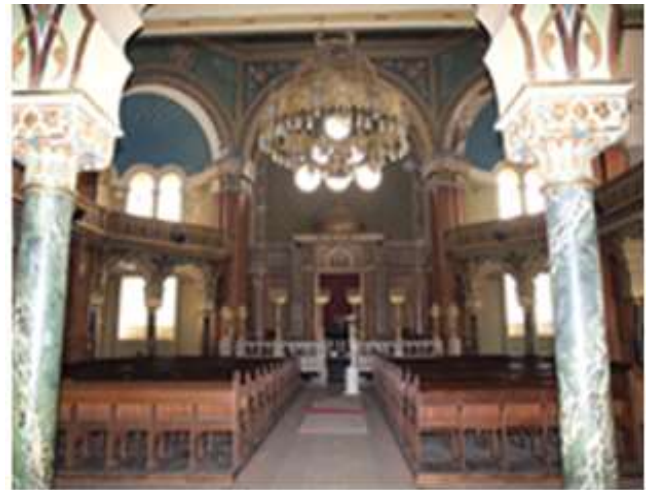
Figure 24: The Inside View of Synagogue

construction - of the second and third types are supported at their lower end by brick columns with dimensions 60/90 which step on cylindrical brick vaults that form the space behind the octagon. The construction of the short edge over the polygon is a brick cylindrical vault that connects to a part of a spherical brick dome that in turn connects with the outer surrounding walls. On the west side of the building, where the main entrance of the Synagogue, there is a two-story body with a basement used as an administrative building. It is related to the construction of the Synagogue, and the two bodies are a common body. The floor structures of the two-story building are made of steel I profiles, located at a distance of 80-100 cm, and a Prussian vault, stepping on the steel beams. During the Second World War, the building of the Synagogue was affected by the bombing, which damaged the roof, the northwest half-balcony, the balcony above it, and the window display windows in the prayer hall. The demolished part is restored with a reinforced concrete structure, which includes a part of the outer enclosing walls and part of the floor structure of the building. Restoration works were completed in the early 1970s. The main supporting elements of the building that resist the action of the horizontal forces are stone masonry, brick masonry and steel truss. Stone masonry is located in a small area at the bottom of the building and has high strength. This load-bearing capacity is determined by the strength of the brick masonry and the steel dome truss. All the brick walls of the building are made of solid single bricks with dimensions: 7x14x25 cm and 6 kg. on a brick. From the constructive point of view, the building presents a complex combination of different outline and shape elements, which differ in static and dynamic behavior. The way of support of the steel dome made it possible to examine the same in a simple way, as a spatial-rod construction was adopted for the calculation model. The number of the concentrated masses is assumed to be equal to 49, each mass having three degrees of freedom. In the study of the steel roof structure, the coefficient of significance is assumed $C = 1,5$ and the response factor - $R-0,2$. The structure has been investigated for 30 forms of proprietary oscillations. The construction of the high and low body of the synagogue building is examined together in a dynamic static study that corresponds to the actual situation. Due to the great complexity of the structure, each bearing element is broken into end elements which are connected to each other in a common network of end elements. Taking into account the type of foundations and foundation depths in the calculation scheme it is assumed that the base is elastically irreplaceable [16].
