# Investigation of Pedestrian Safety Problems and Its Countermeasures: A Case Study in Nekemte City, Ethiopia

Hayu Alemgena, Prof. Emer Tucay Quezon, Tarekegn Kumela

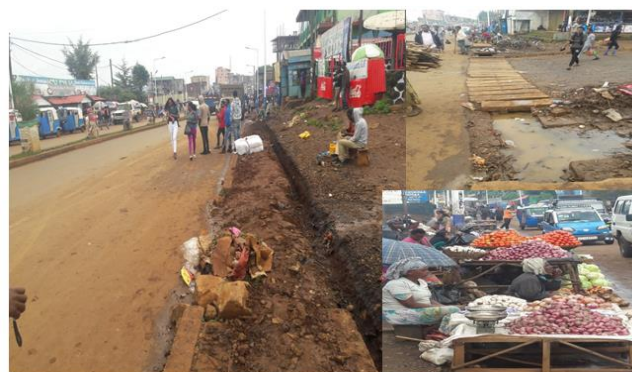
**Fig. 3.1: Sidewalk quality problem, absence of buffer and presence of illegal occupancy on walkway in Nekemte city**

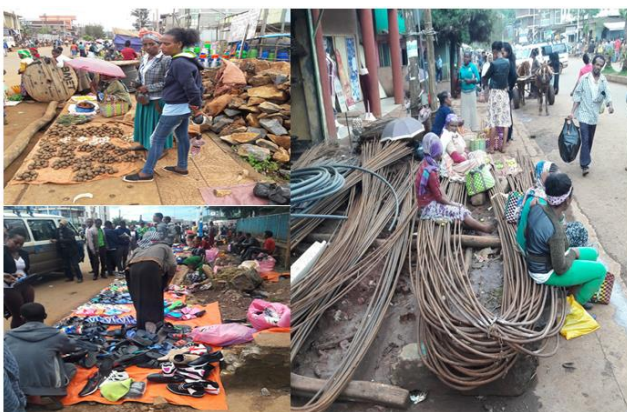
Fig. 3.3: Different types of sidewalk obstructions around Hospital, Bordi and in front of Nekemte Auditorium

Obstructions tend to influence pedestrian movement and reduce the effective walkway width. Therefore, the assessment of obstructions is essential to determine the access available to pedestrians. Thus, the current walkways in Nekemte city entirely encroach especially in Market and Commercial areas by vendors, utility poles, parking carts and illegal construction materials. These segments are not comfortable in general, and it is right to say no walkway in Nekemte market and shopping areas because the behavior of vendors in the city always seen by using only on the sidewalk even where the space available. In a Residential area, parking lot and illegal construction materials are challenging the pedestrians on a sidewalk as an obstruction, and it needs to consider by neighbor authorities to maintain and to take legal actions for further user safety.

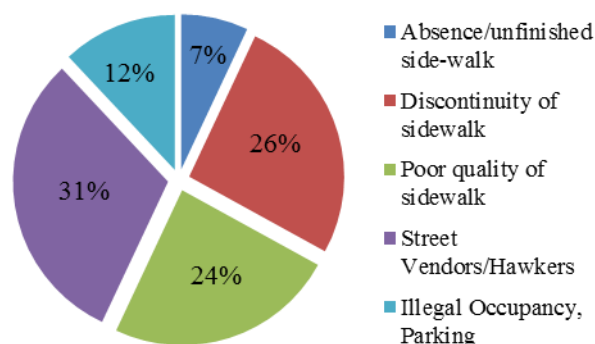
Several options provided for the respondents to choose why they do not prefer the sidewalk. Fig. 4.2 shows that the majority of users of the respondents do not prefer the sidewalks due to street vendors, discontinuity of sidewalk, poor quality of sidewalk respectively.

Fig. 4.2: Reasons for not preferring the sidewalk
