# Stress Corrosion Cracking of a X60 Steel in Carbonated Media.

Avilez A., Flores O., Aguilar A., Martínez H.

**Abstract**— Cracking in steel pipes caused by the corrosion suffered by the material due to the transport of hydrocarbons generates significant economic losses, and even human losses, as well as damage to the environment, so it is very important to know and determine the origin and mechanism whereby a medium rich in  $H_2CO_3$  induces cracking in API X60 steel ducts that are used in the transportation of hydrocarbons in Mexico. Stress corrosion cracking testing of X60 steel in an alkaline solution (pH = 9) of sodium bicarbonate ( $NaHCO_3$ ) at room temperature, at a concentration of 0.1M was performed. A MWOL (Modified Wedge Open Loading) specimen was used to measure the susceptibility to cracking and propagation of steel. It was found that the X60 steel after having fulfilled the test time established in the TM-0177 standard and once it was evaluated microscopically, did not show to be susceptible to the SCC phenomenon in a medium of sodium bicarbonate in the different experimental conditions.

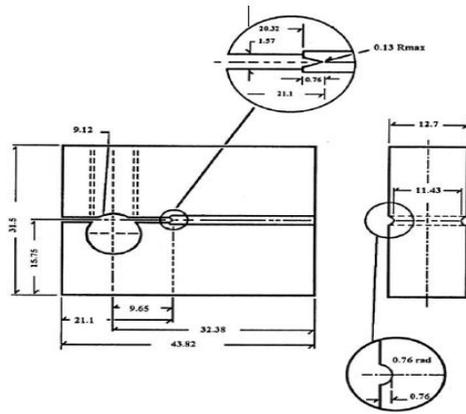
**Fig. 1.** Dimensions of the WOL Specimen Test in mm.

Stress tests threw out that the elastic limit varied between 370.7 MPa and 484.5 MPa [9]. Modified tension compact fracture mechanics specimens were designed by Novak and Rolfe (Fig. 1) [10], known as M-WOL in accordance with ASTM E 399-97 [11]. To determine the behavior of the steel in the proposed medium. After the machining, a coarse polishing of the notch was carried out using abrasive sandpaper from 80 to 2000 grain, in order to observe the growth of the crack.

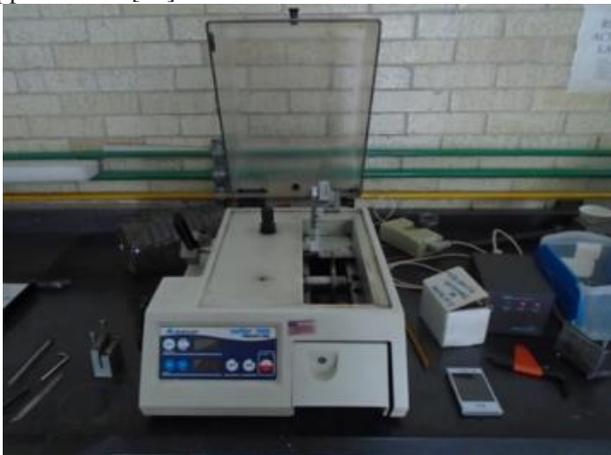
**Fig. 2.** Pre-cracked with Diamond Disk

A precision saw and a diamond-tipped disk with a thickness of 0.014 in were used to have an area almost free of deformation due to the machining cut and as clean as possible (Fig. 2). Once this process was carried out, the strain gages were placed in order to make the static loading (Fig. 3).

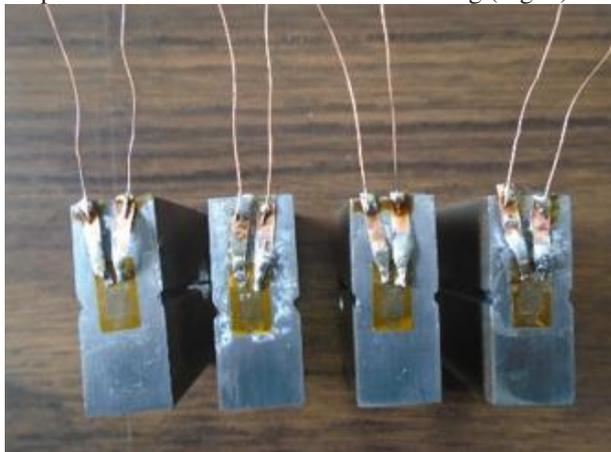
**Fig. 3.** Glue of Extensiometric Gauges.

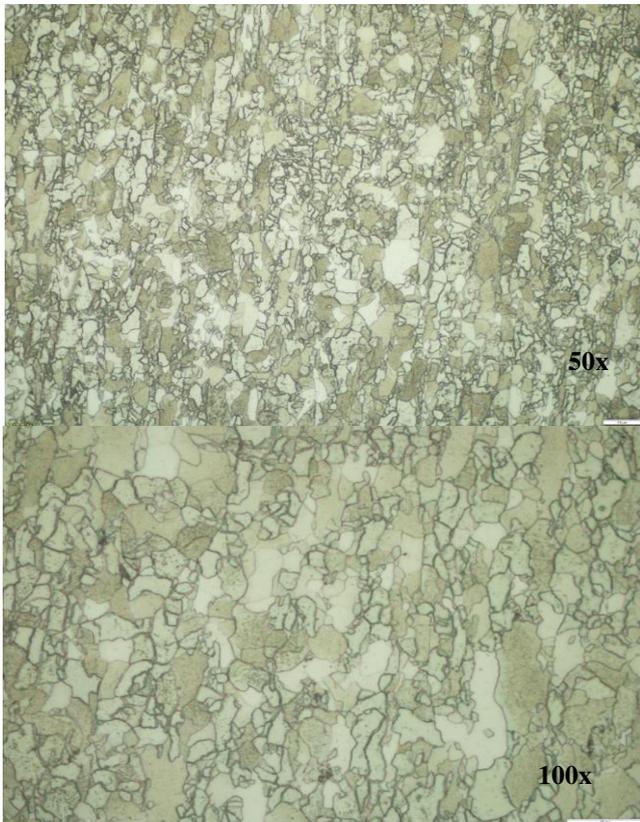
The microstructure observed in X60 steel corresponds mainly to ferrite (clear phase and gray tones) and a low percentage of perlite (dark phase), agreeing with the low carbon content. The distribution of ferrite grain sizes is heterogeneous, equiaxed fine grains with sizes around 5  $\mu\text{m}$  can be observed. Also observed are elongated grains with sizes of the order of 30  $\mu\text{m}$  in the longitudinal direction and

between 10 and 15  $\mu\text{m}$  in width. The percentage of nonmetallic phases is minimal, observing the presence of fine precipitates, probably Ti nitrides. A preferential elongation of the grains in vertical direction is observed, which is evidence of the plastic deformation of the microstructure during the thermomechanical process (Fig. 4).

**Fig. 4.** Microstructure Ferrite Pearlite of Steel X60. The dimensions correspond to 20  $\mu\text{m}$ .

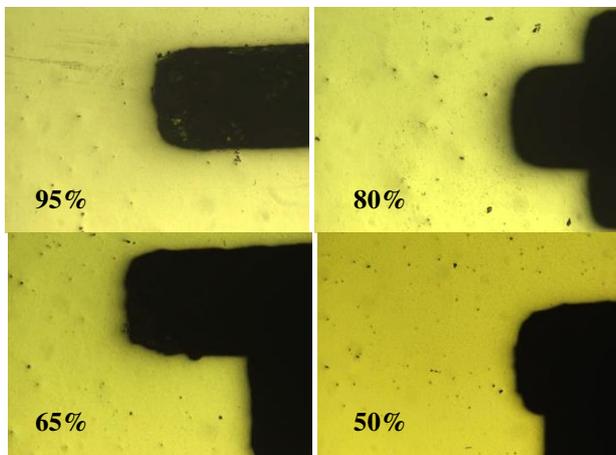
The regions where the cracks grow are shown in Fig. 5. The observed profile corresponds to the cut area with the diamond-edged disk, whose thickness is 0.35 mm. At the amplification shown, no large cracks are observed. But if it is possible to observe the change of the cutting profile associated with the corrosion process in the steel.

**Fig. 5.** Steel specimens X60 at different loads.

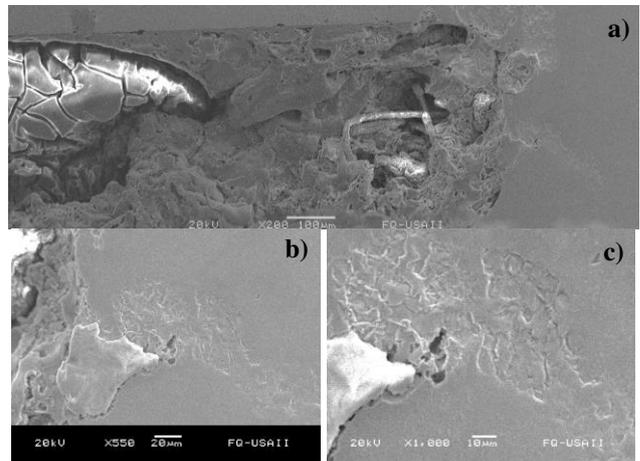
In Fig. 6. The crack tip generated in specimen 1 is shown. Crack growth is limited despite being the highest applied load. This indicates a great resistance of the X60 steel to the cracking process induced by the corrosion in the environment used in the corrosion tests under stress.

**Fig. 6.** Specimen 95% of the Cedence limit.

In Fig. 6a, the region of the diamond edge disk cut is observed. It should be noted that corrosion products are seen inside the cut. In b and c, the region where there is material dissolution and damage to the microstructure is shown at the highest amplification, just at the tip of the crack generated in the steel by the corrosion process under stress.

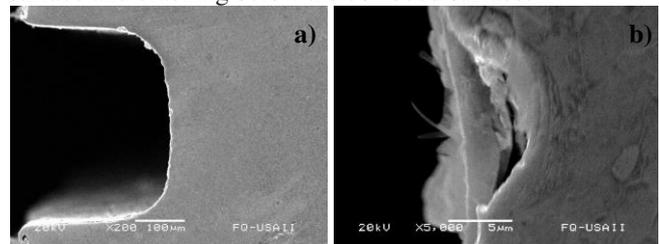
In Fig. 7. Images corresponding to specimen 2 are shown. Similar to sample 1, at low amplification, material damage is not observed, the edge of the cutting surface is almost unchanged. However, in b, there is loss of material on the surface and cracking below the corroded surface.

**Fig. 7.** Specimen 80% of the cedence limit.

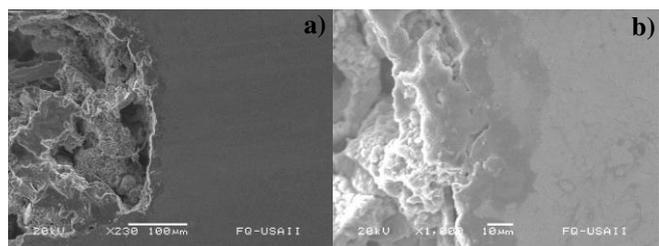
In Fig. 8. Images corresponding to the specimen 3 are shown. In a similar way to the previous ones, corrosion products are observed inside the disk cut with diamond edge. The profile of the cut surface shows dissolution of the material. In b, the corroded surface and the corrosion products are observed, as well as the microstructural damage (intergranular corrosion) suffered below the surface.

**Fig. 8.** Specimen 65% of the cedence limit.

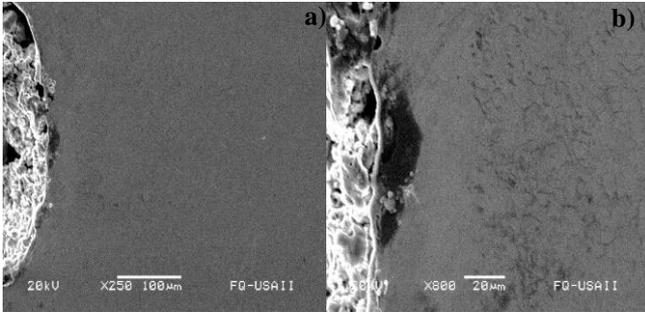
In Fig. 9. Images corresponding to specimen 4 are shown. Similar to the previous ones, corrosion products are observed inside the disk cut with diamond edge. The profile of the cut surface shows preferential dissolution of the material in the central region of the cut profile with the diamond edge disk. In b, the corroded surface and the corrosion products are observed, as well as the microstructural damage (intergranular corrosion) suffered below the surface.

**Fig. 9.** Specimen 50% of the cedence limit.

In all four samples, corrosion of the cutting surface and microstructural damage was identified right at the tip of the cracks, identified as intergranular corrosion.

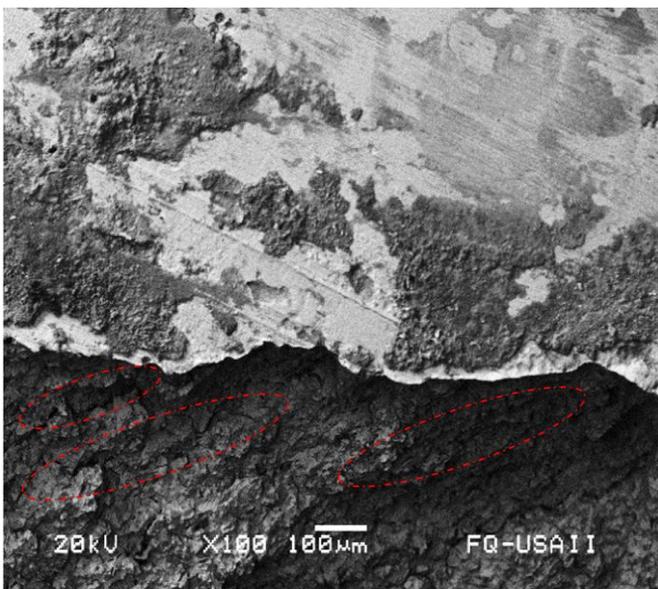
Fig. 10 shows the fracture surface for the sample with the highest intensity of effort at 95% of the yield limit. It is possible to observe the presence of a fragile surface with tearing systems in the pre-cracking zone.

**Fig. 10.** Fracture Surface, Specimen 95%.

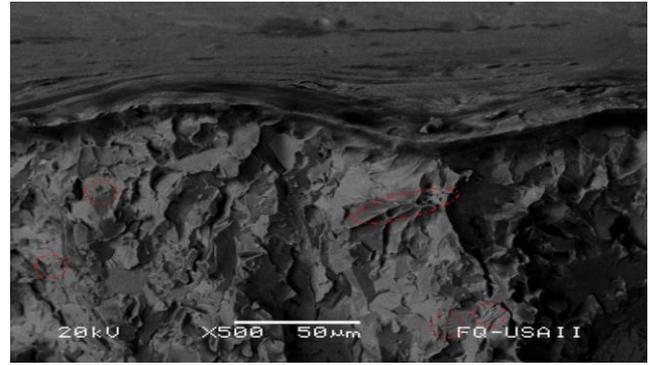
The sample at 80% yield limit has a ductile-fragile surface, in addition to the presence of small microcavities and cleavage (see Fig. 11).

**Fig. 11.** Fracture Surface, Specimen 80%

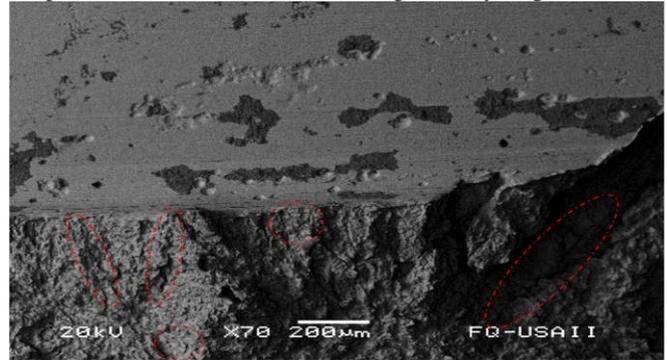
Fig. 12 shows the presence of intergranular cracking and the presence of coalescence, denoting a totally fragile surface.

**Fig. 12.** Fracture Surface, Specimen 65%.

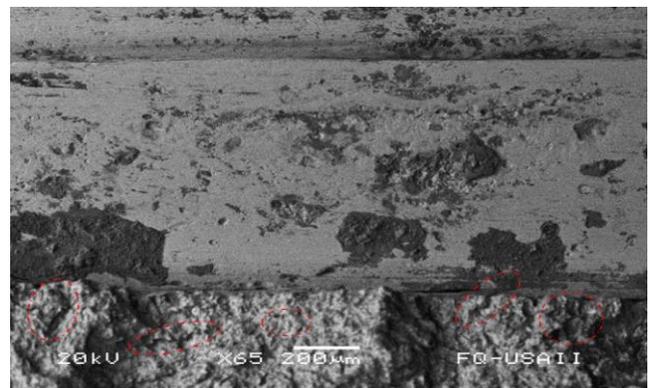
The sample at 50% of the yield limit presents a totally fragile surface with the presence of tearing systems and the presence of small microcavities in the pre-cracked area (see Fig. 13).

**Fig. 13.** Fracture Surface, Specimen 50%.

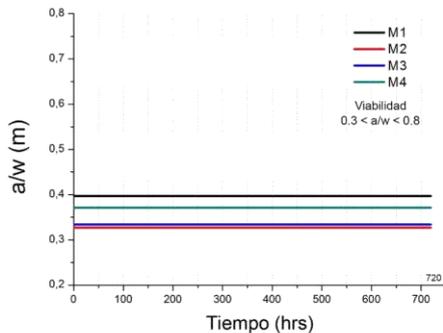
In Figs. 14 and 15, the relation of  $a/w$  with respect to time and the intensity factor of effort are shown where a linear trend can be observed demonstrating that there is no crack growth.

Fig. 14. Crack Growth Graph.

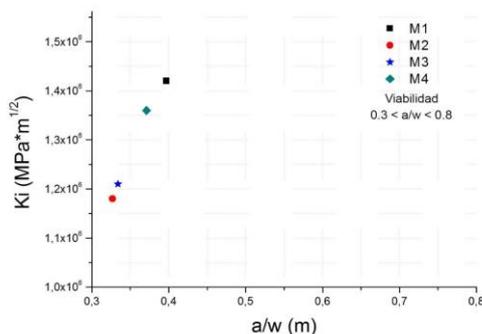
Fig. 15. Graph of relationship between  $K_i$  and  $a/w$ .

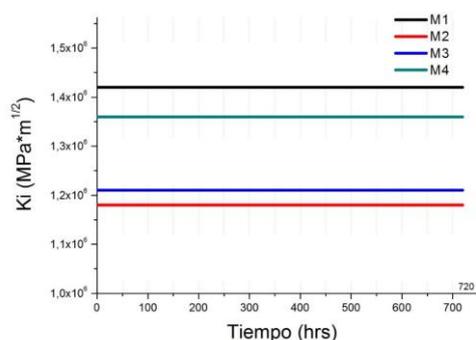
Fig. 16 shows the relationship of  $K_I$  vs time, which shows that the material reached 720 hrs. Without the presence of crack growth. In general, it is shown that the ratio factor of  $a/w$  is in the range of applicability, as shown in the figures.

Fig. 16. Graph of  $K_i$  vs Time.
