Devastating landslides related to the 2002 Papandayan eruption

RUDY DALIMIN HADISANTONO

Center for Vulcanological and Geological Hazard Mitigation

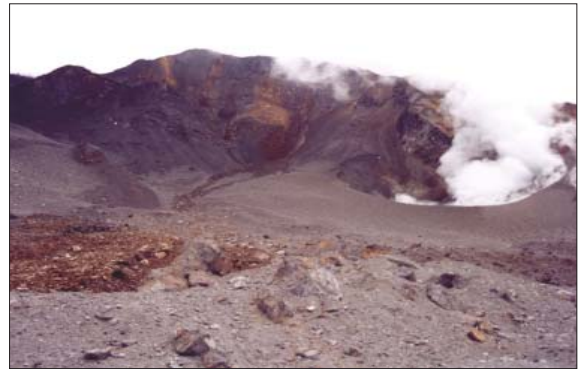
Figure 4. The southern side of Mount Nangklak (smoking) is facing to the crater; directed blast and debris avalanche, part of this hill was thrown away. During this event other new landslides occurred along the inner part of the crater rim, whereas the plain of the first landslides become larger.

Before the 2002 eruption, Mount Nangklak which is part of the rim also contained a plug from the Old Papandayan volcano, which has been covered by fine grained loose air falls and altered rocks. At present more than half of this mountain has been destroyed by the November 2002 eruption (Figure 4).
