A Field Observation on Lightning Performance Improvement of Overhead Distribution Lines

Abstract. Two feeders of 20 kV overhead distribution lines which are located in a high lightning density area are chosen to be observed as a field study due to their good lightning performance after improvement of lightning protection system. These two feeders used the new overhead ground wire and new line arrester equipped with lightning counter on the main lines. The significant reduced of lines outages are reported. Study was carried out to observe these improvements by comparing to the other two feeders line which are not improved and not equipped yet with the ground wire and line arrester. These two feeders located in the nearby area. Two cameras were installed to record the trajectory of the lightning strikes on the improved lines. Lightning peak currents are measured using magnetic tape measurement system installed on the grounding lead of lightning arrester. Lightning overvoltage calculations are carried out by using several scenarios based on observation results and historical lightning data derived from lightning detection network. Lightning overvoltages caused by indirect or direct s

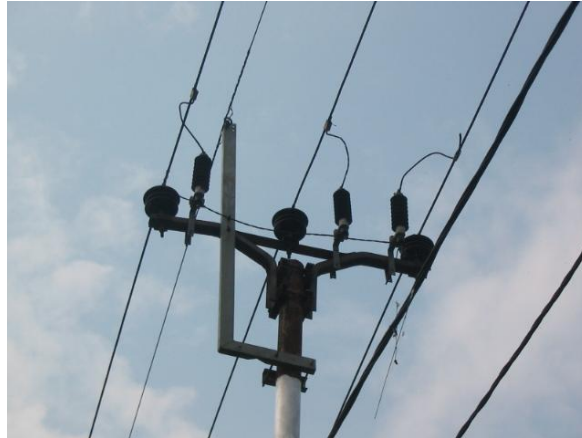
Figure 1 Typically overhead ground wire installation on the pole equipped with line arrester at Kapur feeder.

This improvement gave the significant result of Lightning Performance in the region. It was achieved by installing the overhead ground wire and line arrester on the main line. It shown in Figure 1. This area was located in the flat and open land.

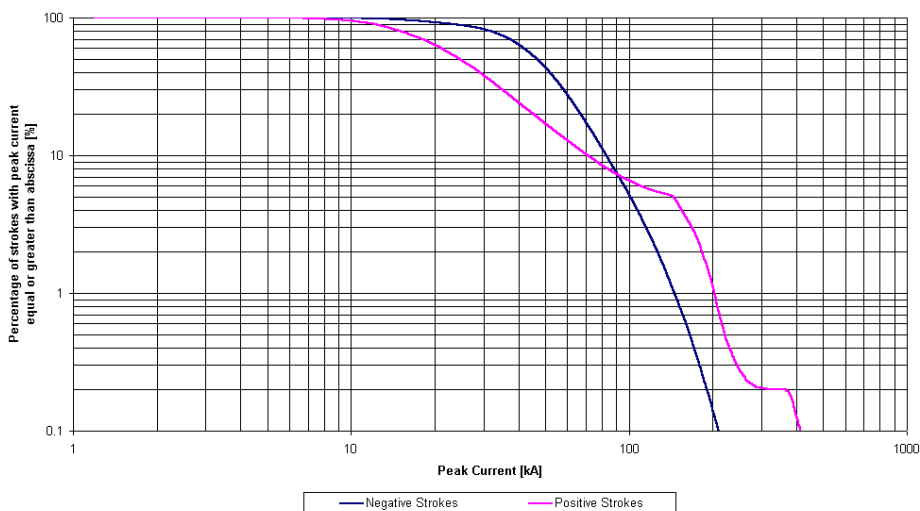
Figure 3 Logarithmic scale of lightning peak current probability.

Figure 3 shows the distribution of probability of lightning peak current in Depok and Bogor area, and Figure 4 shows flash density map of Kapur Feeder located in Depok Area.

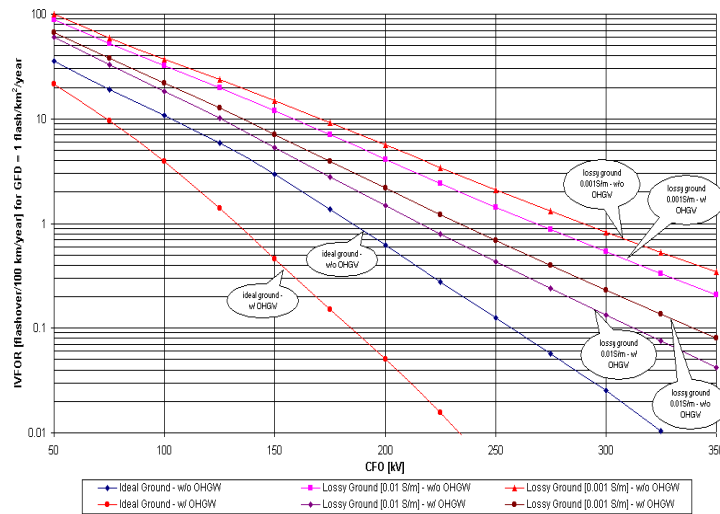
Figure 9 Calculated lightning performance curve for indirect strikes: induced over voltage flashover rate, included lossy ground effect and line with or without overhead ground wires.

The lightning performance calculation is given at literature [6] with some appropriation with local lightning data. Figure 8 and 9 shown the lightning performance of the lines with flash over rate (FOR) as functions of ground flash density, Critical Flashover (CFO) of the line, grounding resistance etc. The use of Over Head Ground Wire gave a significant reduction of FOR for more than 30% from indirect strikes. Direct strikes to the line without OHGW will result

This calculation shown that the main source of the outages is indirect strikes, which is more than 10 times FOR than direct strikes.

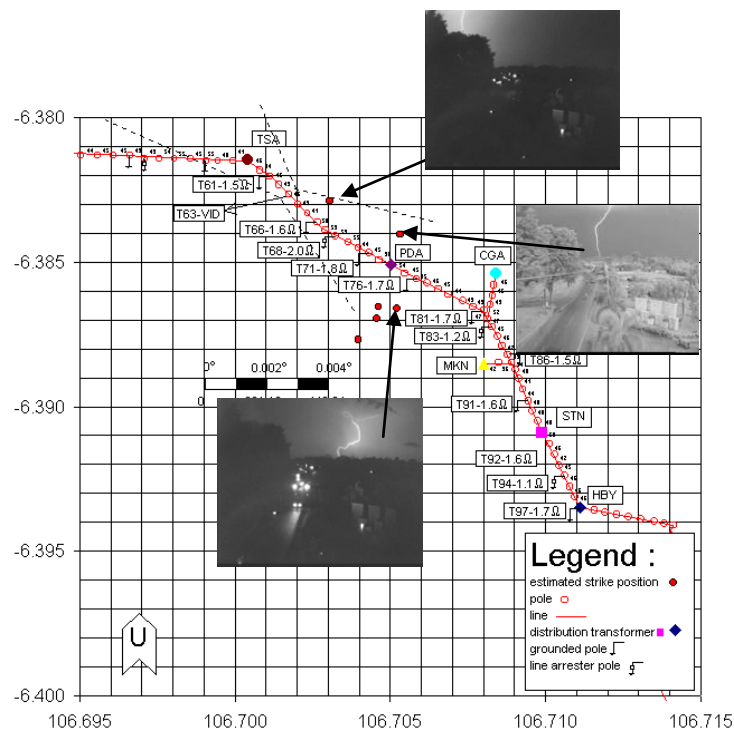
Figure 10 Lightning strikes video frame and its trajectory at the nearby lightning strikes at the observed distribution lines.

A set of video camera is installed at the top of pole, viewing back to back of 20 kV overhead lines. Video recorder is located inside a building near the pole which is operated manually. Based on the lightning data derived from Indonesian lightning detection network [7] shows that lightning activity start at 11.00 to 21.00 hour where the most incident was taken place at 16.00 to 19.00 hour. Most of lightning stroke are recorded on video frame. It was recorded that on the area of observation has a very high lightning incident in month January to April 2005 [3]. During the observation more nearby strike from cloud to ground hit trees and other structures near the lines compare to the lightning direct strike to 20 kV lines. Some of the photos of the lightning strikes are shown in Figure 10.

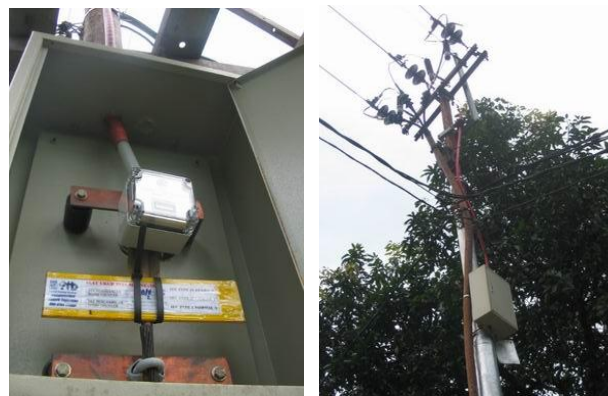
Figure 11 Magnetic tape measuring system and lightning event counter installation on arrester grounding lead.

A peak current measurement system using magnetic tape (APM) consist of three different type of commercial magnetic tape which are IEC type I Normal, type II Chorm and type IV Ferro. These tapes were filled with 315 Hz sinusoidal signal and laid on yellow fiber plate and attached to the arrester grounding lead [1].

The measurement unit installed in several pole with different type of arrester installation such as ; arrester lead on distribution transformer, arrester lead on the line and arrester lead on cable at dead end tower. The magnetic tape measurement system (APM) and lightning event counter (LEC) are placed in a box attached to the tower. Minimum current of 2 kA can trigger the LEC. The lead grounding of arrester is using single core N2XSY 1x50 mm² cable to allow lightning current flows undisturbed to the ground trough the LEC and APM.

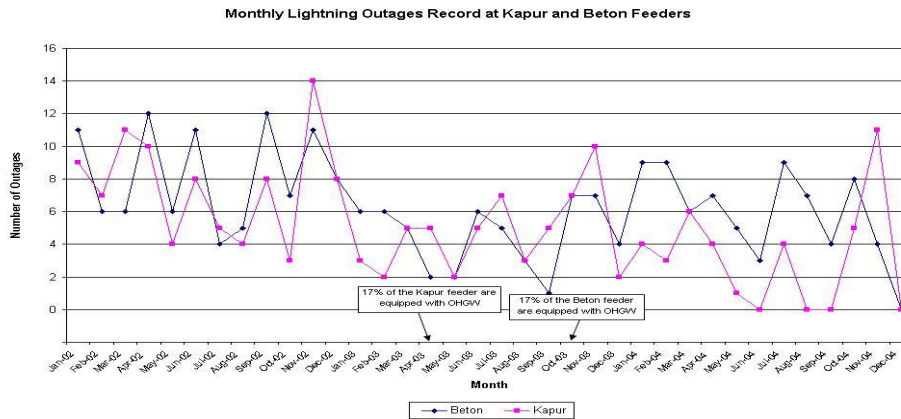
Figure 13 Outage curves of Kapur and Beton feeders shown outages reduction after the installation of OHGW.

The reduction of the outages are very significant for the two improved feeders in Depok. On the first year after the installation of overhead ground wire and line arrester on the feeder at main distribution line the outage has reduced for more than 40% as shown in Figure 11.
