Original Paper

STRATEGIES FOR MANGROVE REHABILITATION IN AN ERODED COASTLINE OF SELANGOR, PENINSULAR MALAYSIA

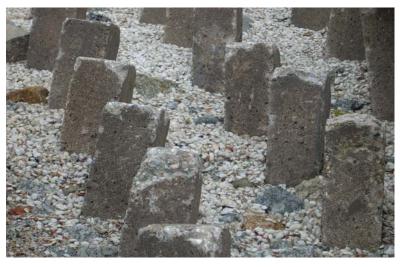
Fig 4. Photograph showing the calcareous deposits on the shore and revetment indicating current erosion and littoral drift

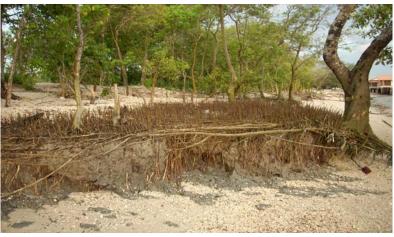
Fig. 5 Photograph showing the effect of coastal erosion on the fringe mangroves – the reference forest patch available to understand the natural vegetation profile is at the verge of extinction

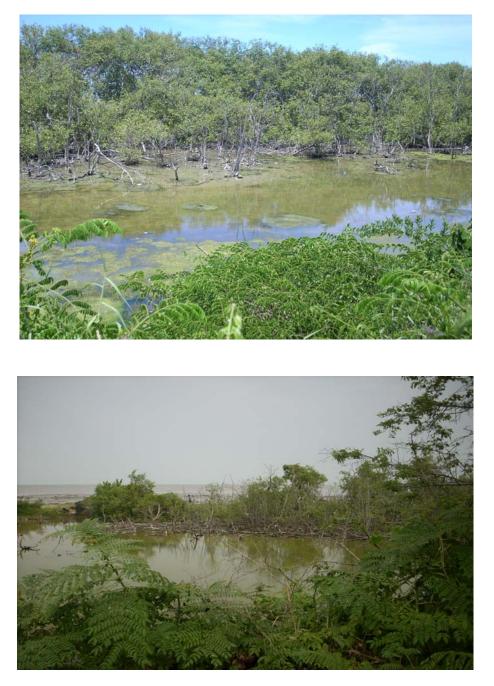
Fig. 6. Photograph showing the water-logging, drying and loss of mangroves in June 2009 in front of FRIM's mangrove plantation site substantiating ignorance to conserve existing mangroves

There is no outlet for the water to drain from mangroves and hence the mangroves are dying. The fate of the existing mangroves, the speed of degradation and ignorance or negligence in conserving the existing natural resource is substantiated in the **Fig. 6 and Fig. 6a**. Unless the hydrology of that area is restored there will not be any mangroves in near future either to protect the shoreline or to provide seeds for future forest establishment. Differential survival and growth of mangrove species studied to date are related to the depth, duration and frequency of flooding and soil.

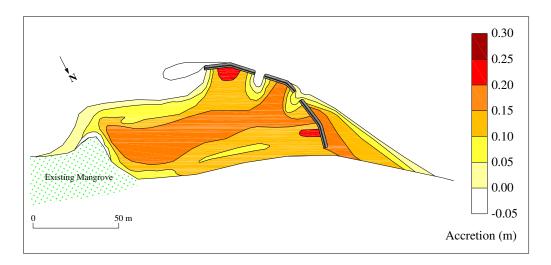
Fig 7.a. Rate of Sediment accretion at the mangrove plantation site in February 2009, 8th month after construction of L Block Break

There is a site specific erosion and deposition occurring along the Sg. Hj Dorani coast due to construction of resort and installation of engineering structures like Geo Textile Tubes and L Block Breakwater. After the construction of breakwater in May 2008, the sediment accretion is ±0.0037cm per annum which is considerably negligible in (Kamali. dynamic patches Personal communication) in mud flat where plantation is carried out (Fig 7&7a). The presence of the large grain size shell hash along the coast indicates that the shoreline is still experiencing some major wave and current erosion. The area prior to the breakwaters being installed was quite deep and has collected fine grain mud over time with the reduced wave action. Along the coastline curvature in few locations sand deposition is observed towards landward side, which fragments mangroves for a small distance up to 100 to 150m. Damage to the mangroves strongly affects sediment budgets and promotes coastal erosion (Kamaludin and Woodrofee, 1993). The eroded sediments may cause further damage to the mangroves. For example, Young and Harvey (1996) showed that sediment accretion interferes with root aeration in Avicennia marina var australasica. Similarly, movements of sand in mangroves habitats on Portuguese Island, Moszambique have caused high mortality of Ceriops tagal. This has altered the mangrove species composition and depleted the crustaceans and mollusks from the mangroves (Hatton and Couto, 1992). The proposed plantation site is experiencing sand erosion that is deposited to the sides, but it could be more complicated than that. Certainly, where sand accumulates to the right elevation (east), mangroves colonize. Where it does not accumulate or erodes, the elevation is too low and hence volunteer mangroves do not exist and planting or replanting will not overcome this limitation.
