EARTHQUAKE DAMAGE INTENSITY RELATIONSHIP FOR RESIDENTIAL HOUSES IN WEST SUMATRA

Febrin Anas Ismail^{*)}, Abdul Hakam, and Fauzan

Civil Department, Engineering Faculty, Andalas University, Padang 25163, Indonesia

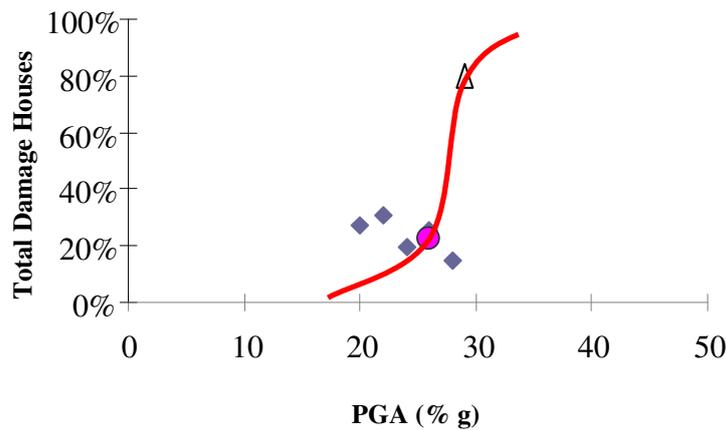
Figure 6. Damage and Earthquake Acceleration, Padang in Average (●), Padang in Districts Area (◆), Pariaman in Average (△)

Furthermore, by dividing the area based on the level of earthquake intensity, it can display a graph of the distribution of damage to houses related to the peak ground acceleration. In the Figure 6 can be seen that there may relationship between the percentage the earthquake intensity with the distribution of the damage. In the figures also plotted the percentage of damaged houses in the city of Pariaman where located only a teens kilometres from the epicentre. The straight line curve is built in the figure to fit the relation between the damage level and the earthquake intensity in West Sumatra.

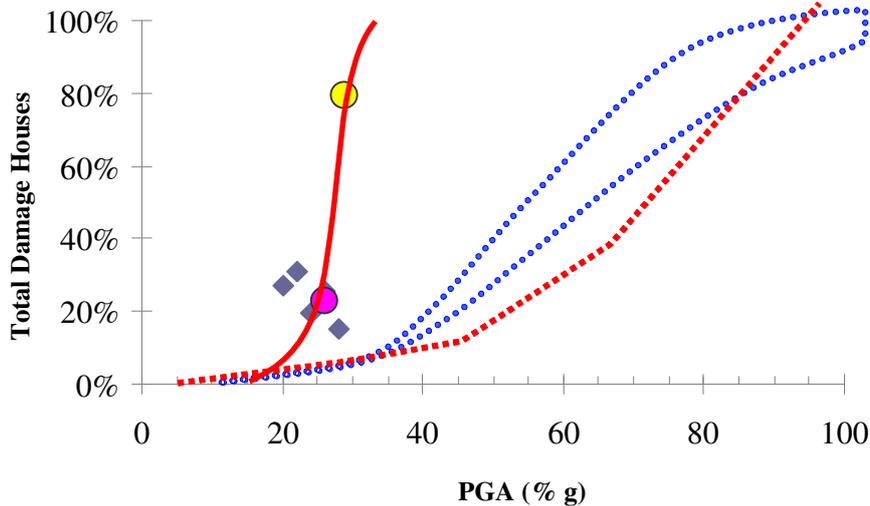
Figure 7. Earthquake Damage Intensity Relationship, West Sumatra (—), Sengara, 2011 (●●●), Birss, 1985 (■●■)

The results of Birss and Sengara both for brickwork structures then are plotted together with the results of this study (Figure 7). It can be seen that the predicted curves given by the other authors give over estimate to the strength of the brick masonry houses in West Sumatra.
