Geotechnical Investigation of Fracture Patterns in a Rock Mass during Excavation by Blasting

Abstract— Overcharging in rocks (wall faces) during blasting and excavation usually causes damage to rock mass in most mining and quarry industries. This creates blast-induced fractures which can relate with pre-existing fracture pattern thereby increasing sliding and rockfall from the crest and body of an excavated wall. The spacing and orientation of pre-existing fractures are predominant at a small-scale mining (galamsey) site at 'Atta ne Atta', a town near Beposo, in the Western Region of Ghana. Geotechnical field studies were carried out to investigate the possibility of any instability within the area to eradicate the occurrence of an unexpected future wall failure (rockfall). The geotechnical mapping conducted was focused on fracture distribution and spacing. Mean spacing (S_m) of existing fractures was calculated and corrections were made to obtain calculated spacing (S_c). The scanlines of wall face 001 and wall face 002 intersect with their corresponding strike and dip at 78° and 80° respectively creating a slightly favourable fracture pattern and rock wall stability. The fractur

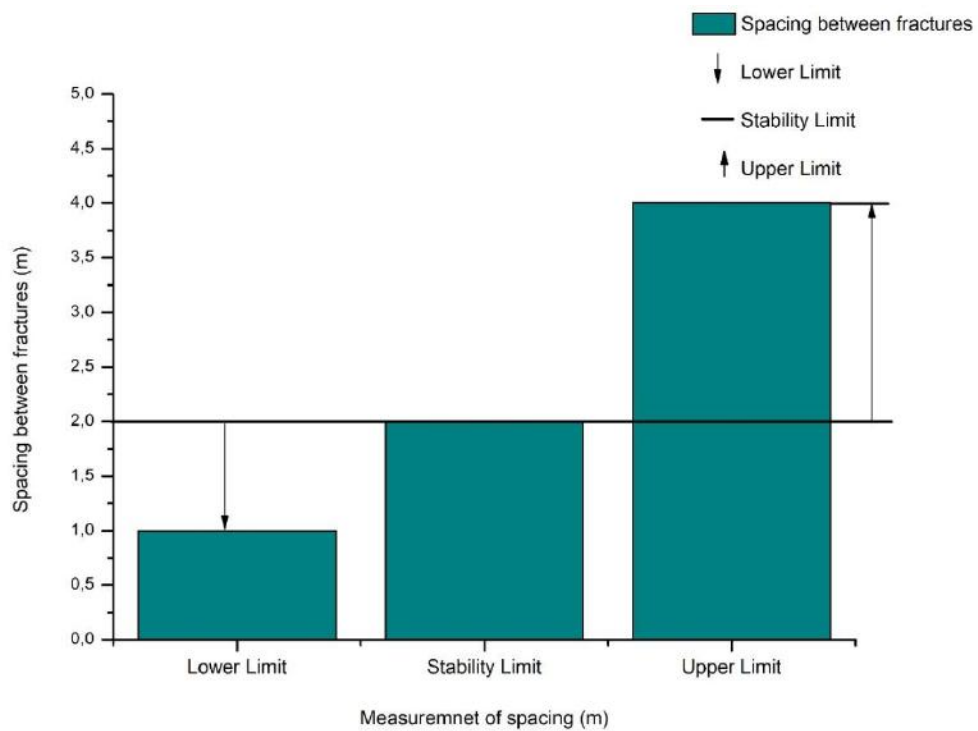
According to the Rock Mass Rating System [11], discontinuity within rock mass is characterized by a standard stability limit less than 2 m for a non-continuous and unweathered wall rock. Therefore, for a wall face to achieve maximum stability, spacing of fracture set above 2 m will be considered to be favourable in this study. Hence, a defined boundary between the upper (favourable) and lower (unfavourable) limits for standard stability of rock masses has establish in this study as shown in Fig. 3.

Fig. 3: A Graph of Standard Stability of Fracture Spacing

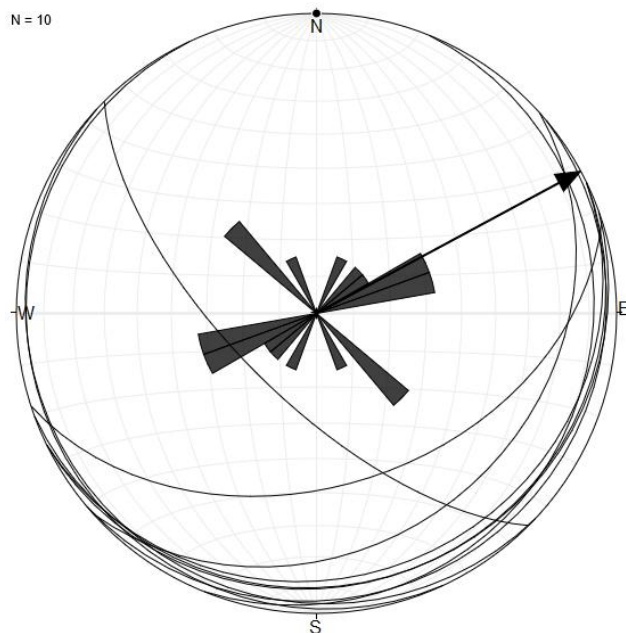
Again, the calculated spacing S_c was used in concluding the results because errors were corrected. As illustrated in Fig. 8, all the fracture sets were below 2 m of mean spacing between fractures indicating high instability condition within the Wall face 002. Stereographic projection of the dip and strike of fracture spacing within Wall Face 002 also shows a general strike of ENE-WSW. Observations made from the Rose plot also shows a maximum of 20 % strike between 061° and 070° (Fig. 9).

Fig. 9: Stereographic projection and Rose plot for Fracture Spacing at Wall Face 002
