On-line Diagnosing on Trayed Column of Ethylene Plant Using Gamma Ray Scanning

demonstrated to figure out the source of the problem in trayed column of quench tower DA 202. The diameter of the column is 4.2 m and the height is 40 m. The gamma emitter, ^{60}Co with activity 70 mCi, and scintillation detector were used to scan the column from the elevation of 26250 mm to the elevation of 35950 mm above ground level which cover tray # 13 to tray # 4. Selected data of measurement are presented come with the conclusion. The problem is identified based on measured data. To my understanding, publications related to this matter are rare, event in handbooks, therefore it is hope that this paper may contribute for dissemination of gamma scanning technology as promising tool for industrial application, especially in developing countries.

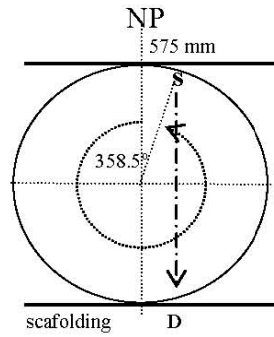
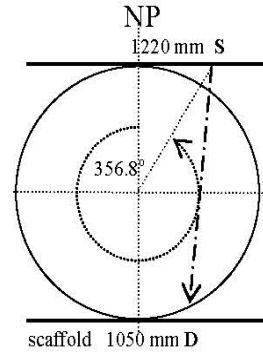
Fig. 4. Profile of Tower DA-202 obtained from scan orientation 2. The source and the detector were positioned 575 mm (1.5°) and 575 mm (178.5°) respectively. Trays # 4 to # 10 and tray # 13 were in position and carried approximately the same amount of liquid. Flooding on tray # 11 and tray # 12 were observed as indicated by their lower and wider scan curve.
