INDONESIAN JOURNAL ON GEOSCIENCE

**Surface Rupture and Geotechnical Features
of The July 2, 2013 Tanah Gayo Earthquake**

MUDRIK R. DARYONO^{1,2} and ADRIN TOHARI¹

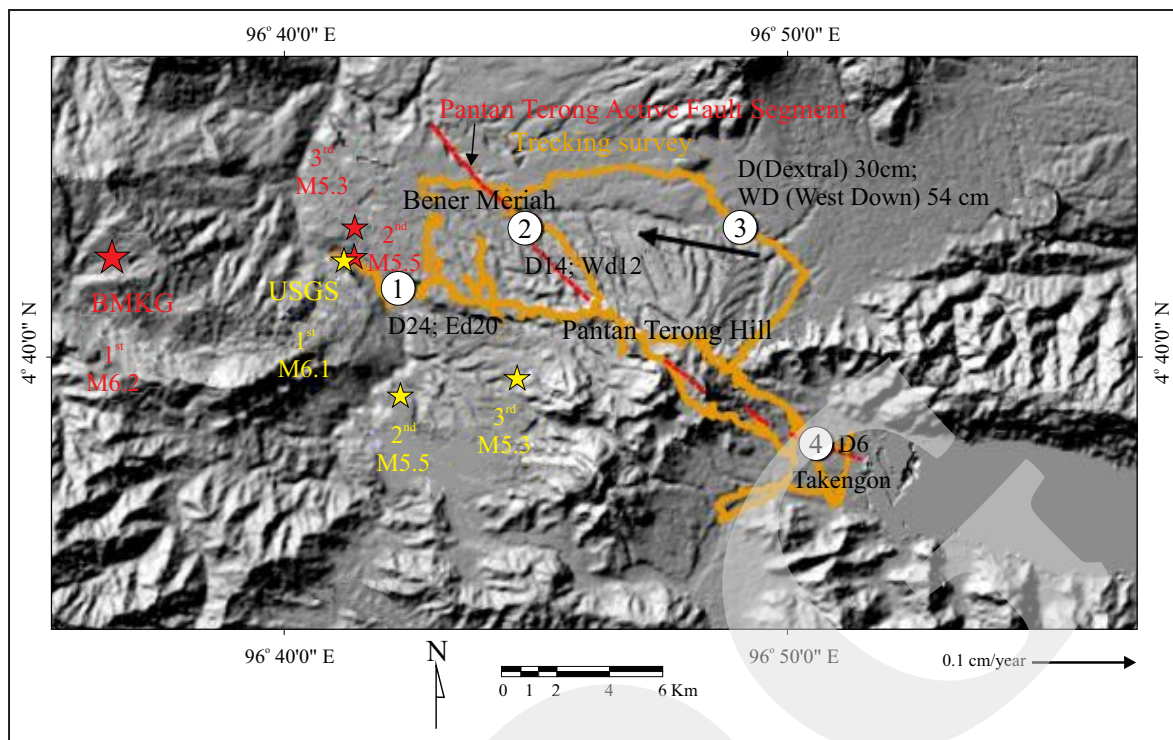
The comparison of these mapped rupture locations to geomorphic features visible on ASTER GDEM (Team, 2010) and World30m DEM topographic data, is visualized using a Swiss hillshade technique (Anonymous, 2010). An active fault line can be traced from Site 2 to Site 4, crossing Pantan Terong Hill. Based on the surface mapping, Pantan Terong fault is proposed to rupture during the July 2, 2013 Tanah Gayo earthquake (Figure 14). This fault has a total mapped length of about 19 km. This length is close to the segment length of the Sumatran Fault that ruptured during the 2007 West Sumatra doublet strike-slip earthquake sequence, which ruptured about 22.5 km of fault length (Daryono *et al.*, 2012). This also correlates with the minimum segment length of about 20 - 30 km proposed by Klinger (2010).

Figure 14. Geological and seismological setting of the previously unidentified Pantan Terong segment. The brown lines show the surveyed path. The red stars indicate earthquake epicentres from BMKG, and the yellow stars indicate earthquake epicentres from NEIC-USGS. The blue circles indicate the best surface rupture sites. The black arrows indicate the GPS results of Ito et al. (2012).
