# EVALUATION OF ROAD ROUGHNESS AND ROAD DETERIORATION

There are two road condition survey methods commonly used, the roughness-based equipment such as NAASRA and the distress and severity type road evaluation method as presented by ASTM D-6433. The objective of the study is to evaluate the relationship between road condition obtained from roughness type equipment and road distress. To achieve the objective, a condition survey using the two methods were performed on two road segments in the East Java Provincial road system. Data obtained from the field was evaluated to obtain International Roughness Index (from NAASRA) and Present Condition Index value (from field condition survey). The results show that the two methods provide a comparable result when the distress type is of un-even surface such as rutting and bumping. A slight different result is observed when the major distress occurred in the road is of crack-type such as fatigue and block cracking.

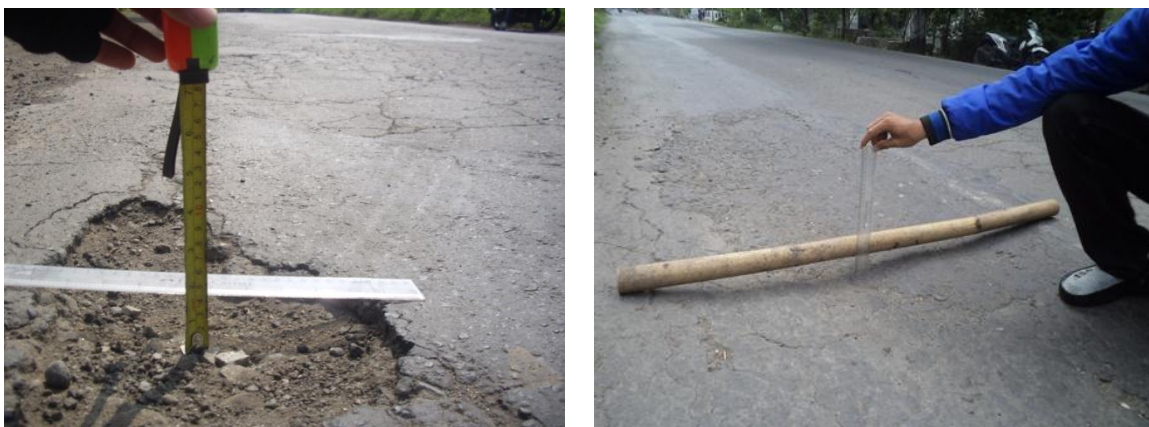
**Figure 4** Sample Road Condition Survey

The road segment is divided into sections each of 1 km length. The survey was conducted each lane, so that the PCI and IRI are analyzed in km/lane. Figure 4 presents a sample of road condition survey, while Table 1 presents a sample of field data collection form. Road condition data collected from the field was analyzed to determine its PCI value based on the procedure presented in ASTM D-6433. The roughness data collected from NAASRA was analyzed to determine its IRI value. After PCI and IRI value were determined, a t-test was performed to determine the relationship between the PCI and IRI. To assess its relationship in a more elaborative way, additional review based on field condition was also performed.
