Application of ECO-RIPRAP riverbank protection model to improve bank stability and to support biotic community in Surabaya River

Abstract: Ecohydraulic river bank protection design was developed as ECO-RIPRAP model and has been applied along 100 meter length to restore accelerated erosion sites in Surabaya River at Wringinanom and Klubuk. The model combined re-profiled and re-vegetated bank with rock toe reinforcement and addition of log groynes at 10 meter length interval. Various native plant species were planted on bank slopes, including water plants *Ipomoea aquatica* and *Pistia stratiotes*, grasses and shrubs *Ipomoea carnea*, *Pluchea indica*, *Saccharum spontaneum*, *Arundo donax*, and native tree species *Ficus glomerata*, *Bambusa arundinacea*, *Dendrocalamus asper*, *Bambusa vulgaris*, *Ficus benjamina*, *Dillenia indica*, *Psidium guajava*, *Arthocarpus camansi*, *Arthocarpus elasticus*, *Hibiscus mutabilis*, *Nauclea sp.*, *Inocarpus edulis*, and *Syzygium polyanthum*. The river bank morphology after ECO-RIPRAP application showed alteration from erosion to sedimentation due to rock toe enforcement, log groynes protection, and increase of plant cover on littoral banks

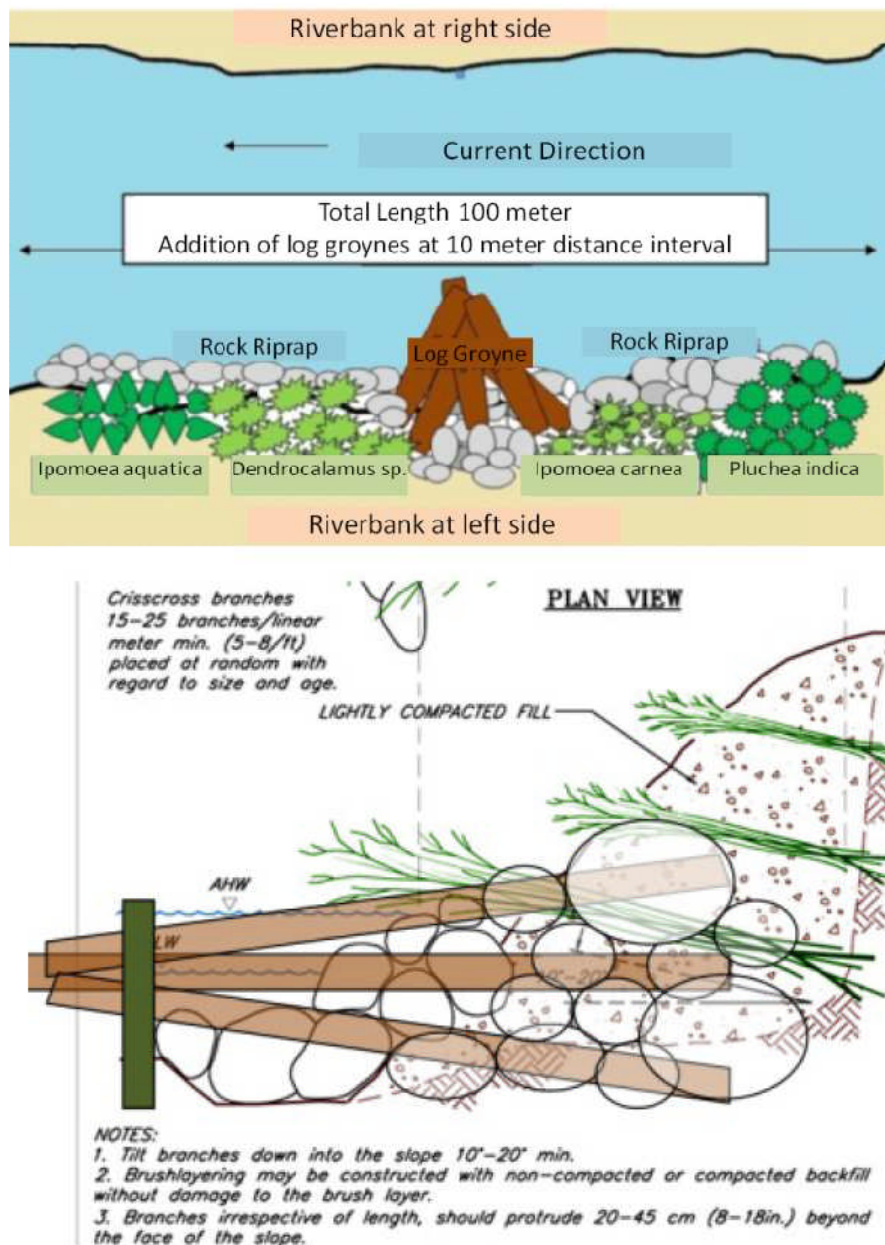
Figure 2. The design of ECO-RIPRAP bank protection model

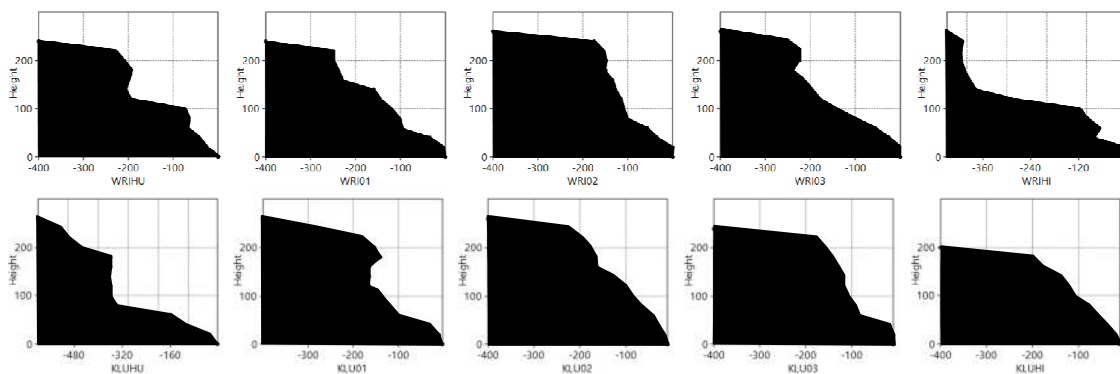
Figure 3. River bank morphology profile at eroded site in Wringinanom (top) and Klubuk (bottom)

impermeable roads. Some native riparian vegetation species can be seen on the banks, such as variety of bamboo and grasses, shrubs, liana, herbs, and tree species. The riverbank area along Surabaya River is bordered by earth dykes with riverbank boundary markers can be found along the dyke toe at certain kilometer distance from Mlirip Water Sluice. There were 18 accelerated eroded sites identified along 7 km section from Mlirip to Lebaniwaras. The length of eroded bank was range from 50 m to 200 m, and the river bank height was range from 1.5 m to 3 m. The bank slope at restored sites before ECO-RIPRAP model application was range from 41,3 - 60 degrees indicated that most part of eroded banks were steep and unstable. The bank morphology profile in Wringinanom and Klubuk is shown in Figure 3 and the condition of bank erosion is shown in Figure 4. River bank erosion occurs in Fish Sanctuary Area due to bank instability, increased

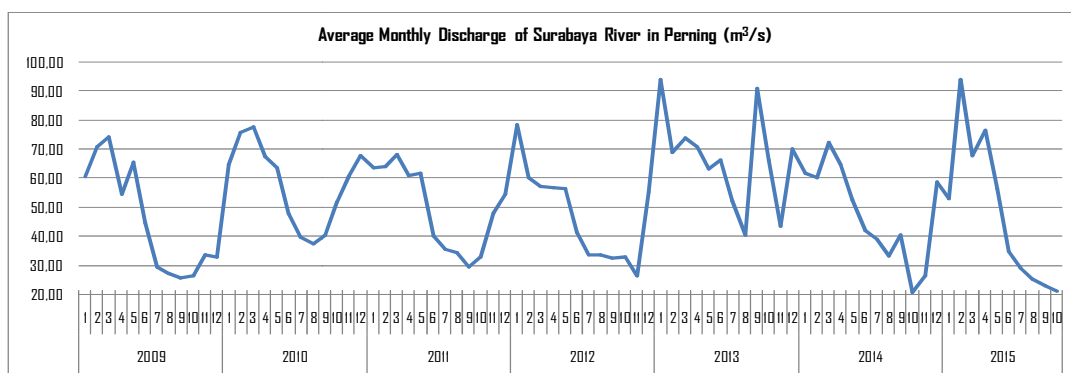
Figure 5. Hydrograph of Surabaya River in Perning

The graph in Figure 5 shows that discharge of Surabaya River during 2009 to 2016 indicated rainy season period occurred on December to May with average monthly discharge above 50 m³/s, range from 57.5 to 74.6 m³/s. Dry season occurred on June to November with average monthly discharge was less than 50 m³/s, discharge range from 31.52 to 48.33 m³/s. The highest average discharge was 94.21 m³/s that occur on January 2013 and lowest average was 20.58 m³/s that occur on October 2014. In year 2013, 2015 and 2016, the highest average discharge in rainy season was recorded above 90 m³/s. In 2013 and 2016, the average low discharge was above 40 m³/s that indicated less significant dry season.

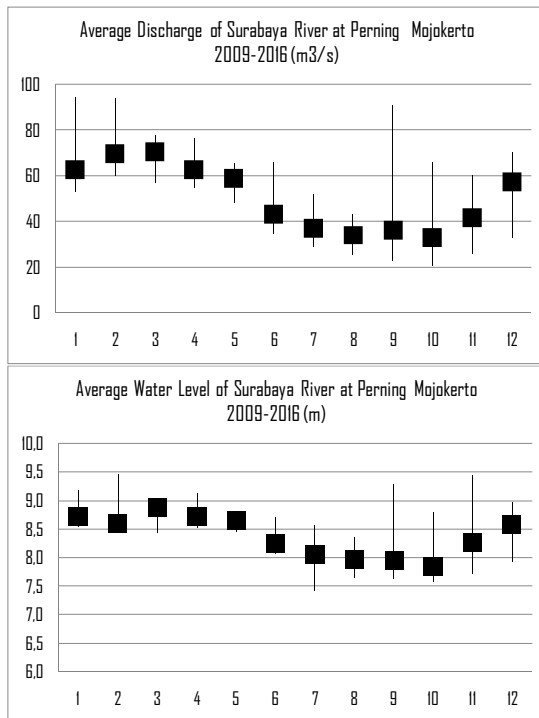
Figure 6. Average discharge and water level of Surabaya River 2009-2016

Figure 6 indicates that average monthly water discharge fluctuation in 2009 - 2016 has the same pattern with water level fluctuation. The wet season occurred in December to May, while dry season occurred in June to November. The water elevation in Kali Surabaya was range from 7.4 to 9.5 meter that maximum water level fluctuation was 2.1 meter. During wet season, water level increase causes periodic floods in riverbank area as natural entity that maintain balance of hydrological cycle in river ecosystem. The floods also create littoral habitat extension for fish and river organisms as refuge area from fast current. Flood management in some developed countries has been shifted from flood control to flood adaptation approach. The flood control relies on structural measures is not a sustainable solution for flood management. Indonesia has 5.590 main rivers, about 600 rivers have been severely flooded that leads to social problems and economic losts. The integrated flood management should adopt ecosystem-based disaster risk reduction. Ecosystems, such as wetlands, forests, riparian and coastal systems can reduce physical exposure of natural hazards. Restoring catchment vegetation along the riverbank reduces surface runoff that will reduce flood damages, particularly in smaller events. Natural green belt serves as natural protective barriers or buffers and thus mitigating hazard impacts of floods (PEDRR, 2010).

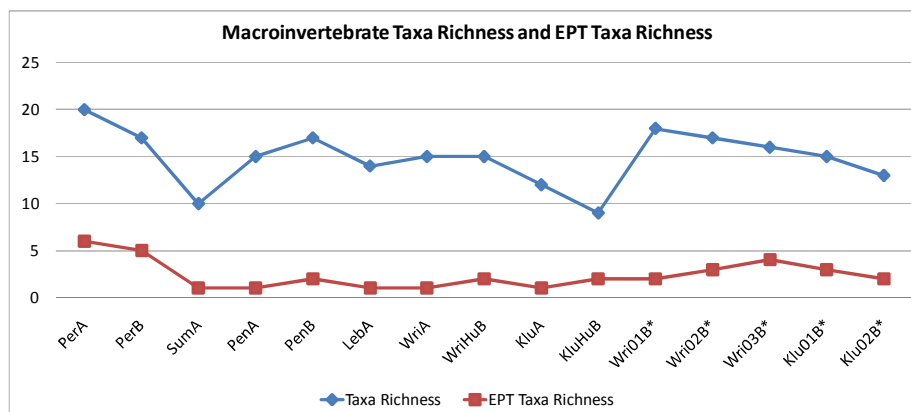
Figure 8. Taxa richness and EPT taxa richness in macroinvertebrate community

River increased of taxa richness, EPT taxa richness, %EPT and %Atyidae, and decreased of %Chironomidae in macro invertebrate community (Figure 8). The fish community at restored sites in Wringinanom and Klubuk reach showed increased of taxa richness, increased of fish abundance by 54,2%, increased of abundance of *Pangasius micronemus* by 25,6%, and increased of abundance of *Hemibragus nemurus* by 6,3 % in Wringinanom - Klubuk reach (Figure 9). The rare fish species also found at treatment area in Wringinanom - Klubuk reach, namely *Oxyeleotris marmorata*, *Mastacembelus unicolor*, *Hampala macrolepidota* and *Notopterus notopterus*. Fish larvae and juveniles were spotted under log groynes, boulder and water plant's roots in the edge water column.

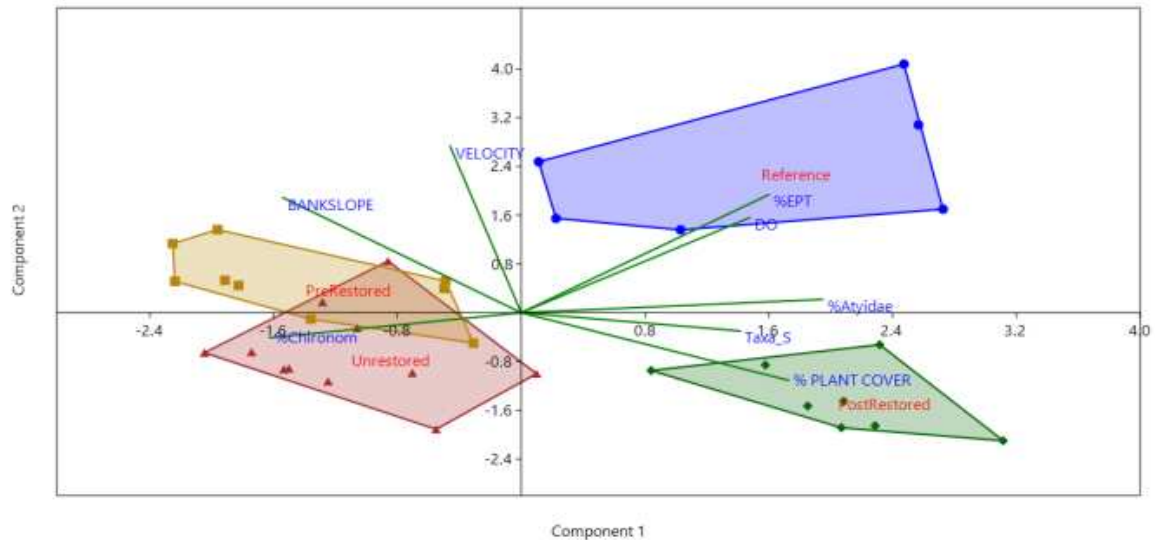
Figure 10. PCA Analysis result

invertebrate attributes. The results shown there were three groups of site distribution that complement with research site groupings as shown in Figure 10.

The reference group laid at upper right quadrant, the post-restored group laid at lower right quadrant, and the unrestored laid through pre-restored at middle left quadrant. The important parameters at reference sites were near-bank velocity, Dissolved Oxygen (DO) and %EPT. Those parameters at reference sites are significantly higher compared to other groups. Dissolved oxygen was strongly correlated with %
