Gampong Jawa Landfill of Banda Aceh: A Case Study of Dumpsite Rehabilitation to a Sustainable Landfill

Mirzayanto^{1*}, Yulian Gressando^{2*}

¹ Dinas Kebersihan dan Keindahan Kota (DK3) Banda Aceh, Province of Aceh, Indonesia
² YKU Aceh, Jln. Sultan Iskandar Muda No. 22 Banda Aceh, Indonesia
*Corresponding authors: mirza dkp@yahoo.com and jgressando@yku-aceh.org

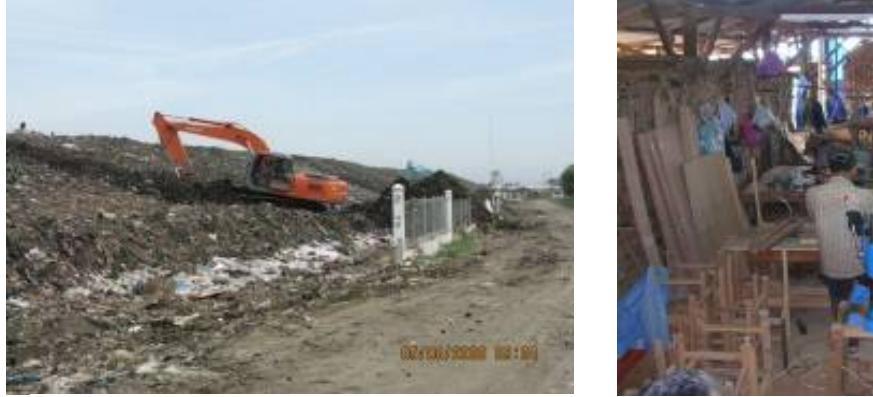
Figure 2. Rehabilitation of GJL in 2008

After the tsunami, it was considered critical to immediate design a regional landfill. In 2006, a master-plan was developed to replace GJ as its capacity was insufficient. However, before the construction, as anticipation for landfill need, in 2006 BAM did land acquisition around the landfill area of 9 ha, bringing the total of GJ to 21 ha. The Feasibility Study and DED was then prepared by Arcadis and UNDP, and Gampong Jawa Landfill (GJL) was constructed by the government through BRR. The construction was not done in accordance with the DED. However, GJL was built in 2008 and went into operation in early 2009.

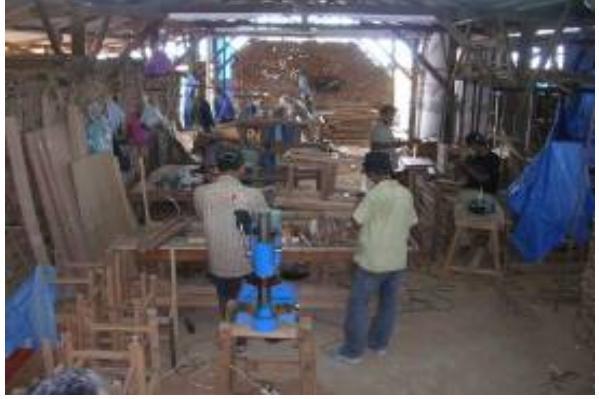
Figure 3. Tsunami waste recyclables in GJL

During emergency response period (weeks after the tsunami hit), the government's main target was to remove all tsunami debris from the city as immediate as possible. The only choice was to dispose them in GJL, which was also destroyed by the tsunami. More than $350,000 \text{ m}^3$ of tsunami wastes, which consisted mainly of sludge, debris, and wood, had been transported and disposed to GJL. In the landfill, they were sorted to detach the sludge from materials which can still be used, mostly rubbles which later were used for road construction and woods for furniture.

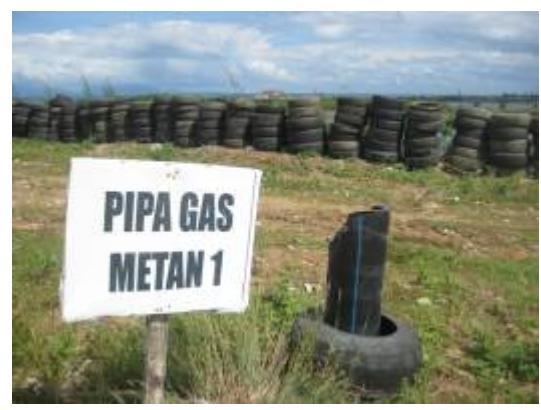
To control LFG, at a certain distance, vertical HDPE pipes are installed, and the height is added continuously following waste pile height. The horizontal HDPE pipes for leachate and gas collection were already in place since the construction.

GJL is divided into two cells, one of which was closed and another is the active cell. In the closed cell, the produced gas has not yet been exploited. But BAM has allocated the budgeted in 2013 for gas utilization unit, which will run a small electricity generator. The active cell still has not produced gas yet. Later on when it is sufficient, the piping will be connected to the gas utilization unit.

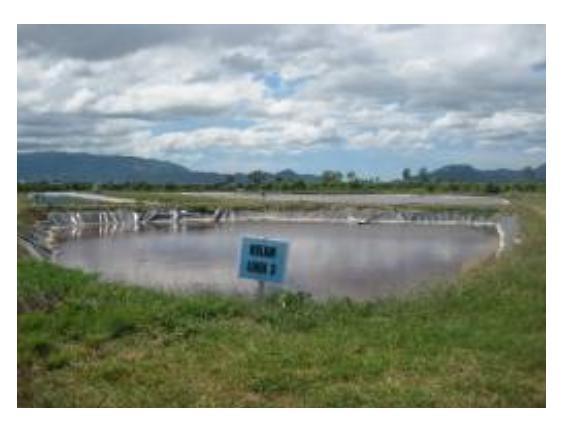
Figure 5. Leachate Treatment Ponds

GIL has leachate treatment system which а consists of three ponds: anaerobic, aerobic, and maturation ponds. The processing is done naturally by gravity principle with the retention process of chemical contents in the ponds. However, it still needs to improve its effectiveness, either by expansion, creating deeper anaerobic ponds, expanding ponds, providing aerobic or additional treatment to one of the ponds. Nevertheless, the effluent quality is still above the minimum standard.

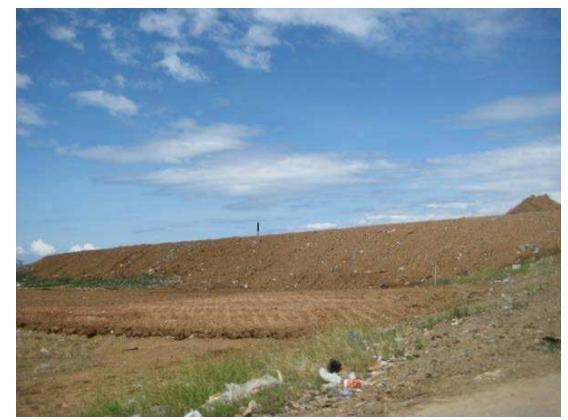
The waste is compacted and covered with regular soil using heavy equipment, and directing the bottom slope towards the flow of collector drainage. This is to ensure that run-off water does not flow to the leachate collector channel. Land covering and compacting process are conducted in stages, cell by cell. Soil cover also has a slope towards the collection point.

The final cover consists of several layers indicated respectively from bottom to top:

• On the top of waste: regular soil cover.

- Gravel layer with the diameter of 30 to 50 mm and 20 cm thickness is put as a horizontal gas collection.
 - Clay layer 20 cm thick or organic waste/shredded wooden waste.
- Under-drain gravel layer with diameter 30-50 mm and 20 cm thickness, into the drainage system.
- Soil layer with a minimum thickness of 60cm.

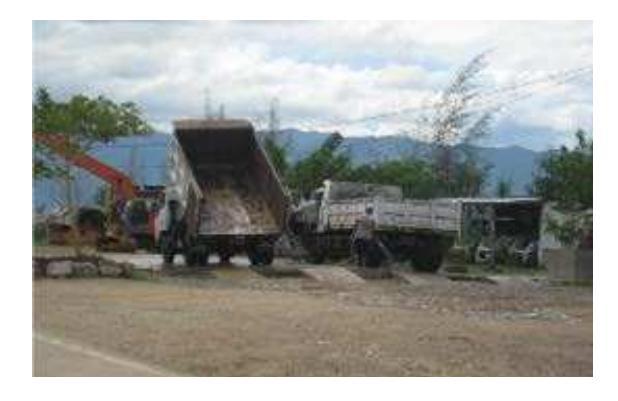
Fig. 7. Improved maintenance in DK3: truck washing before go out of landfill

To support the operation of waste management in BAM. DK3 owns and manages a workshop or garage for and heavy equipment maintenance. vehicle The workshop located inside is GJL complex and has so far been able to handle 100% maintenance of all equipments. Mechanical workshop was constructed by UNDP/ MDF and started to function since 2010. The workshop is supported by complete facilities/equipments.
