SMALL SCALE EXPERIMENT: THERMAL PERFORMANCE COMPARISON BETWEEN FIBER-CEMENT ROOF AND PHOTOVOLTAIC ROOF IN MALANG, INDONESIA

Nurhamdoko Bonifacius^{1*)} and Sri Nastiti Nugrahani Ekasiwi²

1. Architecture Department, Faculty of Engineering, University of Merdeka Malang, Malang 65146, Indonesia

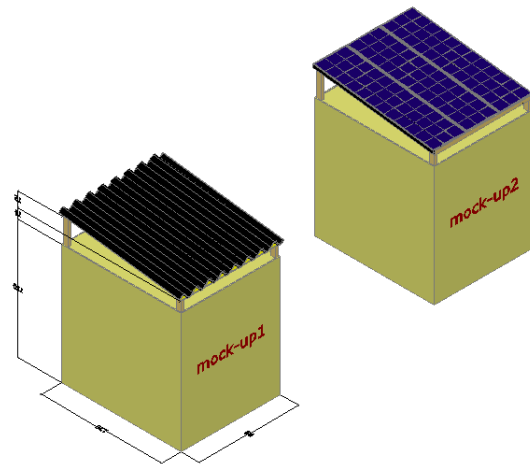
Figure 1. Picture of the Mock-ups

The experiment required 2 mock-ups as test objects: a mock-up room with fiber-cement roof and a mock-up room with photovoltaic modules roof. Mock-up made from fiber-cement was used as a reference because this material is more popular. All mock-ups were made of the same size as follows: length 120 cm, width 99 cm, and height 145 cm. Length and width of the mock-up was decided by practical considerations, following the solar module size. The fiber-cement was equal in size because the size of fiber-cement can be easily customized. Perspective picture and photos of the 2 mock-ups are shown in Figure 1 and Figure 2.

The frames of mock-ups were made from Meranti wood. The areas were covered with 12 mm thick plywood. The top of the mock-ups had space to represent the roof ventilation space. The first mock-up was a mock-up of fiber-cement roof, whose roof was as wide as its plan. The second mock-up was roofed by 3 pieces of photovoltaic modules. Photovoltaic modules used was polycrystalline module M75 with NOCT 25 °C and 8.5% efficiency, the power peak at 750 W/m² sunlight intensity was up to 22.792 Watt and its coefficient of power per temperature = 0.039 W/°C [5].

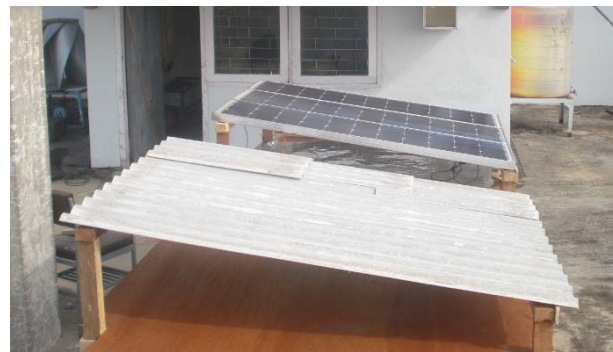
Figure 2. Photo of the Mock-ups

Mock-ups were put on a shadow-free area throughout the day. The positions of mock-ups were also arranged so as not to overshadow each other even though the position of the sun shifted throughout the day. The surface of the roof of each mock-up and the space underneath were mounted with a thermocouple tool to measure temperature. Measurements were done every 5 minutes, starting at 09:47 AM until 14:00 PM or 10:14 to 14:27 solar time. To give an overview of the dynamics of the

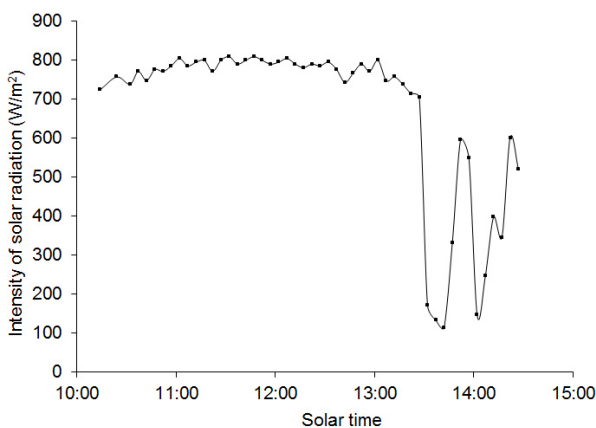
Figure 3. The Intensity of Received Solar Radiation

Weather conditions on the day of measurement. On the day of measurement, the weather was sunny in the morning until noon. Radiation intensity increased normally. From morning until 13:27, closing did not occur by the overcast sunlight. Starting at 13:32, overcast began blocking sunlight on site. However, it does not necessarily overcast preclude but come and go (Figure 3).

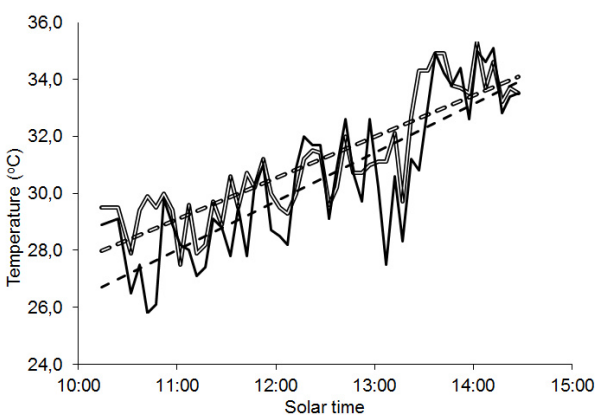
Figure 4. Surface Temperature of Fiber Cement Roof (—○) and Photovoltaic Modules Roof (—□), Trendline of Fiber Cement Roof Temperature (---○) and Trendline of Photovoltaic Modules Roof Temperature (---□)

Temperature and its fluctuations on the roof surface. Temperature and its fluctuations on each roof surface are described in Figure 4.

The temperatures of fiber-cement roof and photovoltaic roof fluctuated with a tendency to increase (Figure 4). This increase is reasonable because the higher position of the sun increases the intensity of irradiation. At 13:32, when overcast began to blow, the temperature of fiber-cement roof fell fewer than the surface temperature of photovoltaic modules. The drop in temperature had only been for a moment because after that the radiation fluctuations occurred again and still dynamic.

Moreover, in essence, photovoltaic module temperature was lower than the surface temperature of fiber-cement roof. Trend lines from each curve give the assertion that, in general, the temperature of photovoltaic roof was lower than the temperature of the fiber-cement roof.

Calculation of average in between both of them also gave the same explanation. The average temperature of the fiber-cement roof was 31.1 °C, greater than the average surface temperature of photovoltaic modules, which was 30.4 °C. The value of the correlation between the two sets of temperature data was calculated for 0.87, which means that whenever there was an increase in temperature of fiber-cement roof, there was an increase in surface temperature of photovoltaic modules. Correlation numbers of 0.87 could be interpreted that the heating happened normally.

The fall in the intensity of sunlight did not necessarily lower the surface temperature of fiber-cement roof, but there was a pause (time lag). Decrease in temperature after a pause occurred in photovoltaic modules and in fiber-cement, but a longer time lag occurred in the fiber-cement roof. This was due to the thermal capacity from fiber-cement roof, which was higher than the thermal capacity of photovoltaic modules.

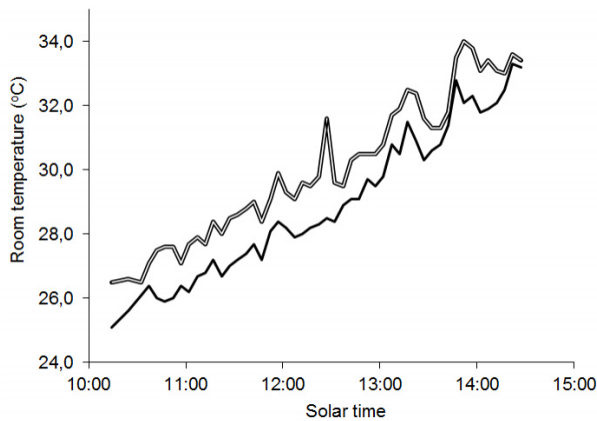
Figure 5. Room Temperature under Fiber-cement Roof (—) and under Photovoltaic Modules Roof (---)

Room temperature. The experiment results also show that temperature of the room under the roof of photovoltaic was lower than room temperature under fiber-cement roof. This is consistent with the previous discussion, that the fiber surface temperature is higher than the surface temperature of photovoltaic modules. This is also strengthened by the thermal properties of corrugated fiber-cement i.e. U-value (6.10 W/m²K) [8], which is greater than U-value of photovoltaic modules glass (3.0 W/m²K) [8]. With this trend, it can be stated that the temperature of the room underneath is strongly influenced by surface temperature and thermal properties from each roofing material. Figure 5 provides the explanation.

Trend lines drawn from each of the curves confirm that the room temperature under the photovoltaic roof is colder than the room temperature under the fiber-cement roof. The difference is at the range of 1.1 to 1.2 °C at the same time.
