Application of Resistivity Method Wenner-Schlumberger Array to Evaluate Brantas River Embankment as Avoid Landslide

Abstract—*The maintenance of embankment is important to avoid some damages like landslide. Brantas river passes 6 cities, include Mojokerto. Landslide of Brantas embankment was occurred at Lengkong and Mlirip, Mojokerto. The location of landslide is near from crowded highway. Therefore evaluation using resistivity method is needed to identification vulnerability of landslide. There are 4 line of data acquisition. First, suspected there are seepage at point 25-35 m and fracture at point 65-75 m from dam. Then, second line, there is a suspect of fracture at point 65-90 m and seepage at point 110-125 m. Third line, at point 20-35 m and 110-140 m are suspected as fracture and at point 55-75 m is suspected as seepage. The last line is indicated that the embankment was good.*

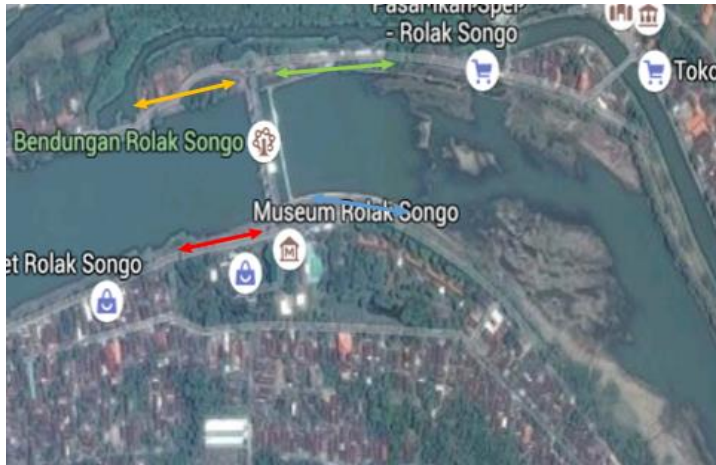
Figure 1. Location of the research from google earth.

The research to evaluate Brantas embankment at Lengkong and Mlirip Mojokerto has been done using resistivity method Wenner-Schlumberger array. The research use four line. Fig. 1 describe about the line of the research. Blue line is first line with length 100 m, red line is second line with length 200 m green line is third line with length 200 m, and the yellow line is last line with length 130 m. The result that obtained from the measurement is resistance value which then calculated to obtain resistivity value as data analysis. Resistivity value is processing by Res2dinv software. The characteristics of subsurface can be known and analysed by compare the resistivity value from inversion result to table reference that describe resistivity value of some material of the earth and data logging of research location.

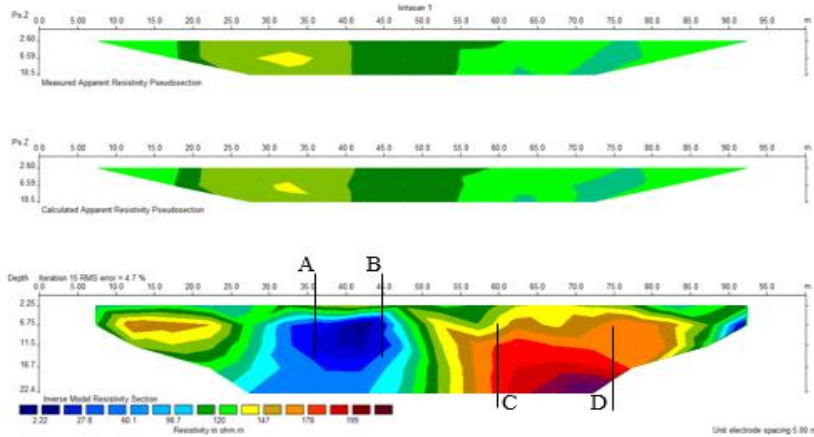
Figure 2. Section of first line.

Based on processing data using Res2dinv has been obtained three section. First section is called measured apparent resistivity pseudosection, second section is calles calculated apparent resistivity pseudosection, and the third section is called inverse model resistivity section. First line is described by Fig. 2 below. From inverse model, first line has range of resistivity value 2,22-199 ohm-m. This value (comparing with table reference and data logging) indicates that materials of subsurface consist of water, sand, sand-gravel, and sandclay. The anomaly at first line occurred at point 35-45 m (A-B) that suspected as seepage of the water because it has lower resistivity value. The other anomaly occurred at point 60-75 m (C-D) that suspected as fracture which consist of air. The inversion result using resistivity then compared by inversion using another method i.e VLF which is done by Realita [9]. Inversion of VLF shown by Fig. 3. Inversion result shown that at point 40-50 m (E-F), there is lower resistivity value that indicates as seepage and at point 70-80 m (G-H) there is fracture consist of air. Both resistivity and VLF shown that first line has range resistivity value

of subsurface 0-200 m and the point where the seepage and fracture was occurred shown by similar resistivity value.

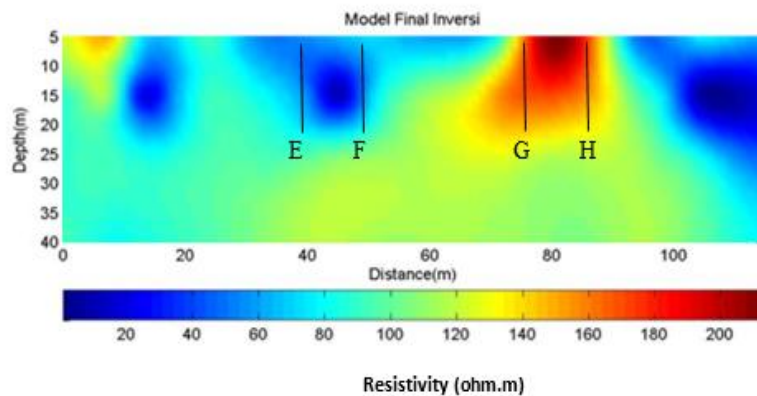
Figure 3. Inversion model of first line using VLF method.

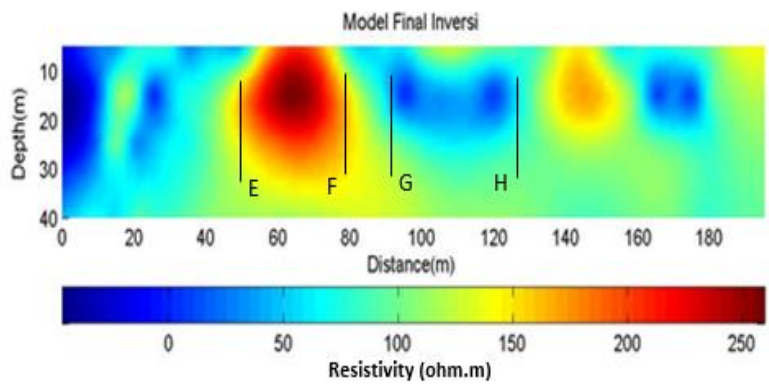
Figure. 5. Inversion result of second line with VLF method.

The inversion result using resistivity compared by VLF method [6] that shown by Fig. 5. From VLF method explain that at point 45-80 m (E-F) suspected as fracture and at point 95-120 m (G-H) suspected as seepage. Third line has range of resistivity value 3-181 ohm-m and the subsurface consist of similar material like first and second line. The inversion model shown by Fig.6. The result obtain higher resistivity value that suspected

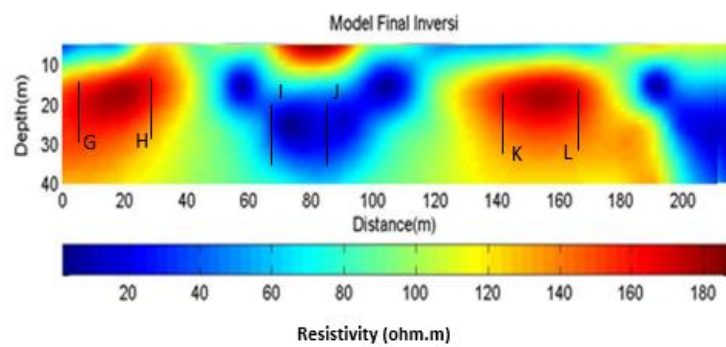
Figure. 7. VLF inversion of third line.

as fracture consists of air at point 20-35 m (A-B) and 110-140 (E-F) m and then at point 55-75 m (C-D) has lower value. The inversion result compared by VLF method. Inversion model shown by Fig. 7. From VLF inversion, the fracture is occurred around 20 m (G-H) and 140 m(K-L), and seepage is occurred at point 60-80 m (I-J).

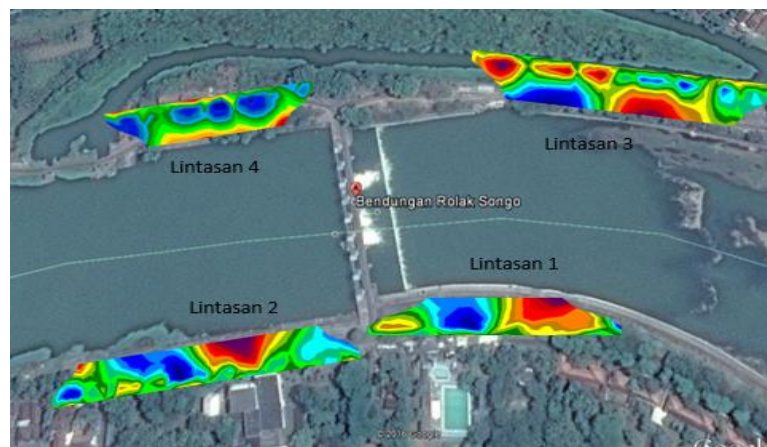
Figure 9. Vertical section for all lin

Fourth line has range of resistivity value 27,2-52 ohm-m shown by Fig. 8. From this resistivity value the material of subsurface consist of sand, sand gravel, and sandclay. The result of the embankment at line 4 is obtained that no anomaly in there. The vertical section is shown by Fig. 9. From the measurement is obtained evaluation result i.e first line, second line, and third line have potency of landslide, fourth line has no potency or minimum of potency of landslide.
