# UNSAFE ACT AS THE RISK FACTORS OF ACCIDENTS IN USING MILL IN ROOF TILE INDUSTRY AT PEJATEN VILLAGE TABANAN REGENCY

Sutjana, D.P.; Adiputra, N.

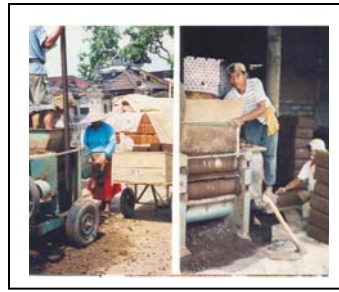
- a. Careless. During milling process some time the operator work with talking to the other worker, so careless with their task. In that case part of his body enter to the dangerous part of the mill such as rollers, gears and crushed it.
- b. To push the row material using foot or hand. To speed up the mill process, the operators went up to the in let of the mill and push the raw material with his foot or hand (Fig.4). The machine had no proper protective device, his toes or heel or plantar foot or his fingers might enter the rollers, and at that time crushed by the roller. This unsafe act was the highest cause of accident.

Figure 4 The mill operator push the raw material using their foot or hand

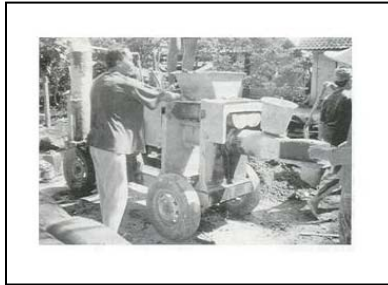
- d. Cleaning the mill. After finishing of milling process the operator clean all part of mill including the rollers (Fig.6). Before start to cleaning they did not turn off the machine. During cleaning the mill some time their hand or fingers enter the roller or gears and crush their finger or their hand.

Figure 6 the operator clean the mill

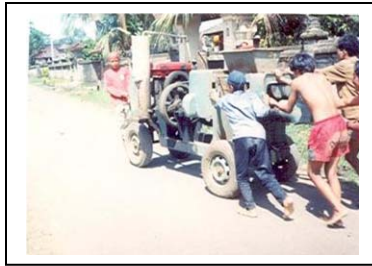
- e. Moving the mill. If the operators need moving the mill to the other place, they push the mill, helped by other person (Fig. 7). During moving the mill some time the machine still on and the mill gears did not cover properly. At that time the hand or finger of the pusher some time enter the gear and crush it.

Figure 7 Moving the mill to other place
