Phosphoric Acid Increases the Porosity and Extends the Contact Area of Dental Osseo integrated Implants

Abstract— *The surface treatments are performed in dental implants in order to increase the chemical and mechanical connection between the implant and bone, favoring the stability of implant-supported prostheses. The aim of this study was to characterize dental implant surfaces treated with 37% phosphoric acid. Implant surfaces were evaluated divided into groups of fifty samples being distributed in: porcelain samples without treatment; metal samples without treatment; porcelain samples with treatment with 37% phosphoric acid for 30 seconds; metal samples treatment with phosphoric acid at 37% for 30 seconds; porcelain samples with treatment with 37% phosphoric acid for 60 seconds; metal samples with treatment with 37% phosphoric acid for 60 seconds. The samples were characterized by Scanning Electron Microscopy. After the phosphoric acid treatment porosity changes were observed and expanding the contact area. The results show benefits of using phosphoric acid, as a surface with increased roughness; this is desired to occur matrix deposition and growth of bone tissue and facilita

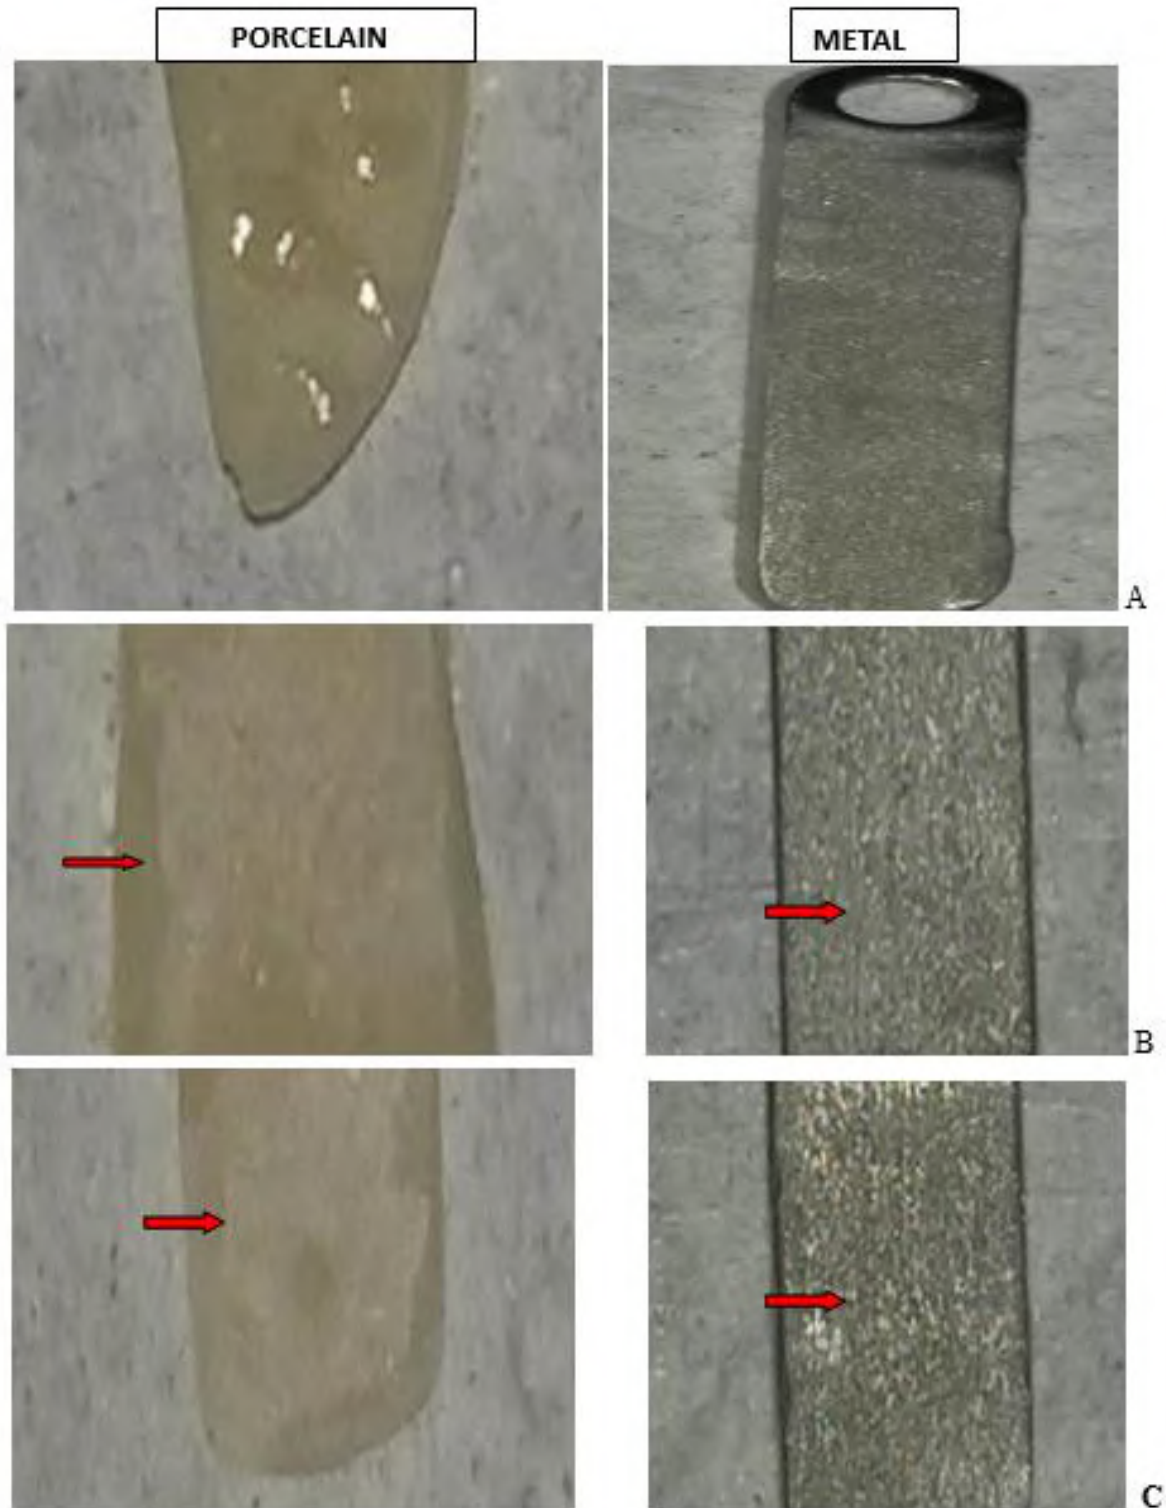
Fig. 1 -1: Visual appearance of porcelain and metal samples without treatment with phosphoric acid attack (A) with phosphoric acid treatment for 30 seconds (B) and treatment with phosphoric acid for 60 seconds (C).

After treatment of the samples with phosphoric acid application at 37% were observed on the surface changes as a function of time. The exposure to phosphoric acid made more opaque surface. Figure 1 shows the differences between the samples without attack on the inner surface of the prosthetic implant and the external surface of the implant, in the presence or absence of phosphoric acid treatment.

What is observed is that surfaces of both porcelain and metal before the treatment with 37% phosphoric acid are smoother and therefore more homogeneous (A), where these surfaces are exposed to the treatment with phosphoric acid 37% for 30 seconds characteristics of surfaces are becoming opaque and therefore less bright (B), however the images in (C) after the surfaces were exposed to treatment with phosphoric acid at 37%, for 60 seconds, the surfaces have much more opaque and less bright, suggesting that the higher the greater exposure to acid changes in their structure.

It is observed that after 60 seconds of treatment with phosphoric acid the surfaces of both porcelain and metal feature are changed, as indicated by arrows in Figure 1.

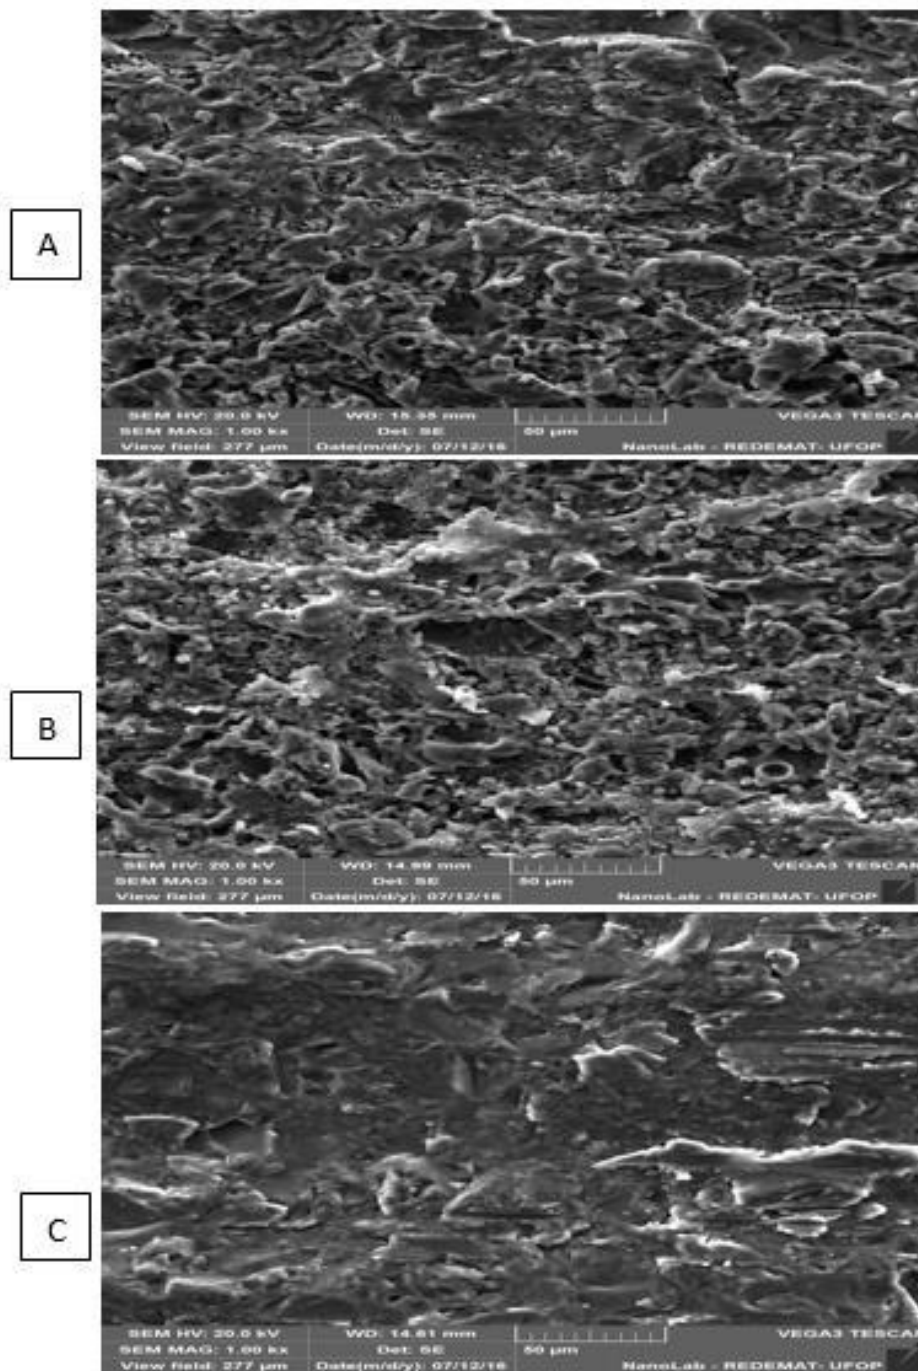
Fig.2: Photomicrograph of porcelain surfaces; in A the untreated, in B treated with phosphoric acid and after 30 seconds and in C treated with phosphoric acid after 60 seconds (SEM image at 1000x magnification).

In Figure 2 is the analysis of the porcelain surfaces treated and not treated by phosphoric acid at 37% in the scanning electron microscope, there is an area treated with strong porosity.

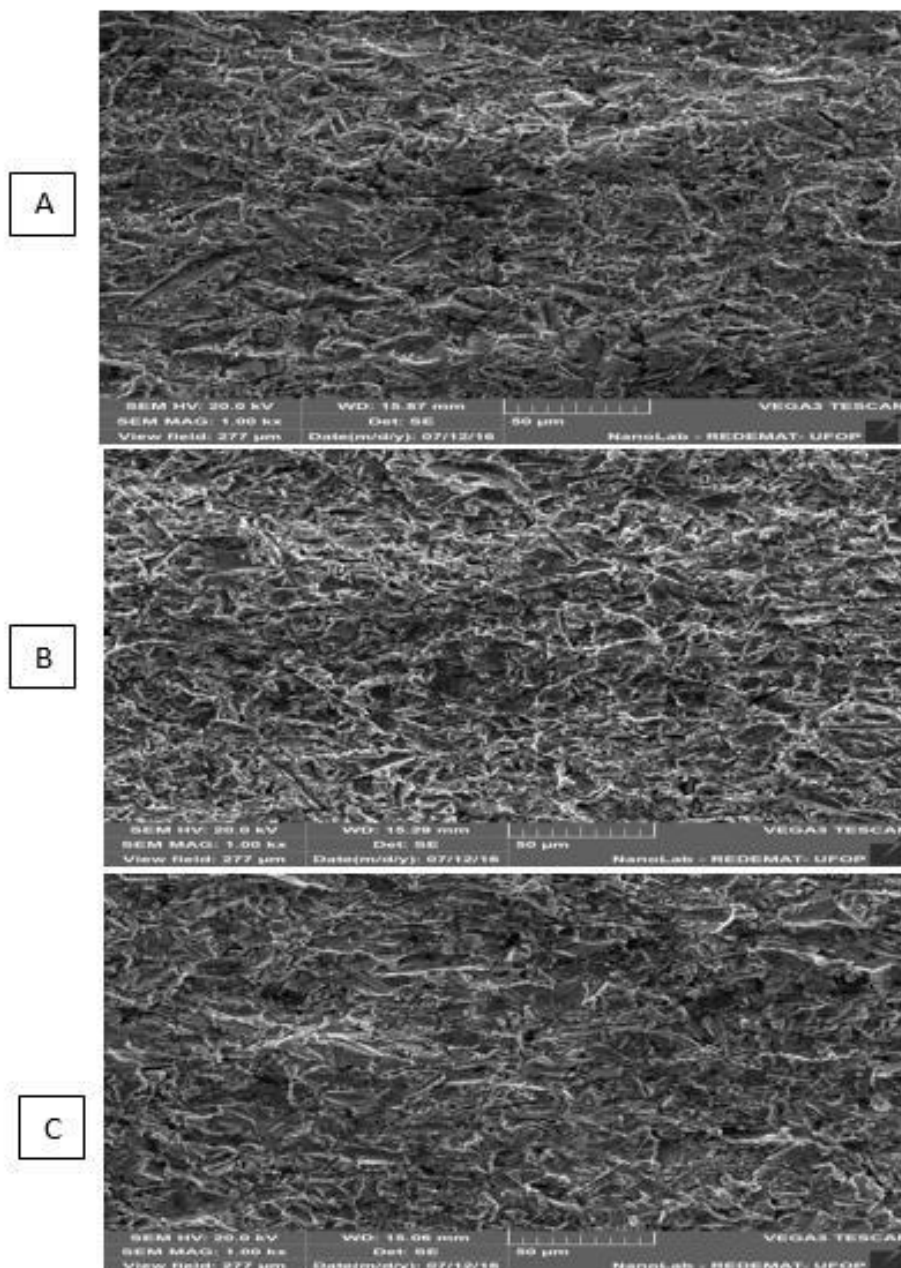
Fig.3: Photomicrograph of metal surfaces; in A the untreated, in B treated with phosphoric acid and after 30 seconds and in C treated with phosphoric acid after 60 seconds (SEM image at 1000x magnification).

Figure 3 refers to the photomicrographs of untreated and treated metal surfaces with phosphoric acid. It is noted that the treatment in metal was effective for increasing the contact area with cement, which may improve the attachment the prosthesis.
