The Effects of Air Pollution on Damages in Historical Buildings, the Case of Gaziantep, Turkey

Index Terms— Air pollution, cultural heritage, conservation, Gaziantep, restoration.

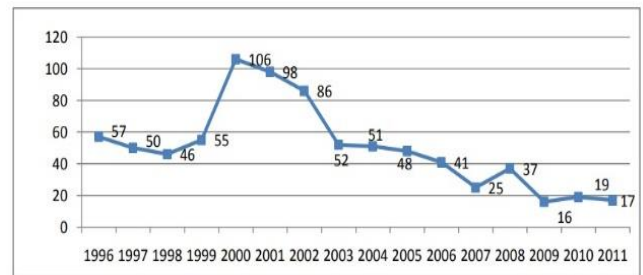
Chart 1. Annual average SO₂ change (1996-2011)

When the annual average SO₂ distribution of the last eight years is examined, it is seen that the average of the six years is above the threshold level set by the World Health Organization (Table 2). It can be said this value reached a high level for all years when examined during the winter season (Chart 1 and Chart 2).

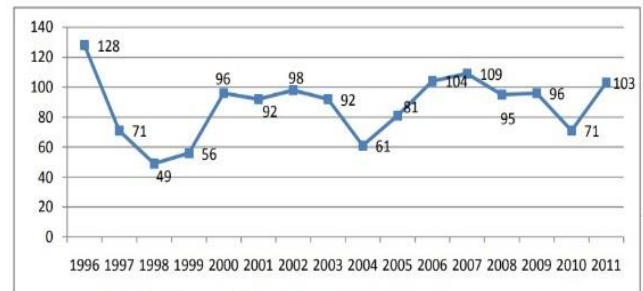
Chart 2. Annual average PM₁₀ change (1996-2011)

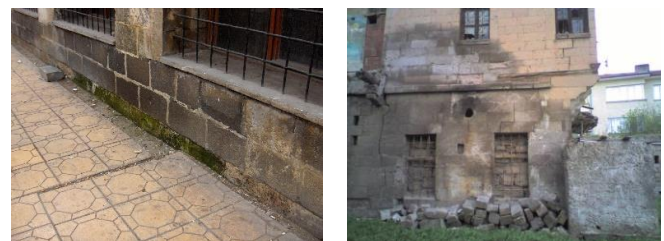
As a result, the surfaces where the rainwater is infiltrated and wetted the roofs, the wet areas formed by the water rising from the walls in regions where collecting the water around the building is insufficient, and the reaction and damage of the particulate matter and gases causing air pollution on the surface of the buildings can be seen in the historical buildings in Gaziantep. It is seen that dry surfaces are cleaner and healthier (Figure 4).

Figure 4. Wet areas on stone surfaces: color change, crusting, salt accumulation

The widespread use of natural gas in the historic city center of Gaziantep will reduce the use of poor quality coal used for domestic heating. Therefore, it is thought that it will have a decreasing effect of air pollution caused by the use of fossil fuel for heating purposes. It is also important to reduce the traffic intensity around historic structures as air pollution, such as nitrogen and oxide, caused by intense pollution, accelerates the chemical reactions that sulfur dioxide gas and particles form on the surface of the stone. In this framework, the completion of the pedestrianization projects in the old city center will contribute to the preservation of historical buildings.

There are not enough researches and findings on the effect on the long-term structure of the surface-protective chemical substances, while reducing the deterioration effects of the short-term. For this reason, it is considered that the use of surface preservative chemical substances in reducing the deterioration due to air pollution in the Gaziantep buildings is not an appropriate approach in today's conditions. If air pollution is reduced, deterioration caused by air pollution will not progress. However, a separate investigation should be carried out to determine the protection methods applied to the degraded stones. It may be necessary to remove the salts that have affected the degradation of the stones. How to do such a study or how to clean the contaminated areas without damaging the stone should be determined by working with a material protection laboratory that conducts research on these matters.
