ECOLOGY

GEO-ECOLOGICAL STUDY OF CENTRAL PIPELINE CORRIDORS IN GEORGIA

Tbilisi State University, Caucasian Alexander Tvalchrelidze Institute of Mineral Recourses

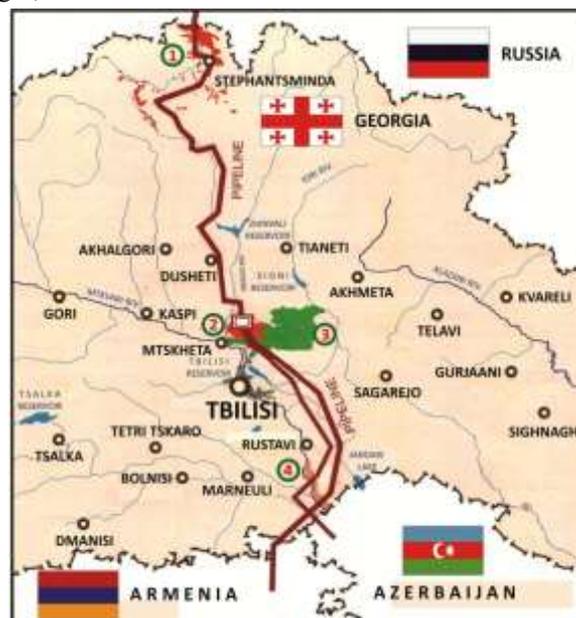
Fig.1. Kazbegi-Red Bridge gasoline schematic map

1 - Kazbegi State Reserve; 2 - Saguramo State Reserve; 3 - Tbilisi National Park; 4 - Gardabani reserve.

The present article contains research materials that were obtained during rehabilitation works on North-South gas pipelines. The completed works mainly cover the first stage of the study, where the geological and ecological situation in the pipeline corridor was determined. Work was carried out on a pipeline with a diameter of 1200 and 1000 mm and was intended for the corridor of safety and adjacent territories (see Fig.1).
