Resisting Timber Joint Performance of Karo Wooden Building

Khairussa'diah and Yulianto P. Prihatmaji

Abstract

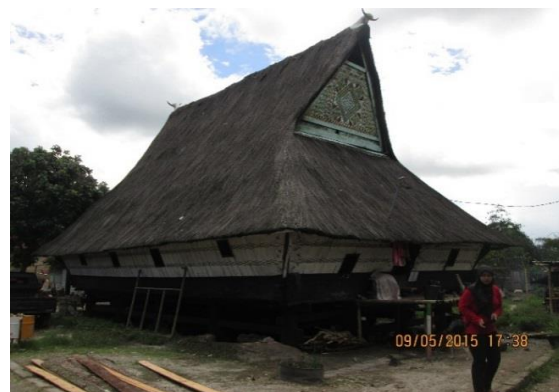
Figure 1. Wooden house Siwaluh Jabu of Karo Batak tribe (Prihatmaji and Widodo 2015).

Wooden house of Karo known as Siwaluh Jabu. Nowadays its existence has been difficult to found. In 2011 Lingga village only four houses left, but due the earthquake that occurred a few years ago, two of them are collapsed and could not be occupied again (Prihatmaji and Widodo 2015). Siwaluh Jabu is very famous with the beauty of architecture which is typical, stout and sturdy and decorated with philosophical values ornaments. Form, function and meaning from Siwaluh Jabu illustrate the close relationship between human each other and also with natural environment. Selection of materials for Siwaluh Jabu and the construction process without the use of nails, iron or wire binding, but using pegs and rope fibers adds to the uniqueness of Siwaluh Jabu (Sembiring 2010).

Pillars resting on a stone serves as base isolation in a wooden house. This system is called base isolation because the poles are not contact with the ground directly, but rests on a rock. As a result, these wooden houses can move from its original location when receive the lateral seismic loads. Moreover, it can cause vibration damping effect of the earthquake (Pudjisuryadi *et al.* 2007).

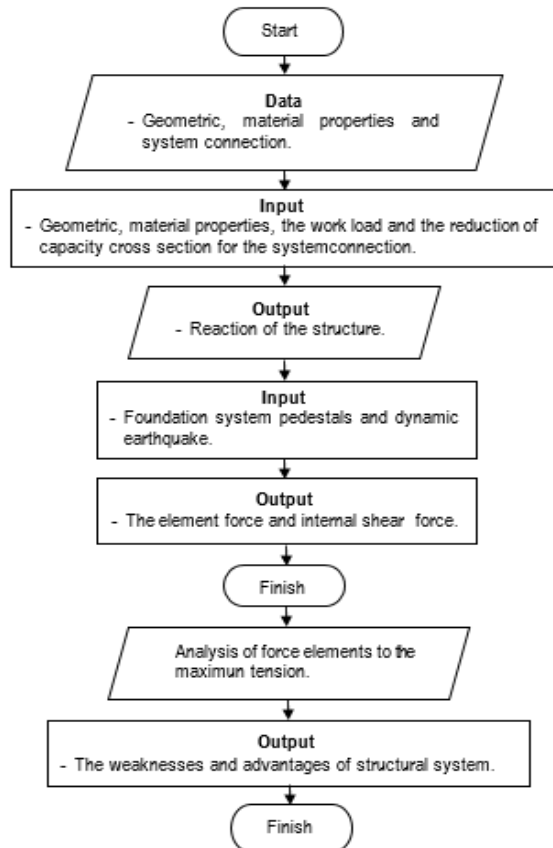
Figure 4. Analysis of the structural strength from the program SAP2000.

SAP2000 program will help analyze the strength of the structural elements to the maximum voltage that occurs (Satyarno *et al.* 2012), so that it can be known weaknesses and strengths of the system structure of wooden Batak Karo house.
