**Research Article**

**Clay and organic matter applications on the coarse quartz tailing material and the sorghum growth on the post tin mining at Bangka Island**

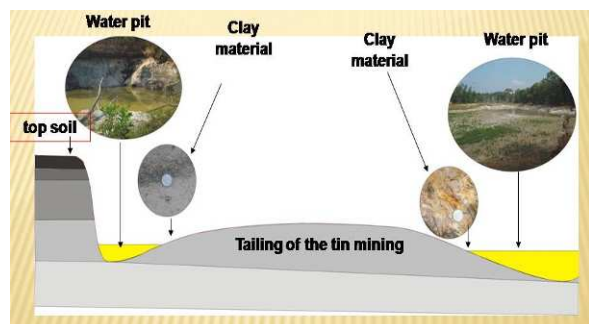
Figure 1. The land surface on the post tin-mining activity

In the process of extraction tin with a spray method can leave a coarse material deposited directly on the site. Then the fine-sized material is slowly deposited gradually in accordance with the size of the material. With the size of very fine material, forming a layer

which sediment is impermeable to water. In the advance of small basin land as a result of excavation until the tin ore is found then the basin becomes water reserve a place called the pit water (Figure 1). The presence of the pit water could potentially be used as irrigation water in reclamation by re-vegetation when the plant needs water.

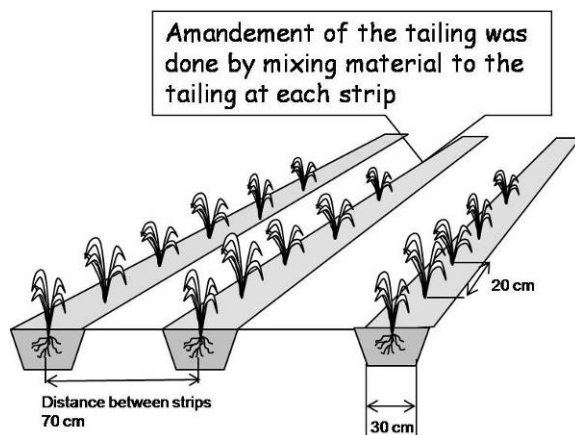
Figure 2. Model of the reclamation on the tailing of the post tin-mined land

The experiment was set by constructing the planting strips with distance of 70 cm. In order to minimize the requirements of the amelioration materials, the amelioration was done by mixing it with the tailing only on the strips of the planting at 30 cm in width and depth.

The combination of tailings, clay and organic matter alone could not suffice and provided good conditions for plant growth. This was because the clay used did not have enough nutrients, and this was shown by the growth of sorghum plants were stunted. In this study the application of amendments made in the form of strip so that the costs used to improve tailing were low (Figure 2).

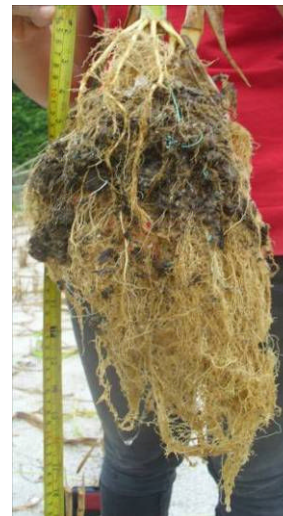
Figure 3. The roots of the cultivated sorghum at the treatment of the clay + OM + NPK.

The present study showed that sorghum plants can grow well in media with acidity levels and also a high percentage of exchangeable Al. This was shown by morphological roots that grow well (Figure 3), so that plant roots can grow well without showing any

Figure 3 also showed that root growth was in the zone of tailing that had been improved by the additions of clay and organic matter. This treatment could enhance the media's ability to absorb water and provide adequately for sorghum plants, especially when the media did not receive water supply. Management of sandy soils was based on the soil characteristics and crop suitability to achieve sustainable (Zhao et al., 2005). In addition, nutrients were added in this study, that were nitrogen, phosphorus and potassium, could be stored and then available in the exchange complex. As for that was not added clay could be made possible many of these elements were leached. This was indicated by stunted growth in other two treatments of NPK + OM and clay + OM, and moreover those without treatment (control) plants can only survive within a month.

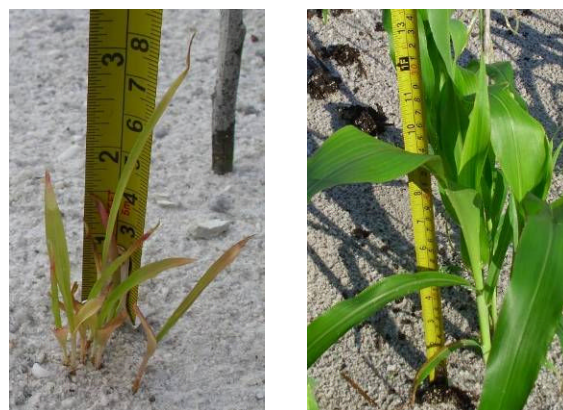
Figure 4. The colour of sorghum leaves at control (left) and the treatment of clay + OM + NPK (right) after three weeks.

There was a very clear distinction between the treatments with complete and control on sorghum leaf colour (Figure 4). In the control treatment, leaves showed yellowish green in colour and then gradually became red and leaf tip showed a purplish red colour. The leaf colour might indicate that the control treatment there was deficiency of macro elements of N, P and K, while for the other three treatments showed the adequacy of the third element of the macro nutrients. Sorghum was reported as very responsive plant to N and P nutrients (Booker et al., 2007). The change of leaf colour is caused by a deficiency of nitrogen element that few of  $\text{NO}_3^-$  and  $\text{NH}_4^+$  are transported through the phloem, resulting in discoloration and eventually chlorotic. Sorghum

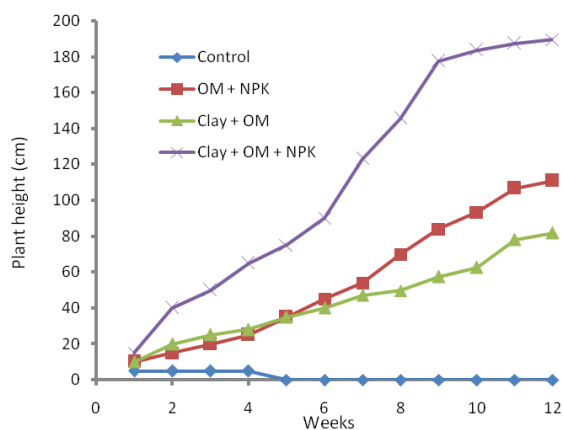
Figure 5. Plant height of the sorghum that cultivated on the tailing after reclamation

Figure 5 shows a very obvious difference between the height of plants that received the treatment and control. Sorghum plant height increases linearly and significant up to 13-week-old plants on tailings that were given a mixture of clay + NPK + OM. This was supposed due to the addition of clay media structures originally single grain to be structured so might hold water longer to suffice the needs of plants. In addition former tin mine tailing was very poor in nutrients can be improved by the addition of organic matter (OM) and NPK fertilizers so nutrients become available.
