THE IMPROVEMENT OF BUILDINGS AND INFRASTRUCTURE CONDITION TO ANTICIPATE DEGRADATION PROCESS OF FISH-SMOKING CENTRE IN BANDARHARJO, SEMARANG

Gagoek Hardiman

Laboratory of Building Science, Department of Architecture, Faculty of Engineering, Diponegoro University,
Jl. Prof H. Soedarto, SH. Semarang 50275, Central Java, Indonesia

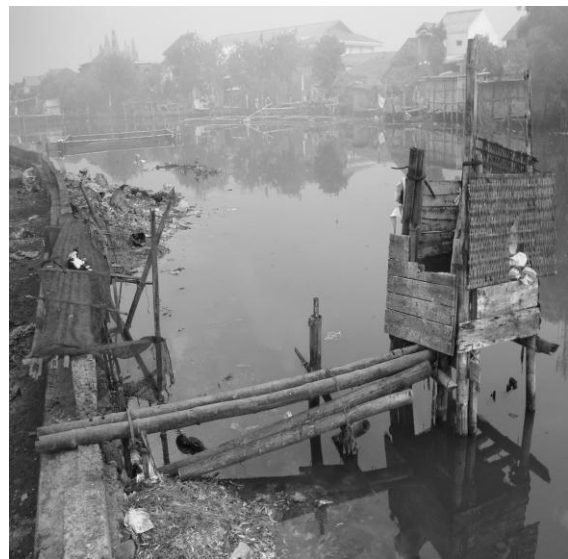
Fig. 12. Shallow well. (left); Toilet is on the riverbank (right).

The toilet is built on the riverbank that the waste directly flows into the river stream (**Fig.12**). Users need to bring their own water taken from the nearby well to wash their hands. There are three toilets in the fish-smoking centre. The toilets are not properly built that they may endanger the users. Besides, the toilets also spoil the aesthetic of the environment. There are no permanent toilets built on the ground and the toilets built by local government have long been out of order.

- Proper toilets need to be built to prevent people from using the toilets at the riverbank.
- It is important to plant more trees in the fish-smoking area. The trees can reduce the emission resulting from fish smoking activities. Trees also provide shady spaces for parking area, rest area, and spots for vendors selling food and drink.
